# Saving the Day: On-line DGA Monitoring Case Studies

**The use of on-line DGA monitoring has allowed the detection of developing faults in transformers in a timely manner.**

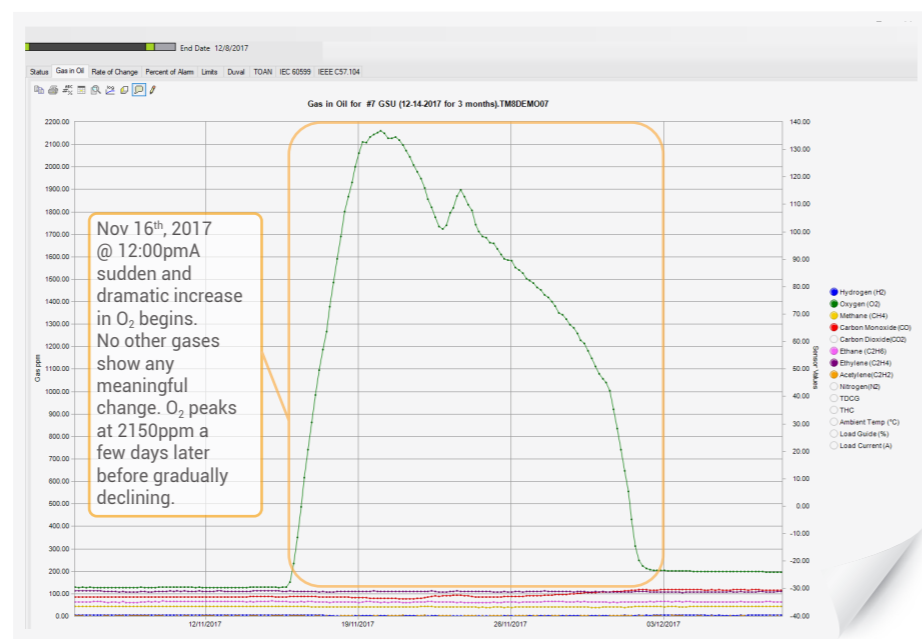
An 8 gas monitor is monitoring an old (30+ years) 3-phase 230kV shell-form nitrogen (N<sub>2</sub>) blanketed GSU. At midday on Nov 16<sup>th</sup>, the monitor alarmed for increasing concentration of Oxygen (O<sub>2</sub>), which had been stable at 130ppm for an extended period. Over the course of the following 3 days O<sub>2</sub> concentration continued to increase, peaking at 2,150ppm before gradually declining back to a stable 200ppm.

The sudden O<sub>2</sub> increase, with no associated change in any other gas indicated that the O<sub>2</sub> originated from the atmosphere. The supporting vendor experts suggested that the transformer may have had an atmospheric air injection and requested the operator to investigate. Upon a physical examination of the transformer, it was noticed that there was a leaky manhole cover gasket and that the pressure of the nitrogen blanket was close to atmosphere. It was determined that a partial vacuum occurred in the transformer during a cool down that resulted in atmospheric air being sucked into the transformer.

N<sub>2</sub> pressure does not prevent entrance of water — only a good gasket seal does.

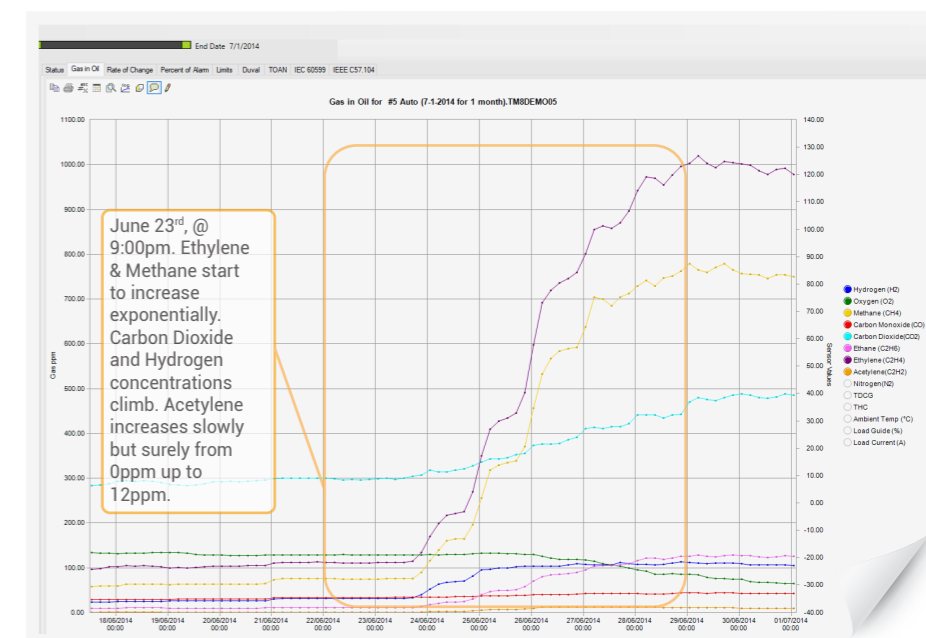
Figure 1: TRIANGLE 1. Thermal Fault >700°C

transformer had been heavily loaded at the time and that increasing load correlated well with increasing gas production. Reviewing the DGA data, Duval Triangle 1 indicated High temperature overheating while Triangle 5 indicated Medium to High temperature hot spots.

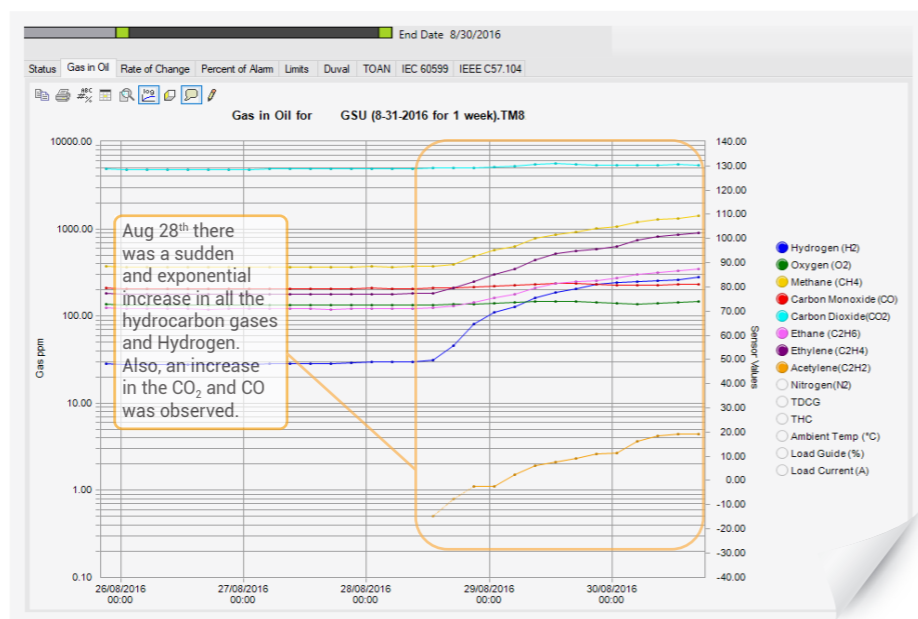
An 8-gas DGA monitor was being used to monitor a 3-phase, 1100 MVA, 345 kV GSU transformer. While gas concentration for all gases were relatively high and stable there was a sudden exponential increase on Aug 28<sup>th</sup>, 2016, at midday. While not recorded in the chart the transformer load was reduced by 50% after 48 hours of gassing and was reduced to zero load 8 hours later when it became obvious that

paper had occurred. With paper stripped back from the crimped ends of the LV connection there was evidence of hot metal damage. Thus, it was concluded this was the site of the gas production.

The conclusion in this case was that the root cause was a combination of high eddy losses in the crimps, overheating because of over-insulation of the LV crimped connections and poor oil circulation in the crimped bundle areas. Remedial work was undertaken, and the transformer was subsequently put back into service.

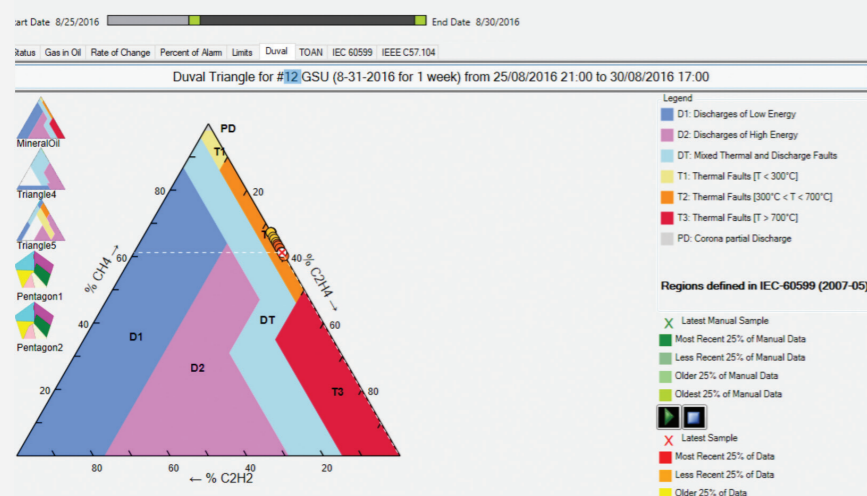
Figure 3: TRIANGLE 1. Thermal Fault 300°C – 700°C

Table below represents Results of reviewing the DGA data on a range of common diagnostic systems. This is all performed automatically. All diagnosis systems pointed to a thermal fault >300°C with some suggestion that there was paper involved in the fault.

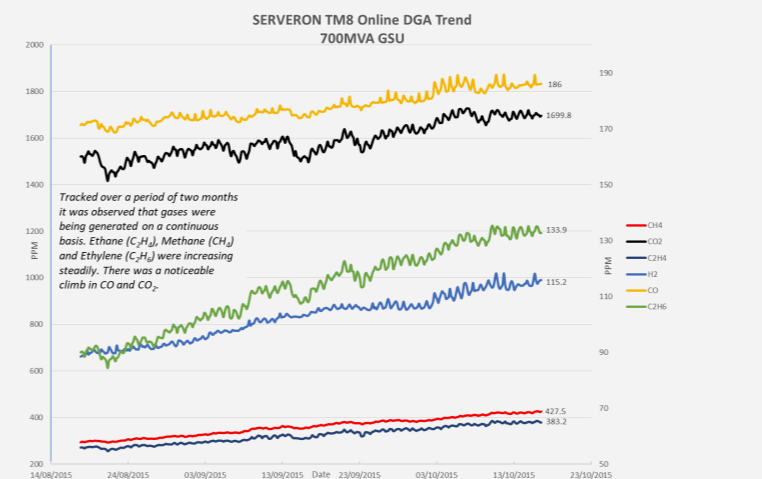
Monoxide. Unsure as to the nature of where and when these gases were being generated, a monitor was employed to provide hour by hour tracking of gas generation (Figure 5). Reviewing the DGA data with vendor software resulted in the following fault indications.

Figure 5: A gradual climb in 6 key gases was noted. There was no acetylene (C<sub>2</sub>H<sub>2</sub>), meaning this fault had not yet advanced to include any arcing. The continuously increasing gas levels were a significant concern.

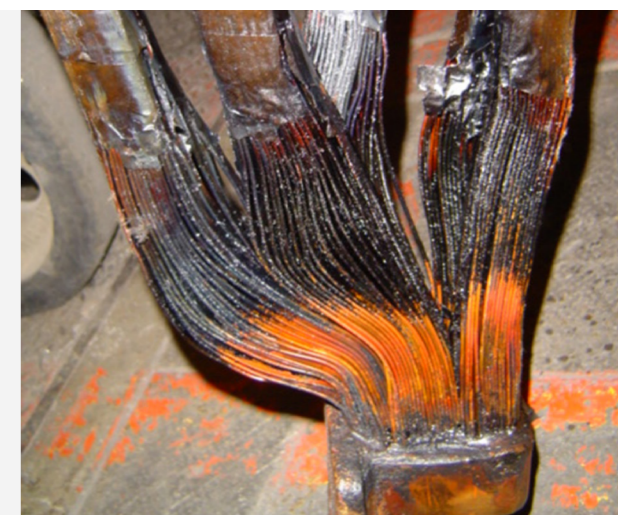
Physical inspection revealed evidence of significant overheating at the site of a brazed connection at the bottom end of the LV winding lead (Figure 6).

(C<sub>2</sub>H<sub>6</sub>) there was also charred / burned paper which would have created CO and CO<sub>2</sub>.

In addition to the discoloration of the metal associated with overheating (the source of the ethane (C<sub>2</sub>H<sub>6</sub>), methane (CH<sub>4</sub>) and ethylene

Figure 6: Overheated brazed connections at the bottom end of the LV winding lead.

This transformer was repaired, together with appropriate design changes, the leads were retaped where the paper was significantly damaged and put back into service.
