# Risk Management Requires Actionable Insight:

# Adding Value with Truly Integrated Transformer Monitoring

by **Marco Tozzi**  
+++++

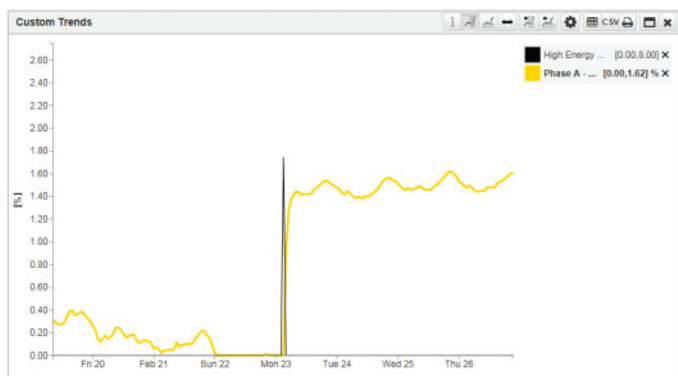
On February 2015, a sudden step increase of the capacitance (C1) in bushing A was detected by the monitoring system, estimating a capacitance change in the order of 1.7% which corresponds to a rough increase of 7 pF. Such a small change could have been caused by a partial short circuit between two layers in the condenser core, considering >60 control layers for 345 kV bushings. KEPCO planned an offline test to confirm the online readings, but the results proved difficult to interpret. Indeed, the absolute value of bushing A capacitance had not changed significantly from the previous measurements, as shown in Table 1.

Figure 2. Capacitance increase in bushing A1 and high energy event recorded at the same time

It was then found that at the precise moment of the bushing capacitance increase, a high energy event (partial discharge activity with significantly high magnitude, generally equal or higher than 20 V peak-peak [6]) was recorded in the same phase (from same sensor) by the online monitoring system. In this case, the recorded event had just 8 pulses per second and it happened just once. The fact that this event was recorded in conjunction with the capacitance increase was an important detail that prompted an additional offline test: oil sampling from the bushing and Dissolved Gas Analysis (DGA). Table 2 reports the results of the DGA analysis for bushings A and C. It can be clearly seen that the amount of acetylene in bushing A is well above the tolerance values, being 76 ppm; while level of acetylene in bushing C was zero, as expected.

Following the results shown in Table 2, KEPCO promptly planned and executed the bushing replacement within a few months, thus saving the bushing from a potentially catastrophic incident. It must be noted that the repetition rate for both the capacitance change and the high energy event were quite small in terms of absolute magnitude. But being able to detect both these phenomena online and see that they occurred in the same moment provided crucial information enabling KEPCO to take a very successful action.

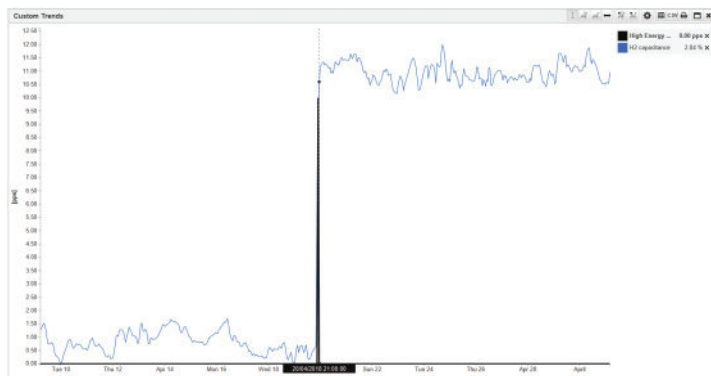
Similarly to Case #1, a sudden step increase of the capacitance (C1) in bushing H2 was detected by the monitoring system, estimating a capacitance change in the order of 2.9%, which can correspond to a short circuit between two layers.

By looking at the data it was observed, once again, that a high energy event was recorded in conjunction with the capacitance increase in the same phase. Figure 4 shows the recorded data (not averaged, published every hour) and the partial discharge pattern. The event was characterized by impulses with significant magnitude (60 V peak-peak) and very small repetition rate (just 6 pulses per second), almost describing a sudden arcing activity. Recognizing the same correlation pattern (capacitance change + high energy event) seen in the KEPCO case, it was then suggested to the utility to take an oil sample of the bushings.

Figure 4. Capacitance increase in bushing H2 and high energy event recorded at the same time

Table 3 reports the comparison between the DGA from bushing H2 and H1, showing the acetylene concentration exceeding 20 ppm in the bushing where the capacitance change and high energy events have been detected, confirming the online analysis and enabling the utility to immediately plan the bushing replacement. The correlation of partial discharges and bushing monitoring data, along with proper offline tests, was successful in identifying the problem at a very early stage, optimizing the maintenance (in this case truly condition-based) and ultimately saving the transformer.

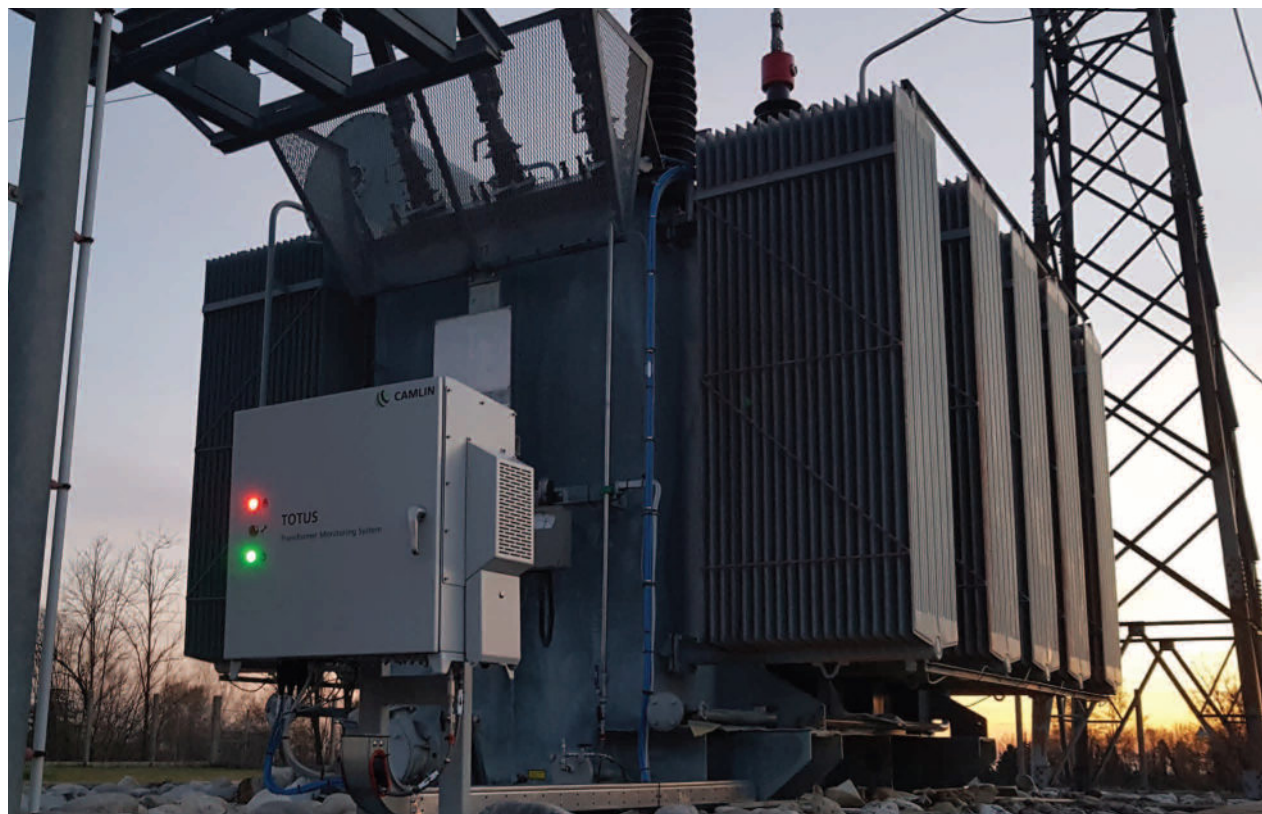
Figure 5. Online holistic monitoring system installed in 25 MVA GSU

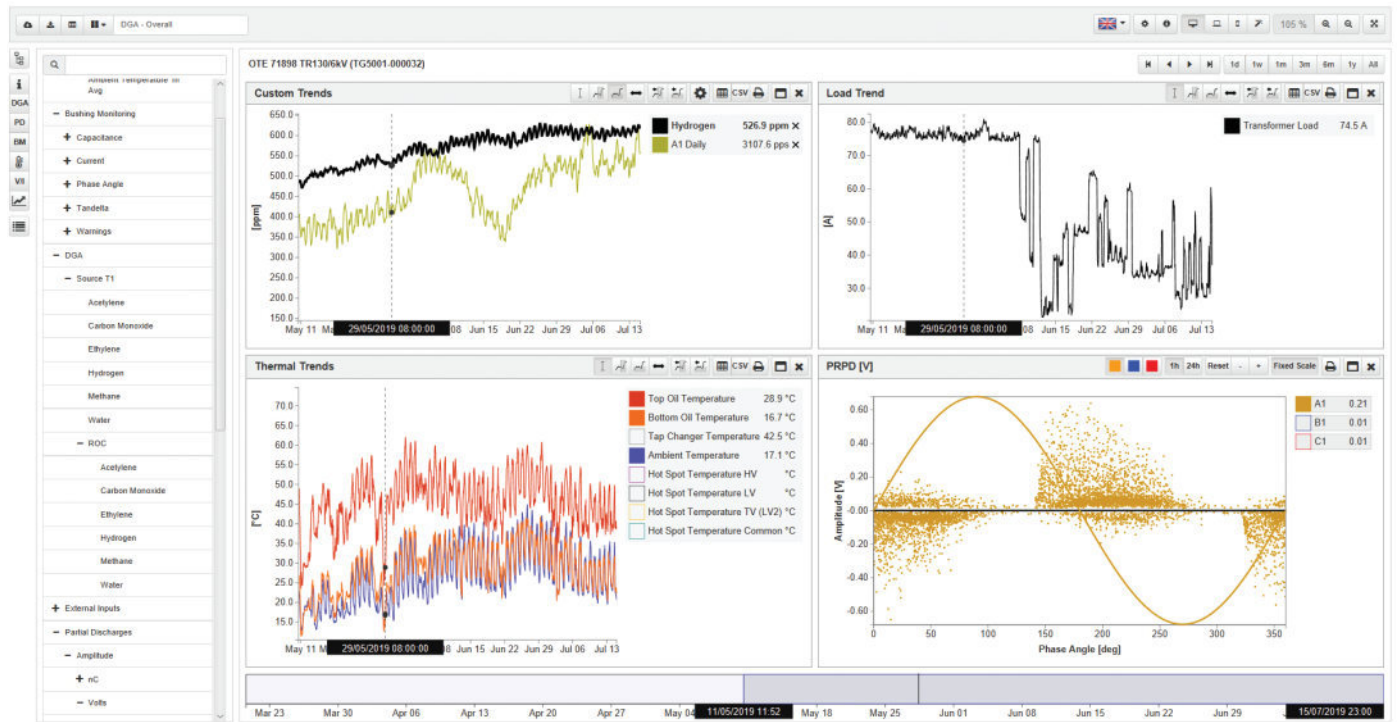
- After a first H2 increase of about 4 ppm/day, the subsequent two months showed that the H2 was still increasing but with a lower rate, at about 1.6 ppm/day, reaching an absolute ppm level of roughly 700 ppm. All other gases had normal concentrations. There was clearly an active defect.

- Looking at all the data collected by the holistic monitoring system, it is possible to see that there is almost no correlation between data. The gas generation and partial discharge activity are not influenced by the load, nor by temperatures and humidity.

Figure 6. Online results synchronized and visualized in a way to enable further investigation on the possible correlation

The first speculative analysis, after having looked at the online data, was leading towards the possibility that the defect was likely to be due to the last oil filling process that apparently had not been carried out under vacuum (due to the fact that gaskets are not suitable for the vacuum process).

- Keep the transformer monitored and under control in order to analyse the gas and partial discharge development during the next few months.
- Plan the gasket replacements in order to perform a proper oil treatment and refilling under vacuum to remove any possible trapped bubble.
- Agree that maintenance was to be planned. However, this could be deferred to the next stop of the generator considering that:
  - the overall picture provided by the online monitor indicated that the transformer was not in a critical condition, and
  - the transformer was continuously monitored so any unexpected change in the condition would promptly notify the Subject Matter Expert.

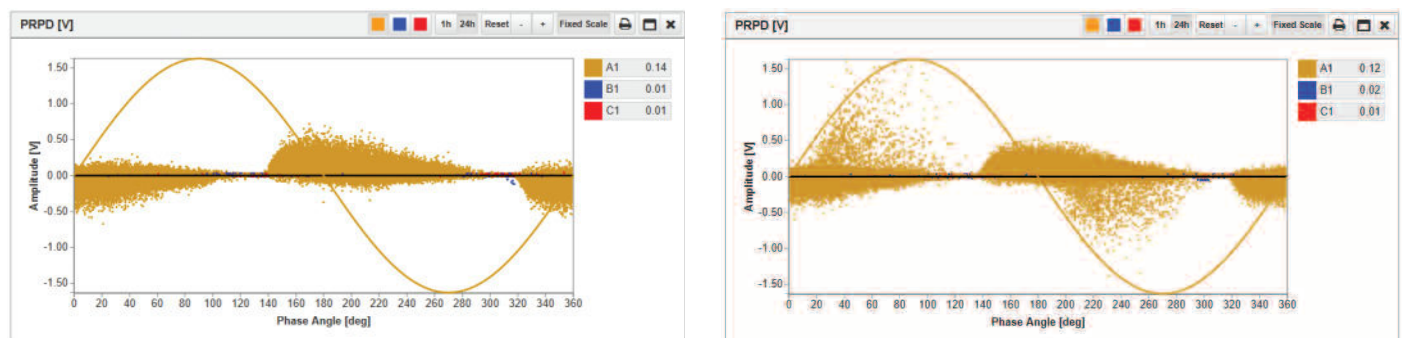
- The first is always present and constant in amplitude and repetition rate (5000 pps) with indirect polarity and typical for defects inside the main tank (including the bushing turrets, i.e. whatever is outside the bushing core). This activity has no cross coupling with the other phases which means that the source is far from the other two phases or very close to the partial discharge sensor.

- The second is sporadic, with smaller repetition rate (in the range of 1000-2000 pps) and with direct polarity indicating that it could be inside or very close to bushing A. The overall partial discharge activity was increasing over time in terms of repetition rate, indicating that the active defect was in phase A.

- From the phase-resolved partial discharge (PRPD) pattern it was difficult to identify the partial discharge source, however similar shapes of the pattern had been recorded when the oil treatment was not conducted properly leaving small air bubbles trapped, or when small puncturing activities were present in the paper insulation on the top of the winding column (e.g. in the stress ring).

Figure 7. PRPD pattern of the stable partial discharge activity in Phase A1 (left) and the sporadic activity overlap (right)
