# Twin Technologies Test Transformer Reliability

by **Allan Rienstra**  
+++++

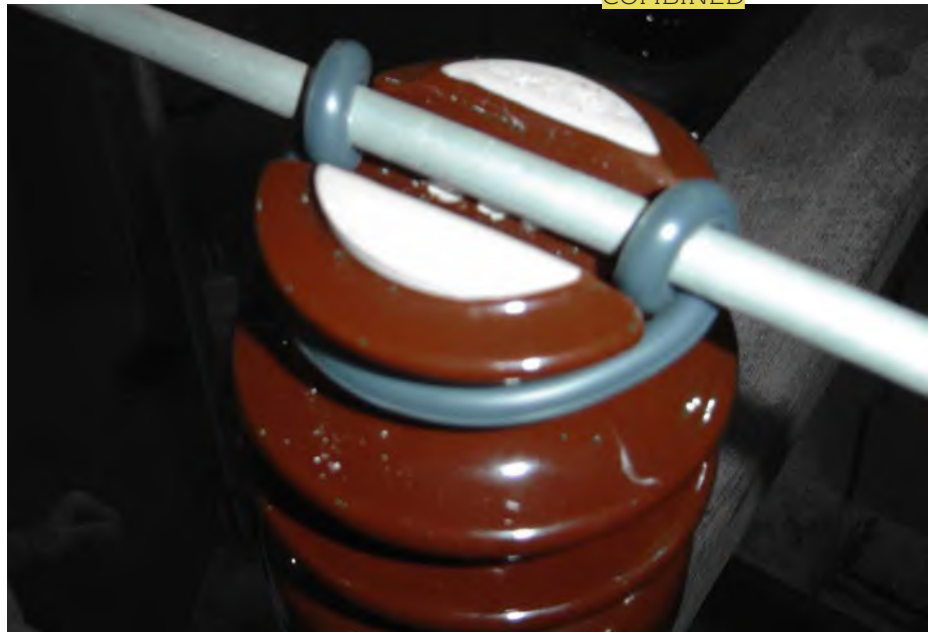
Figure 2. Tracking has begun to erode the enamel coating on this insulator. Moisture can impregnate and either super heat (arcing) or freeze. The insulative properties are failing and partial discharge will only worsen from here.

Figure 2 displays an example of an electrical problem detected in its early stages with ultrasound. The insulator was damaged with tracking which indicates the presence of an equipment fault. When caught at an early stage, it can often be fixed with simple maintenance procedures.

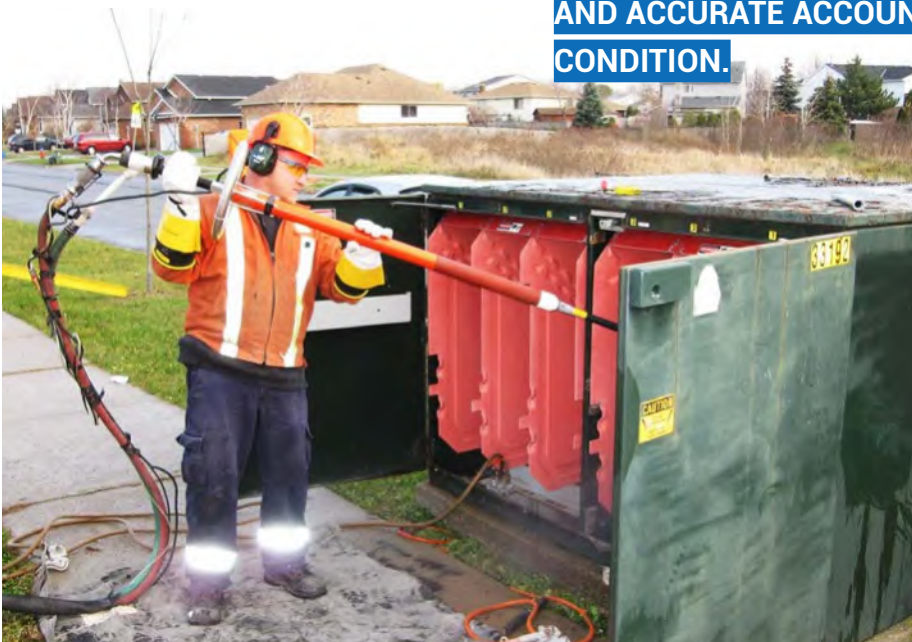
Figure 1. An electrical service technician applies simple dry ice cleaning on a residential transformer.

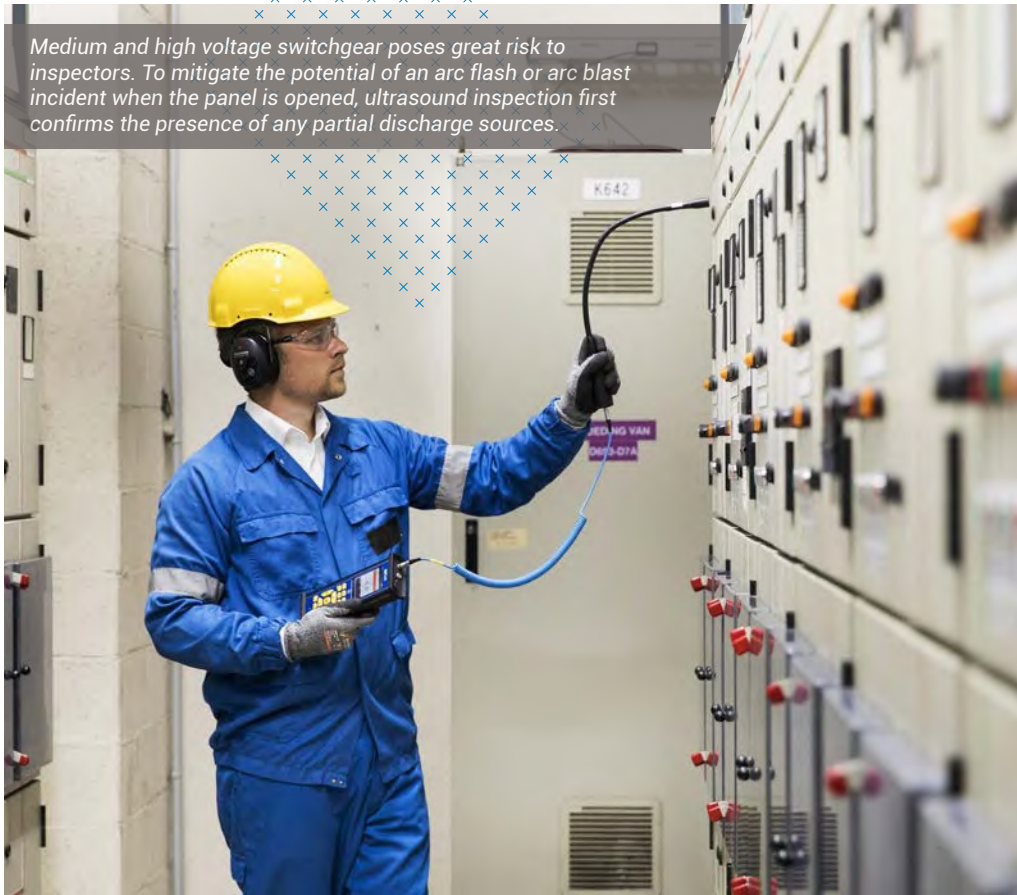
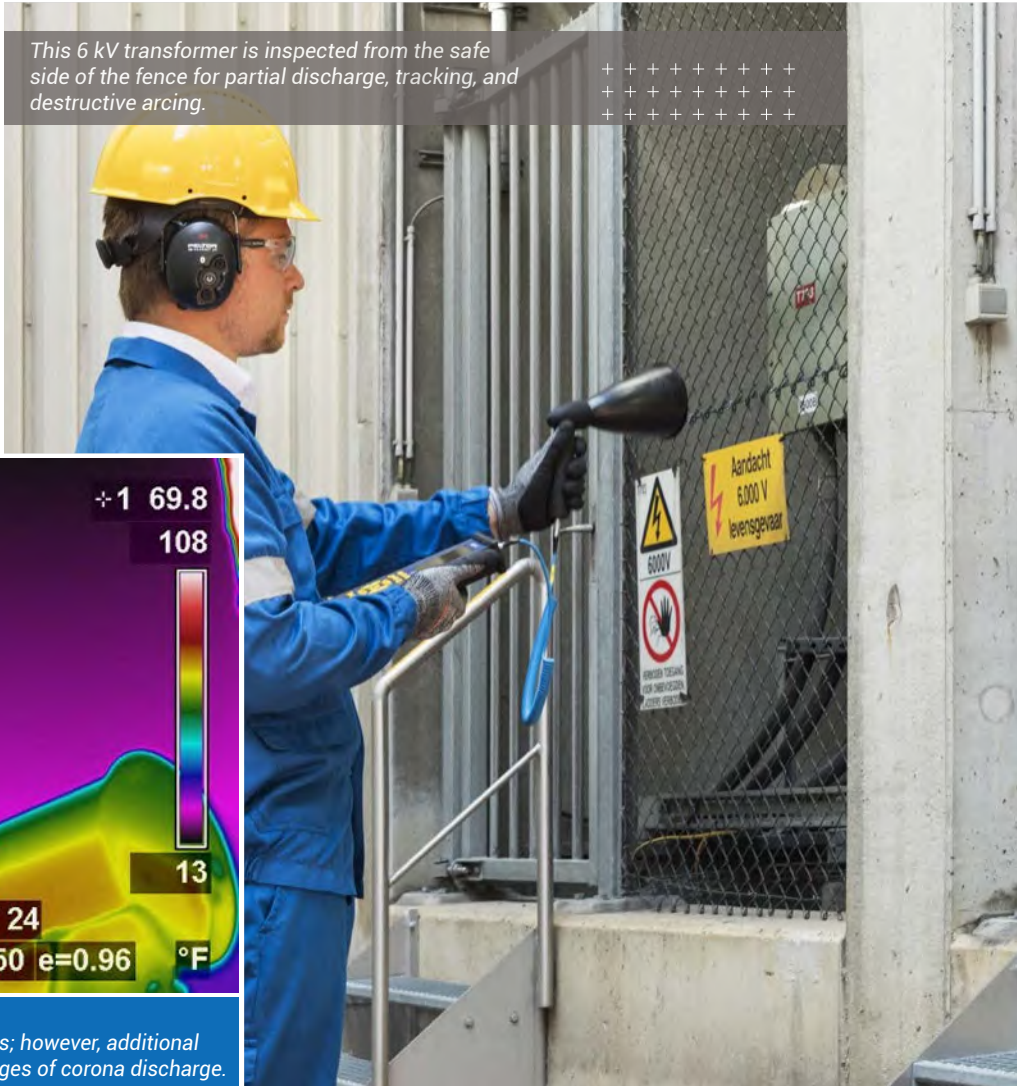
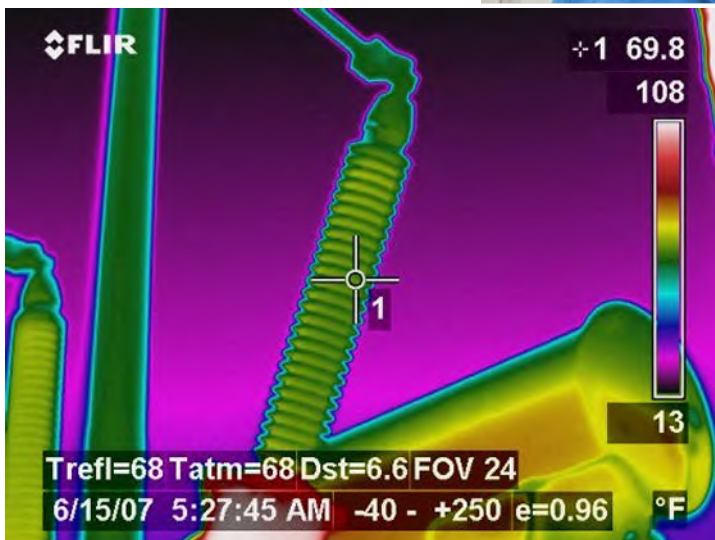
Thermal images from several 161 kV to 13.8 kV step-down transformers were included in Young's report. The infrared image reveals no hot spots on the A phase bushings (Figure 3), but an ultrasound scan produced a sound file with obvious indications of early tracking.

Figure 3. Infrared did not discover any electrical anomalies; however, additional ultrasound scans revealed the onset of early stages of corona discharge.

Similar tracking activity was discovered from the B and C phase bushings, while neither showed any signs of heat when scanned with an infrared camera.

Once the diagnosis was made on the suspect transformers, the decision to perform simple maintenance during the next planned outage was made. Since the problem was discovered at an early stage, the simple maintenance could be done on the terms of the maintenance crew rather than dictated by asset failure. This involved a cleaning and tightening of all connections on A, B, and C phase bushings.

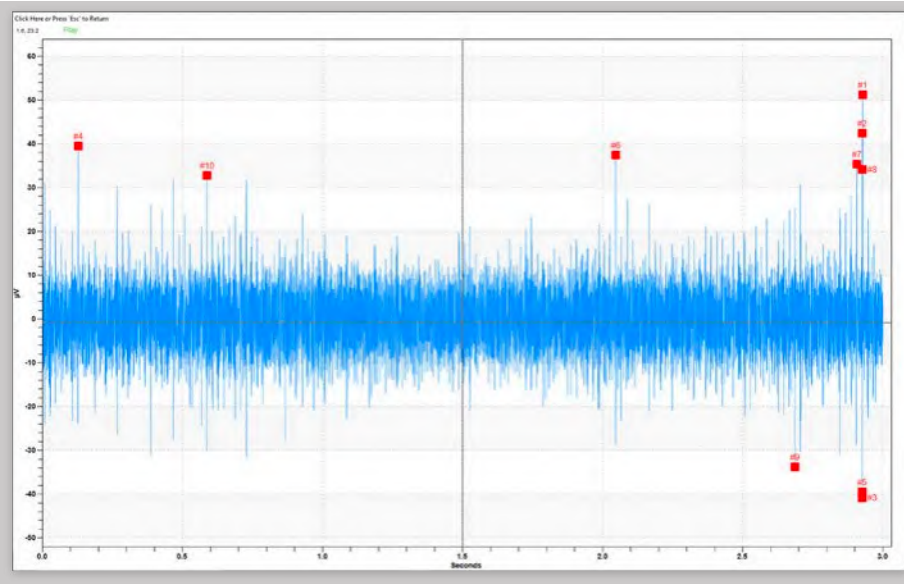
Figure 4. Time waveform taken with SDT270 shows partial discharge activity classified as nuisance corona. Simple maintenance such as cleaning and tightening is required.

Figure 4 illustrates the time domain showing the build-up and release of the ionization discharge as it finds a path to ground. Ultrasonically, we hear the build-up and then a neutralization of the air surrounding the problem. Heat does not build up here until the situation progresses and there is sufficient flow or current to produce heat along the discharge path.

here. First, the repetition of 60 Hz events in the spectrum clearly reveals the presence of nuisance corona at the line frequency. Secondly, the short, abrupt bursts of energy in the timewave image, without the presence of heat, confirms there is tracking activity.

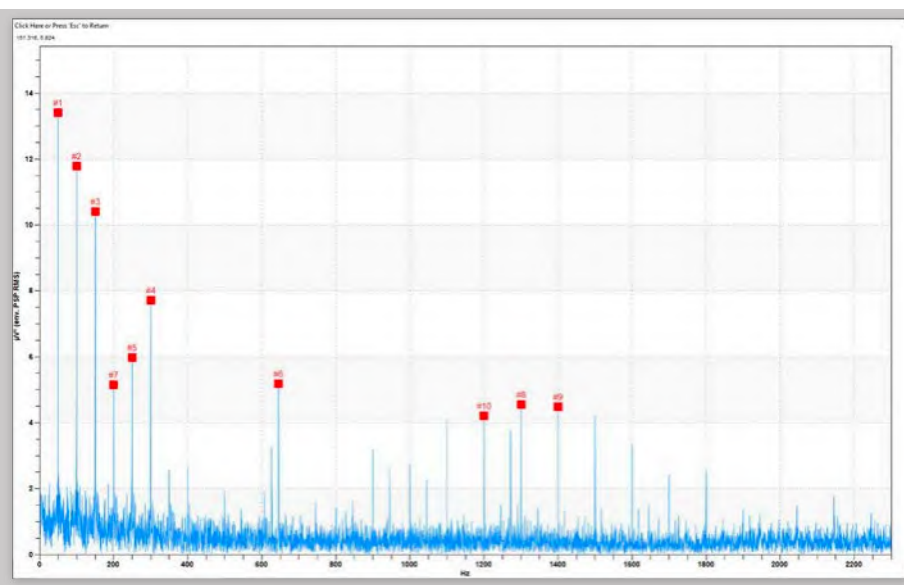
Figure 5 illustrates the spectrum domain from Young's ultrasonic data. There are two things to note

Figure 5. The frequency view of the same ultrasound signal clearly shows 60 Hz line frequency. This is a classic example of nuisance corona.

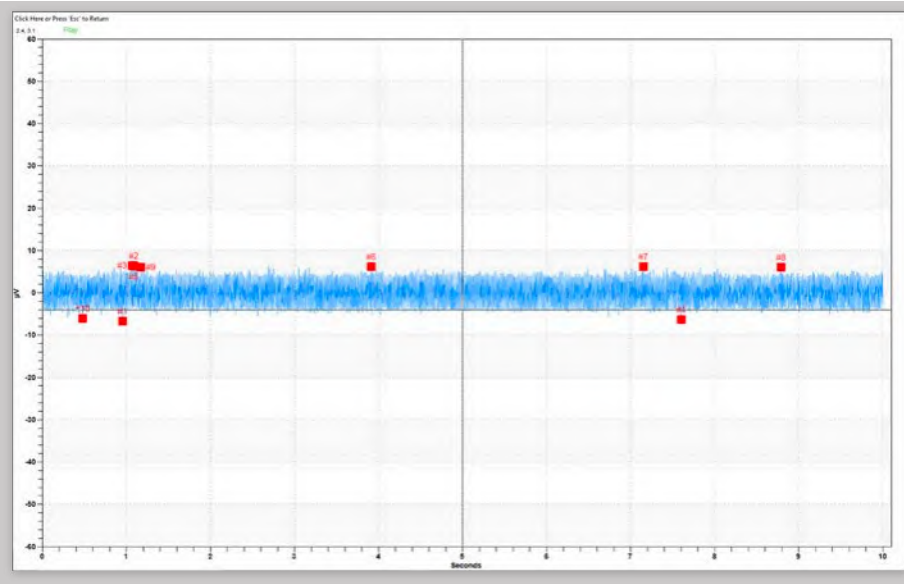
Figure 6. Time waveform after simple maintenance shows a satisfactory drop in discharge activity.

Looking at the time signal in Figure 6 and the frequency signal in Figure 7, maintenance definitely improved the condition of the asset. Since tracking is a stage of partial discharge that does cause damage to connectors and insulators, it will be necessary for Young to continue his vigilant ultrasound scans moving forward.

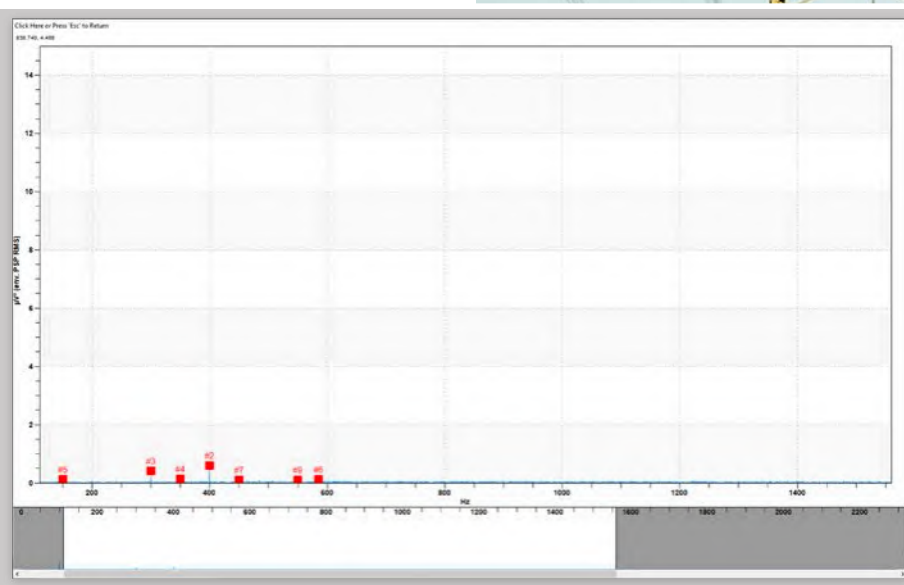
Figure 7. Spectral view after simple maintenance confirms the system was restored to good working condition.
