Investigation and Teardown of OIP Bushings

by **Lance Lewand**
and **Leah Simmons**

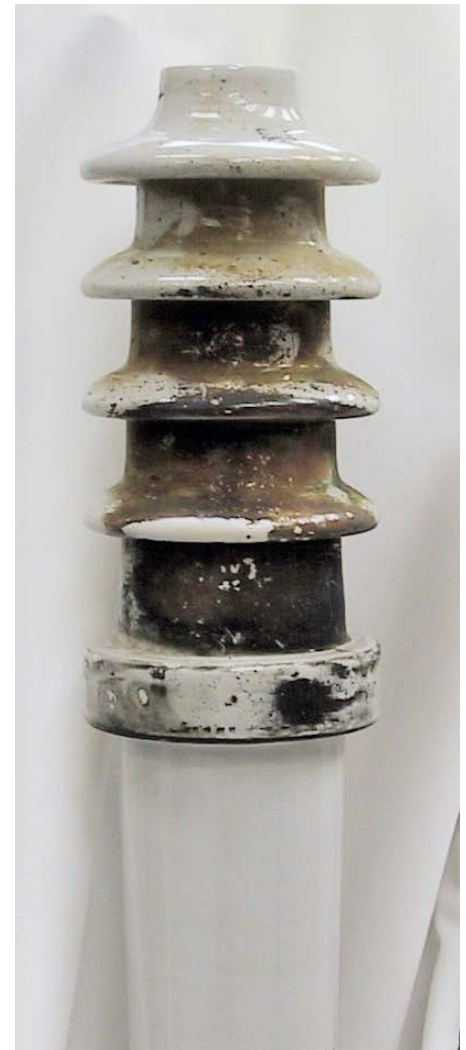
Deposits on the bushing sheds (see Figure 1), the oil level in the sight glass, the color of the oil, any deposits in the sight glass, and arc marks on the flange, the lower assembly below the flange, upper porcelain or the head of the bushing is additional information to gather.

Figure 1. Hot oil and fire soot deposits

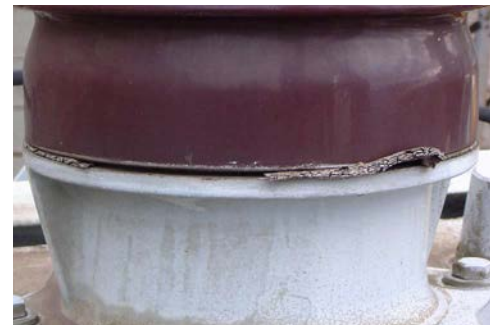
O-ring compromises have occurred as seen by the elastomeric material exuding from the gasket/O-ring groove or material crumbling (refer to Figure 2) away from areas that they were supposed to seal. In all, some bushings can have as many as 20 gaskets and O-rings, each of which must be fully studied and most of which will be found during disassembly.

Figure 2. Compromised bushing gasket at flange-upper porcelain interface

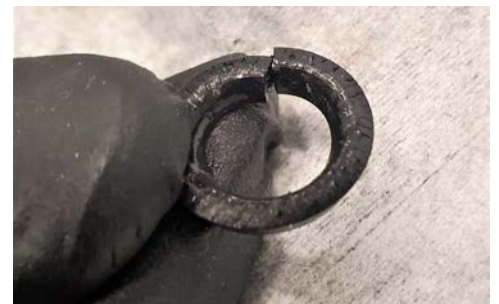
Dissolved gas-in-oil analysis (DGA) will provide information on arcing, partial discharge, overheating of the oil, overheating of the paper and possibly other issues. Oil quality tests will provide information on the condition of the oil and can determine if air and water ingress has occurred. This is important as water ingress is one of the primary drivers of bushing failures. The photo in Figure 3 shows a broken and deteriorated O-ring from the oil fill plug which allowed water and air ingress into the bushing.

Figure 3. Broken and deteriorated oil fill plug O-ring

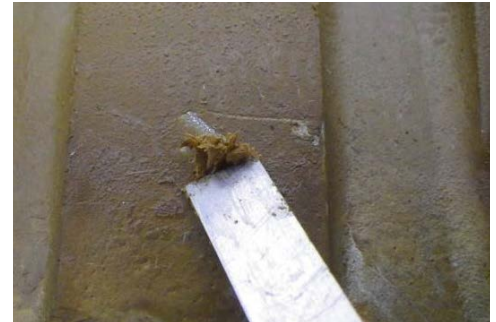
Once the pressure is released, dismantling can begin but it must be performed in a managed way, so no evidence is missed. The head of the bushing can provide a variety of evidence that will be useful, so it needs to be inspected inside and out and possible samples retrieved for analysis such as the sludge found on the internal surface of the aluminum head housing shown in Figure 4.

Figure 4. Sludge found in bushing head

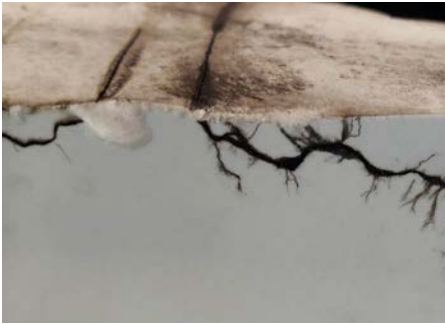
Once the head is removed, removal of the porcelain can ensue but there maybe one or more separate pieces of porcelain above the flange, so they need to be removed one by one without damaging the paper insulation of the core. Inspection of the internal surface of each piece of porcelain removed can also yield evidence. Figure 6 shows arcing found on the inside porcelain of one failed bushing.

Figure 6. Arc tracking on internal porcelain

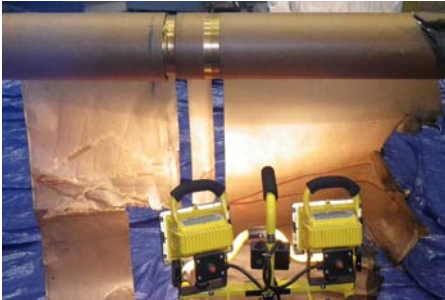
Figure 7. Partial core of a bushing showing tap foils

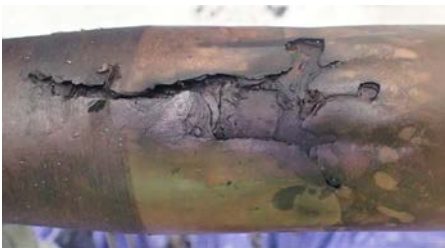
Figure 8. Arcing through core

Often paper samples are taken at different depths and positions within the core so that they can be analyzed for degree of polymerization (DP) and water content along with a variety of other physical, chemical and electrical analyses. Along the way, area of discharge may be found as shown in Figure 8 or partial discharge treeing in Figure 9.

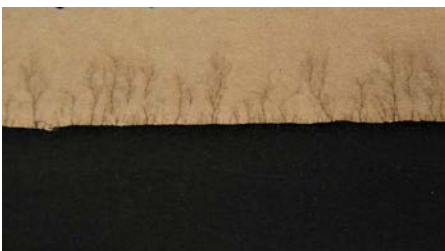
Figure 9. Partial discharge treeing from edge of ink layer

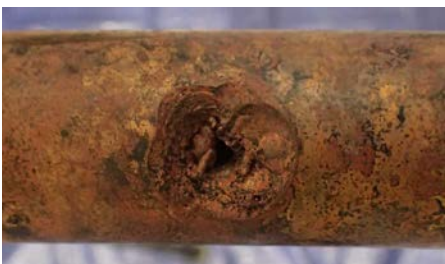
Figure 10. Arc hole through copper conductor

Once the unwrapping of the core is completed, the actual center conductor can be inspected. Most often copper is used in lower kV bushings whereas aluminum is used in larger voltage bushings to reduce weight. Occasionally, a combination of the two may be present. Some examples of damage done to the center conductor are found in Figures 10 through 12.

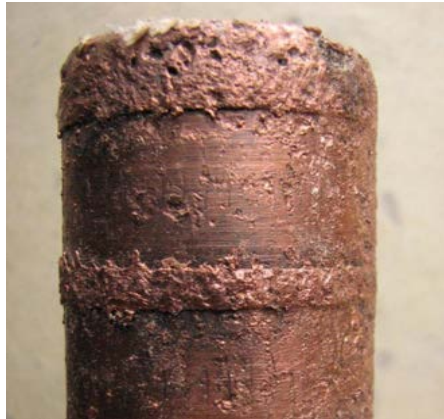
Figure 11. Pitting and melting of copper conductor

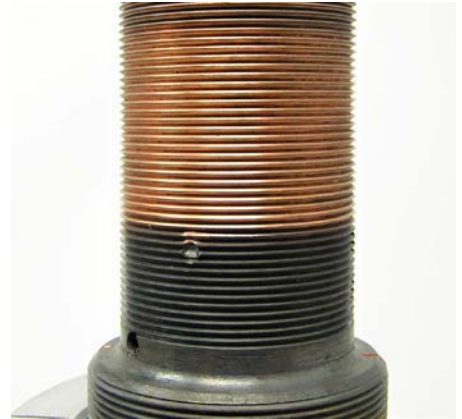
Figure 12. Copper sulfide formation on copper conductor
