When PD Won't Go Away: A CT Fault Revealed

High levels of partial discharge (PD) were detected over several years on the main electrical components (Generator, Step-up transformer, HV Connections) of a 660MW thermal generating unit in the UK. The significance of the PD, both in terms of the levels observed and the wide area of the plant over which the PD could be detected raised serious concerns

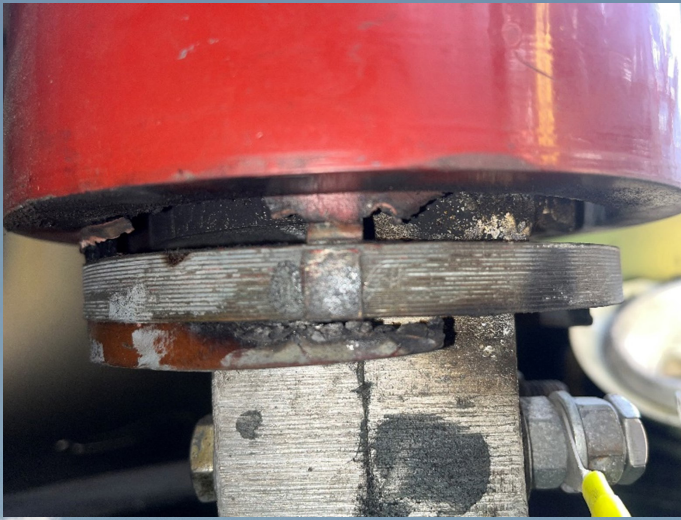
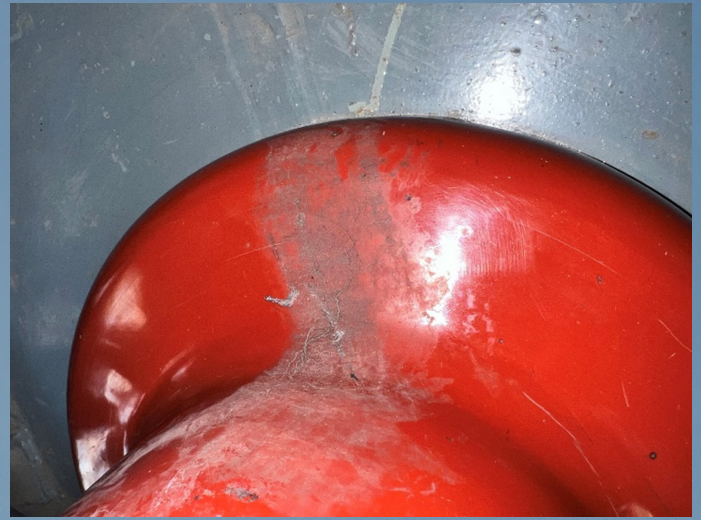
- Identification of the PD source:** Following testing, full strip-down inspections of the IPB and all associated components were commenced. All conductors and insulators were found to be intact and clear of earth paths which could have explained the test flashover. Inspection behind an IPB CT cover presented a 50-year-old current transformer (CT) and evidence of extensive burning and insulation damage around the base of the CT unit. Further inspection within the CT chamber identified a broken equipotential bonding strap and severe insulation damage (electrical treeing) and charring (See figs 1 & 2). The equipotential bonding strap is intended to bond the central HV conductor to the inner layer of the insulation tube within the CT, so as to avoid discharge across an extremely small air gap. Further inspection with the CT isolated from the rest of the IPB system presented the same results during AC testing (voltage instability & audible noise at 7kV), whilst the rest of the disconnected IPB system passed at rated voltage without issue. Loss of the equipotential bond had resulted in excessive damage & charring to the inner liner of the insulation, as well as significant electrical erosion on the outer composite insulator (see figures 3 - 5) The failed bonding strap was identified as the source of the persistent PD. 9

Figures 1 & 2 - IPB Mounted Current Transformer (CT) showing evidence of damage to equipotential bonding ring, inner insulation sleeve and tracking marks (treeing) in composite insulator.

Temporary repair implemented:
 Due to obsolescence and lack of spares, replacement units were unavailable either locally or within acceptable timelines from national or international manufacturers. A temporary repair was therefore made by wrapping the inner conductor with high voltage busbar heatshrink tubing to effectively insulate the damaged CT resin sleeve and use the heatshrink tubing as the primary insulation, allowing the unit to return to service safely. See Figures 6 & 7.

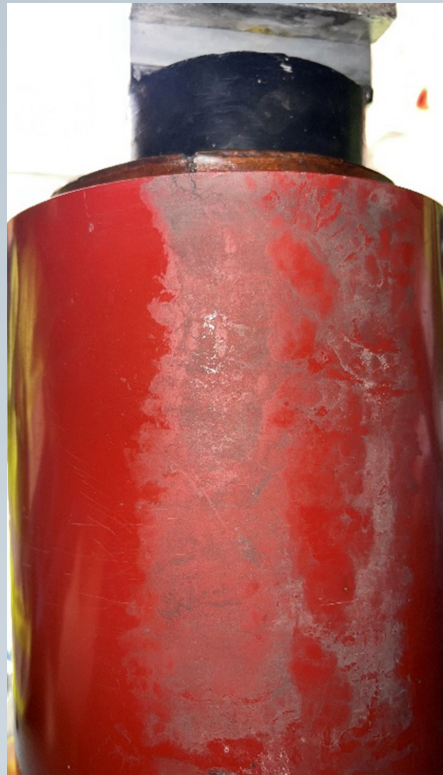
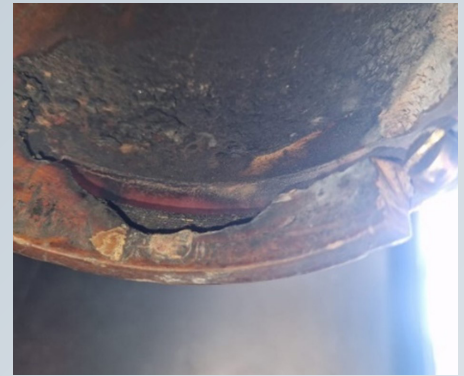
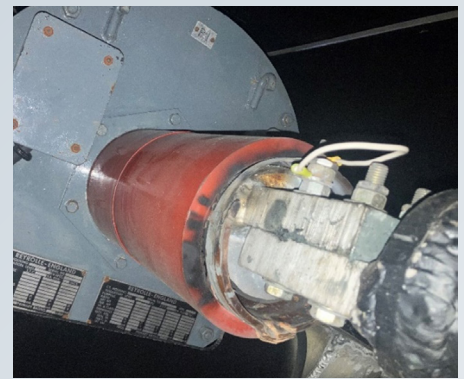
Figures 3, 4 & 5 - Further evidence of electrical tracking along composite insulator tube (Left) and internal view of inner insulation liner/bonding layer showing damage as a result of electrical discharge due to loss of equipotential bond (Right Upper & Lower).

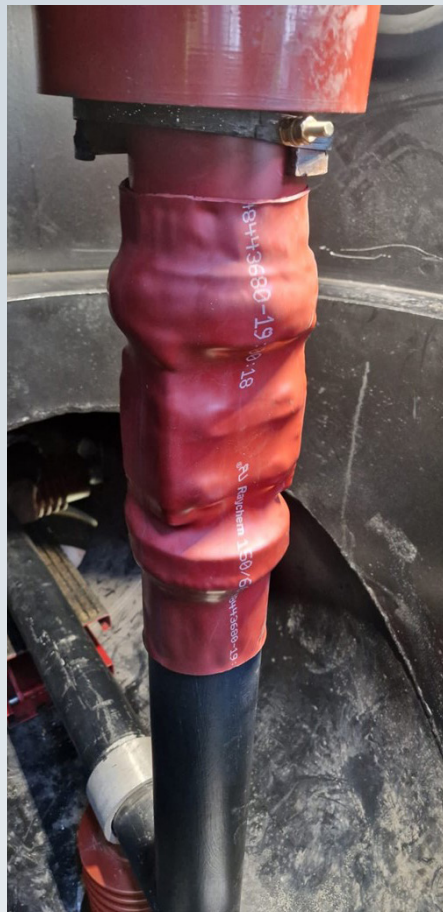
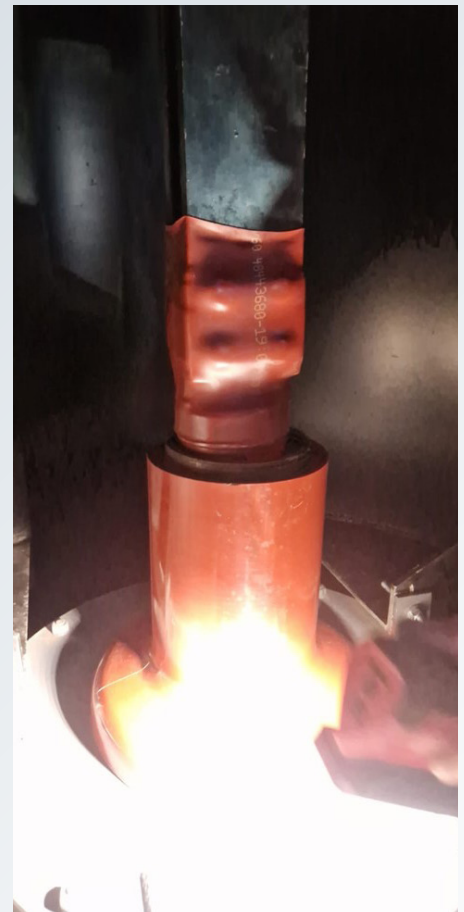
Figures 6 & 7 - Images showing revised conductor arrangement with central conductor now sleeved in heat-shrink busbar insulation material to act as primary insulation (Temporary Repair).

Post-repair PD reduction:
 Subsequent PD measurements post repair showed a significant reduction to expected levels consistent with other units, with no further deterioration observed, validating the repair effectiveness. In the longer term, this then provided the necessary time and space required to obtain replacement CT units as a permanent replacement scheme.
