The Value of Performing Power Factor Sweep Measurements on Bushings

by **Brandon Dupuis**
+++++

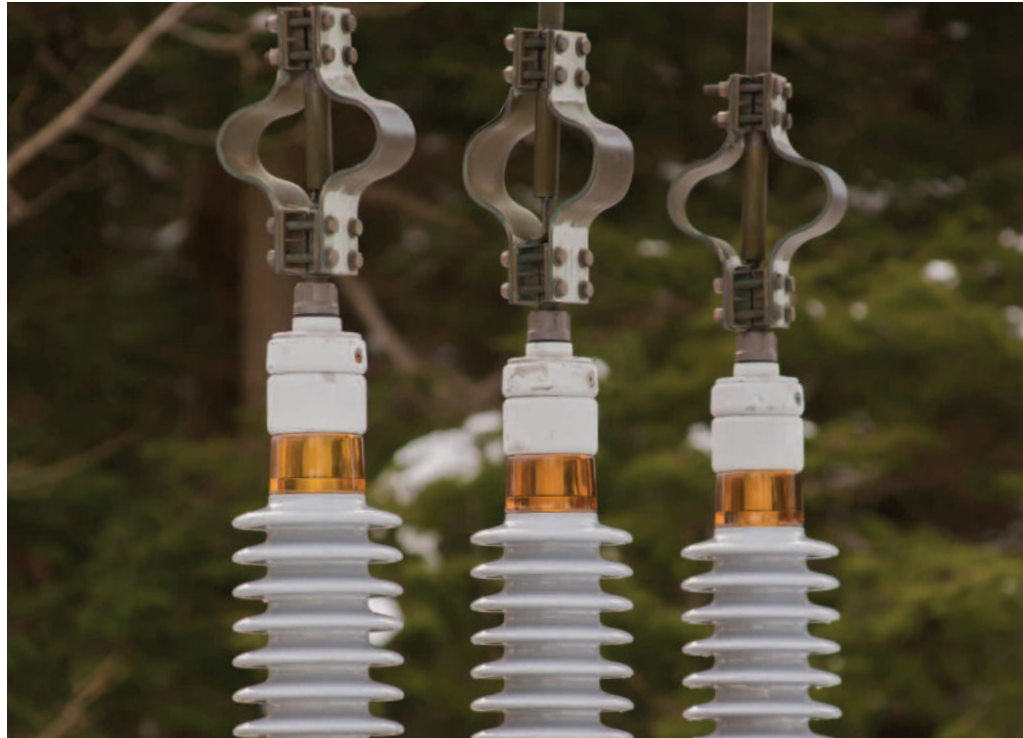
The analysis of the voltage-sweep and frequency-sweep measurements is performed visually. The Power Factor measurements are plotted versus the applied test-voltage and versus the applied test-frequency, and the condition of the insulation is assessed based on the shape of the plots (aka, the traces).

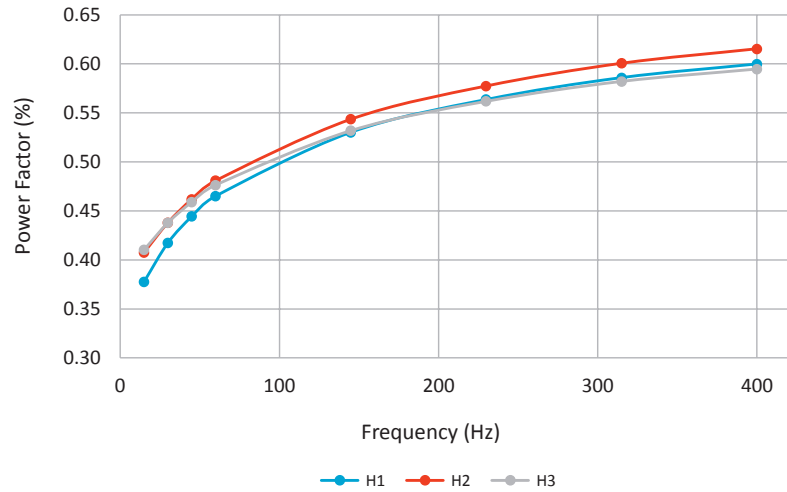
Figure 1. Acceptable C1 Power Factor frequency-sweep traces

The C1 Power Factor frequency-sweep measurements for three sister-unit bushings are provided in Figure 1. Notice that the shape of the traces is similar when comparing the similar-unit bushings, and in all the traces in Figure 1, the measured power factor increases versus frequency (from left to right). This is typically indicative of healthy insulation.

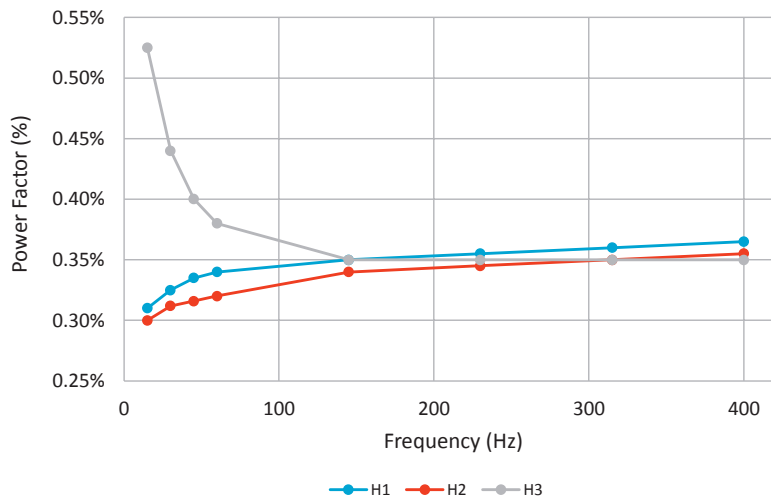
Figure 2. C1 Power Factor results for three Haefely 115 kV bushings

Based on the results in Figure 2, the 10 kV Power Factor for H3 is higher than its nameplate value, whereas the 10 kV Power Factor for the other two bushings is below their respective nameplate values. Notice that the 2 kV and 10 kV Power Factor measurements for the H3 bushing are dissimilar. In contrast, the 2 kV and 10 kV Power Factor measurements for the H1 and H2 bushings are reasonably similar, which further suggests that the H3 measurements are abnormal.

When comparing the Power Factor frequency-sweep traces among similar-unit bushings, the shape of the traces should be reasonably similar. Clearly, the shape of the H3 trace is dissimilar relative to the traces of the other two bushings. Moreover, the H3 trace decreases versus frequency and has the distinctive fish-hook in the lower frequency range; this is typically indicative of compromised insulation.

Interestingly, the 10 kV Power Factor for H3 is below 1.5 to 2 times its nameplate value, which the industry generally considers to be acceptable. However, the H3 bushing is clearly behaving differently than the other two similar bushings, which is cause for concern. This case demonstrates that Power Factor sweep measurements are more sensitive to compromised insulation than conventional 10 kV Power Factor measurement. The H3 bushing should be flagged as the weak link among the three bushings, and if returned to service, should be tested more frequently to gauge the severity of the situation.

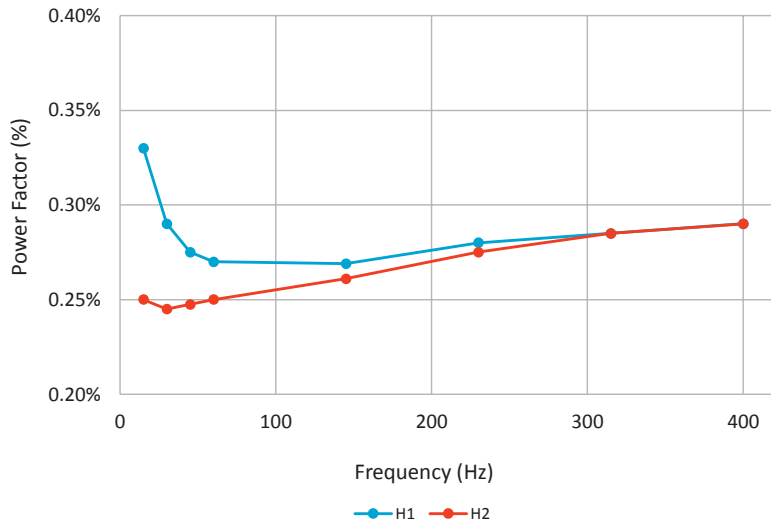
Figure 3. C1 Power Factor results for three Lapp POC Series 2 115 kV bushings

The Power Factor frequency-sweep trace for the H3 bushing is not plotted because its 10 kV Power Factor value is three times its nameplate value, which is already enough to condemn the H3 bushing. In other words, the Power Factor frequency-sweep trace for the H3 bushing only confirms what we already know. Additionally, the 2 kV and 10 kV Power Factor values for the H3 bushing differ significantly – further evidence to condemn the H3 bushing.

Based on the results in Figure 3, the 10 kV Power Factor value for H1 is higher than its nameplate value, whereas the 10 kV Power Factor value for the H2 bushing is the same as its nameplate value. Additionally, the frequency-sweep trace for the H1 bushing is clearly dissimilar relative to the frequency-sweep trace for the H2 bushing. The H1 trace decreases versus frequency and has developed the distinctive fish-hook in the low-frequency range – typically indicative of compromised insulation. Although the 10 kV Power Factor for H1 is well below 1.5 to 2 times its nameplate value, the H1 bushing is clearly behaving differently than the H2 bushing. As a result, the H1 bushing should be tested more frequently to gauge the severity of the situation.

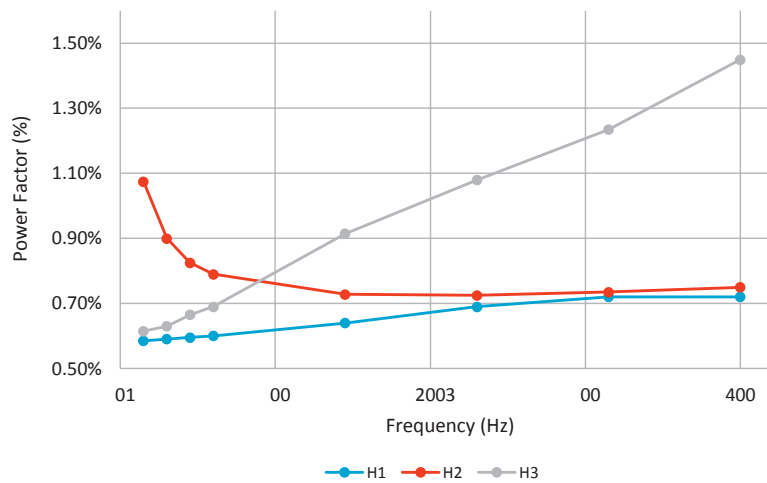
Figure 4. C1 Power Factor results for three Westinghouse Type-S 37 kV bushings

This case provides an example of three sister-unit bushings that produced three completely different Power Factor frequency-sweep traces. The Power Factor frequency-sweep trace for the H1 bushing is a typical example of a trace produced by a healthy bushing, whereas the Power Factor frequency-sweep trace for the H2 bushing is a typical example of a trace produced by a questionable bushing. However, the Power Factor frequency-sweep trace for the H3 bushing is an example of an abnormal or non-typical frequency-sweep trace, which warrants concern.

Based on experience, there appears to be a bushing insulation failure mode where the measured capacitance (pF) value of the bushing is dissimilar different relative to its nameplate value and to the other sister-unit bushings. For this type of insulation failure, in addition to the measured capacitance (pF) value being different than expected, the Power Factor frequency-sweep trace becomes more-or-less linear and exhibits a steep incline from left-to-right (as demonstrated by the H3 bushing in Figure 4).

Interestingly, the H1 and H2 bushings tested with capacitance values well below their respective nameplate values; the capacitance value of the H3 bushing is above its nameplate value. If the measurements provided in Figure 4 can be verified, then the insulation system of the H3 bushing is behaving abnormally, and if returned to service, it should be tested more frequently to gauge the severity of the situation.

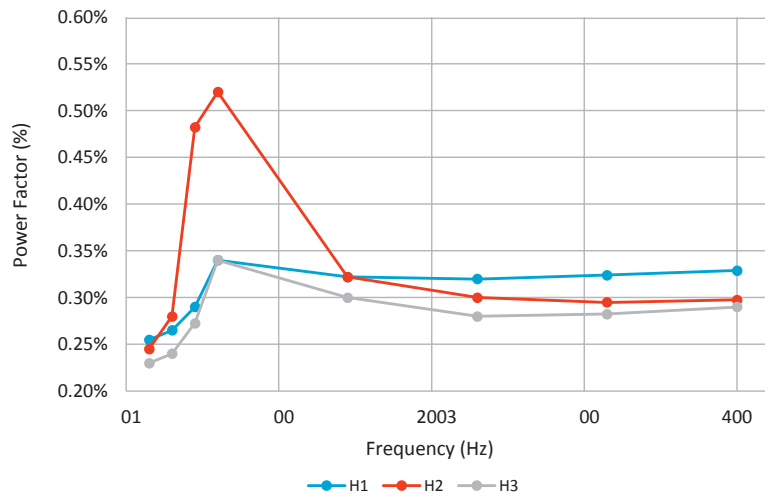
Figure 5. C1 Power Factor results for three Lapp POC 138 kV bushings

Based on the results in Figure 5, the Power Factor values for all three bushings are higher than their respective nameplate values. Notice that the Power Factor measurement for the H2 bushing is clearly voltage sensitive. Furthermore, the Power Factor frequency-sweep traces for the three bushings are erratic and jagged. In general, jagged Power Factor frequency-sweep traces are indicative of invalid Power Factor measurements. Regardless of whether an insulation system is healthy or compromised, its Power Factor frequency-sweep trace should be smooth.

By analyzing only the 10 kV Power Factor measurements, it is not obvious that the Power Factor measurements for the three bushings are invalid; however, the voltage and frequency-sweep test results make it obvious that the Power Factor measurements are invalid. In this case, the customer determined that the primary-side bushing terminals were not short-circuited together when the C1 Power Factor measurements were performed; this identified the cause of the abnormal Power Factor measurements.
