# Mitigating Failure Risk in Power Transformers: Eletronorte Case Study

by **Iran Prado Arantes**  
and **Geraldo Nicola**

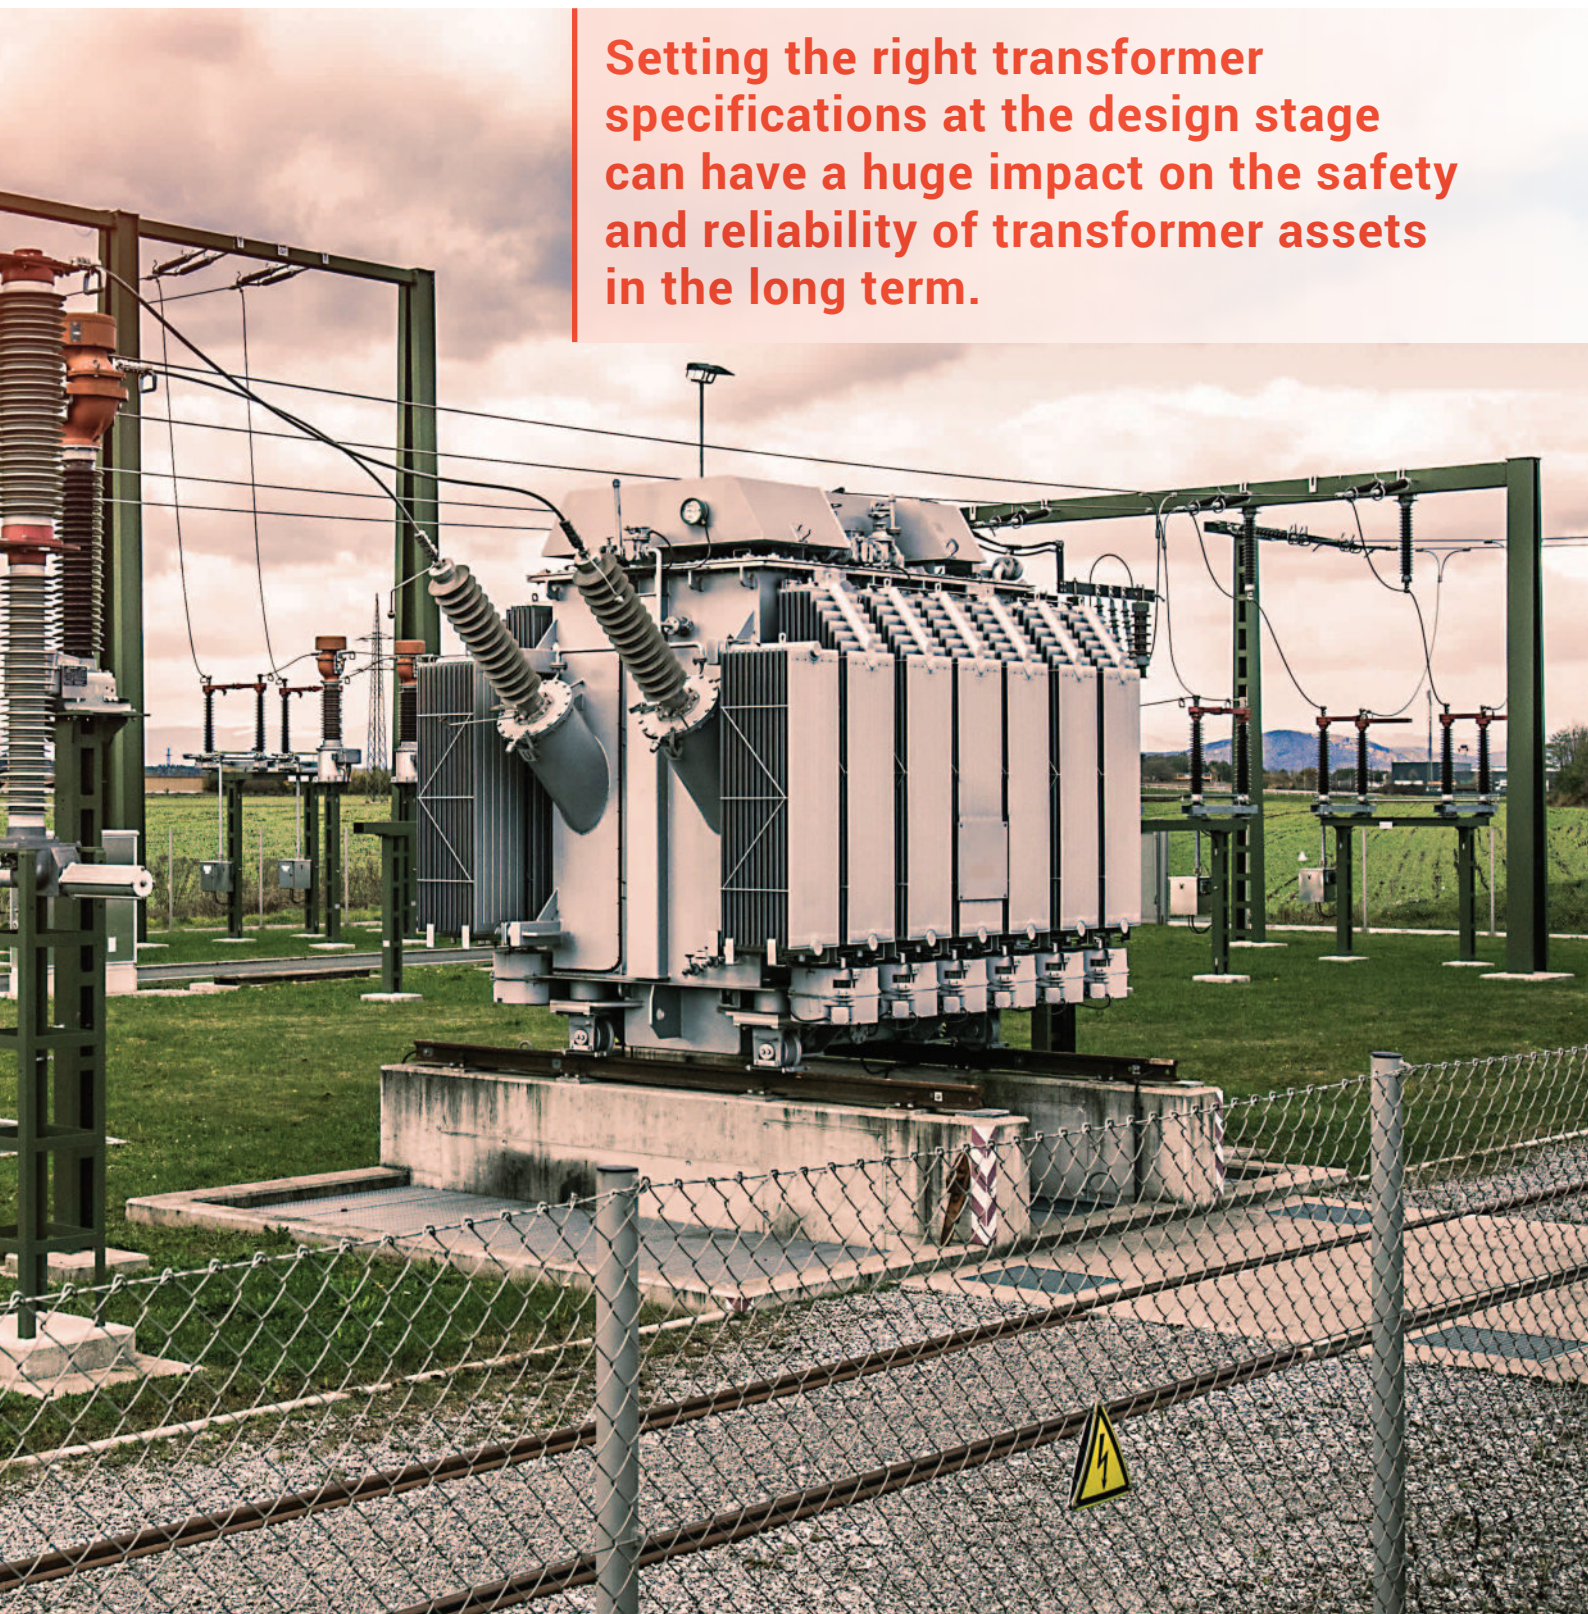
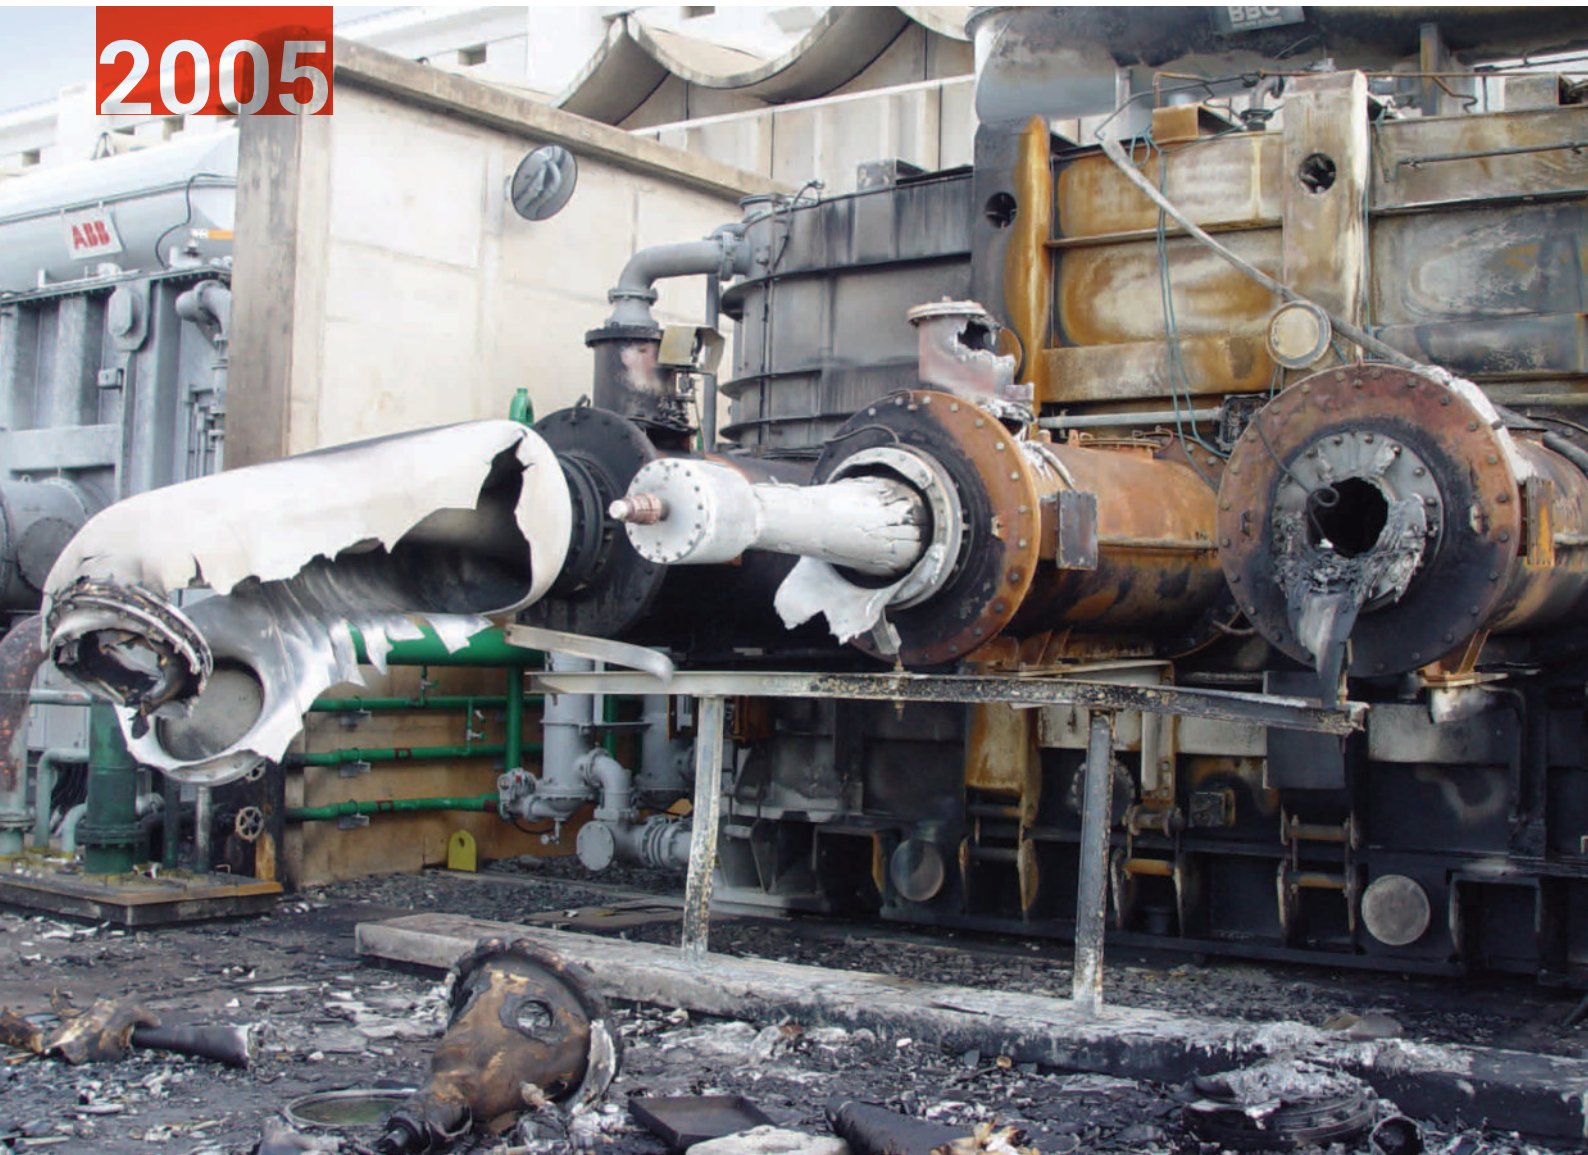
Figure 1. Catastrophic failures at the Tucuruí hydroelectric plant in 2005 (left) and 2007 (right)

From 1988 to 2008, Eletronorte observed twelve incidents of fire in power transformers whose damage extended to entire GIS substations, neighboring equipment, auxiliary transformers and buses. The four most significant occurrences were at the 8,370 MW Tucuruí hydro power plant located in the state of Pará, in the northern region of Brazil, which has been in operation since 1984 (Figure 1).

From 1988 to 2008, Eletronorte had twelve incidents of fire in power transformers with catastrophic consequences, four of which took place at the Tucuruí hydroelectric plant.

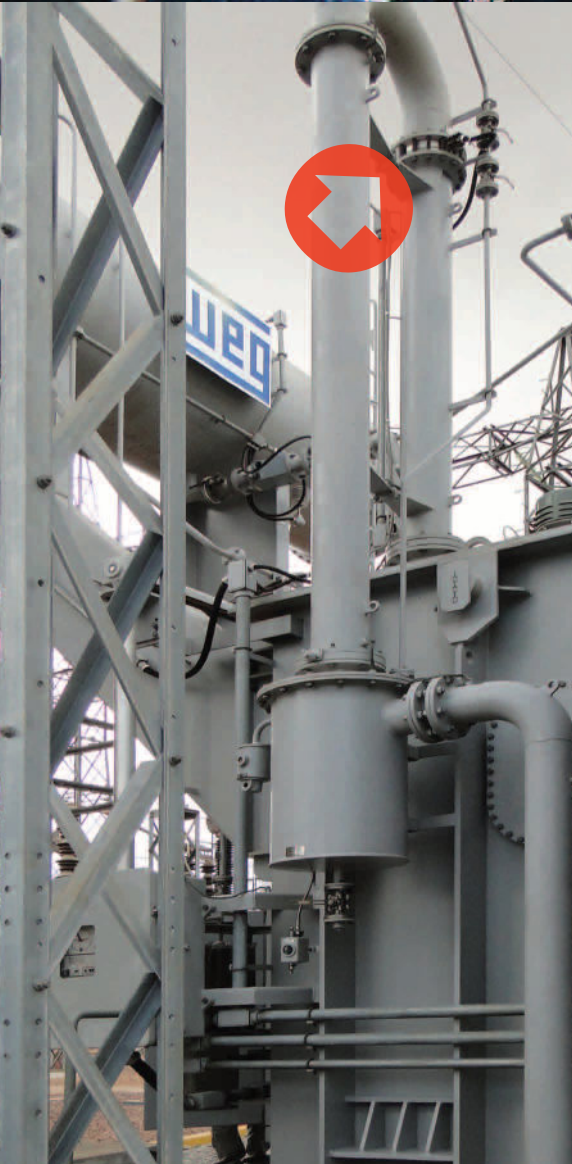
Figure 2. A ruptured disc in the confined discharge explosion tube in a 245/145-15 kV, 100 MVA autotransformer

- Pressure relief: Pressure relief valve opening adjustment considering expansion tank oil column as per NFPA-30 recommendation and use of rupture disc burst tube as per NBR 5356-1 and confined discharge.

Thanks to the measures taken, a bushing failure in early 2018 (shown in Figure 3) that would possibly have led to major external effects was reduced to replacing only the components: the bushing and the rupture disc (as shown in Figure 2).

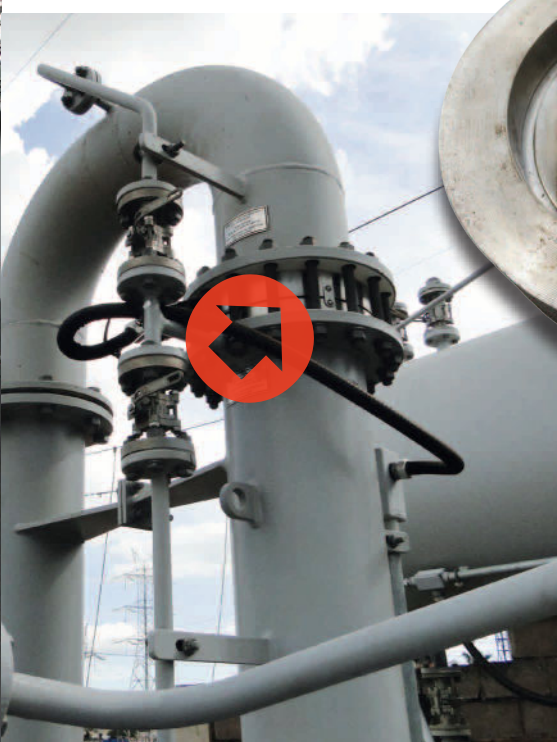
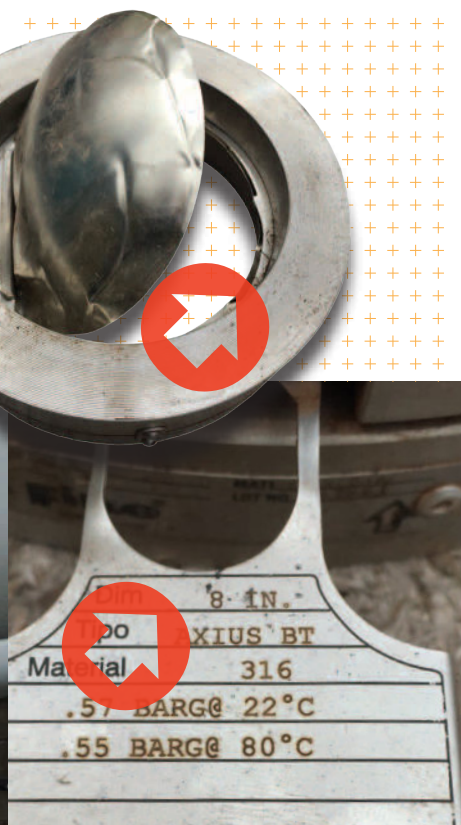
Dim	8 IN.
Material	TIUS BT 316
	.57 BARG@ 22°C
	.55 BARG@ 80°C

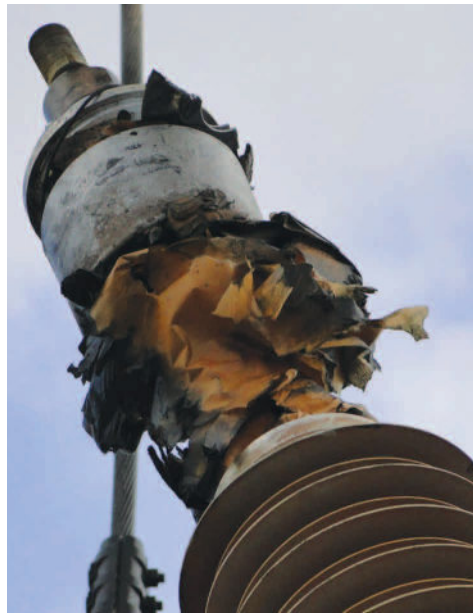
Figure 3. A bushing failure in 2018 had minimal impact on the operation of the substation.
