The Benefits of Online Bushing Monitoring

Introduction

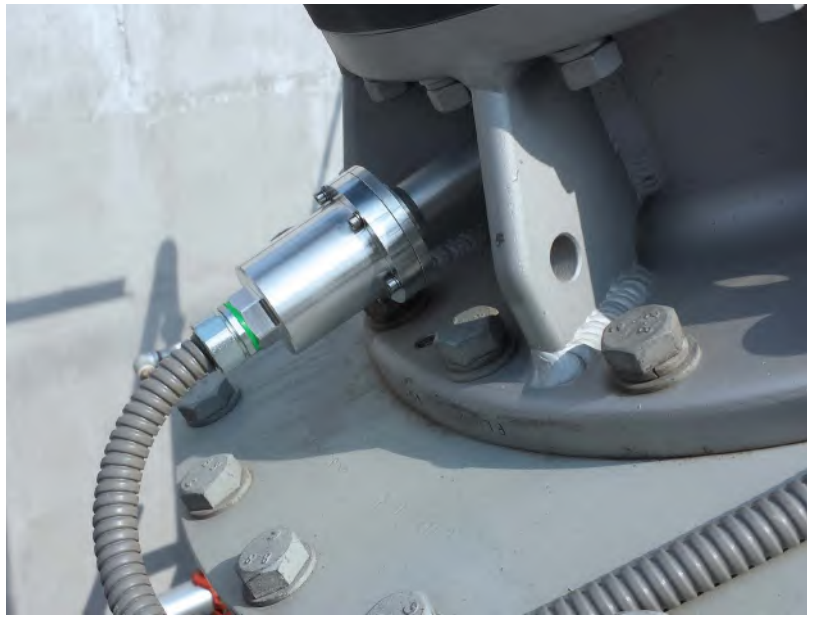
Figure 3. Bushing adapters (left); screenshot of SCADA screen (centre); picture of the bushing monitor (right)

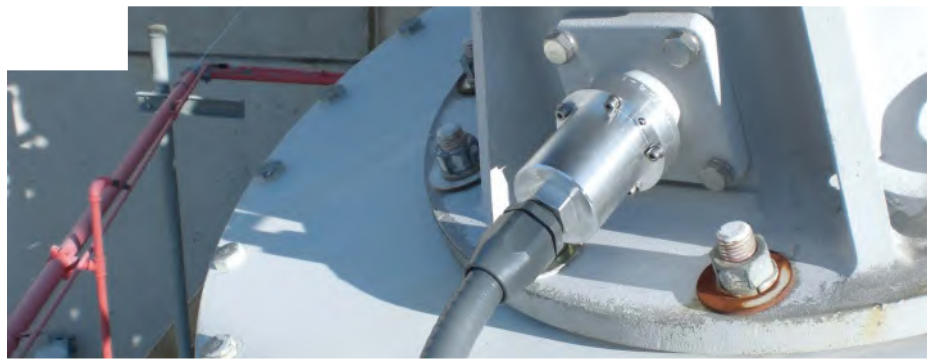
Figure 2. When installing a bushing monitor, it is important to ensure a secured installation and uncompromised contact with the test tap

The installation of the bushing monitor requires information which can be found on the nameplate, in addition to the transformer's operating voltage. This information consists of the mechanical aspect of the bushing tapping point, where the bushing monitor adaptor will be inserted. This is to ensure a secured installation and uncompromised contact with the test tap (Figure 2).

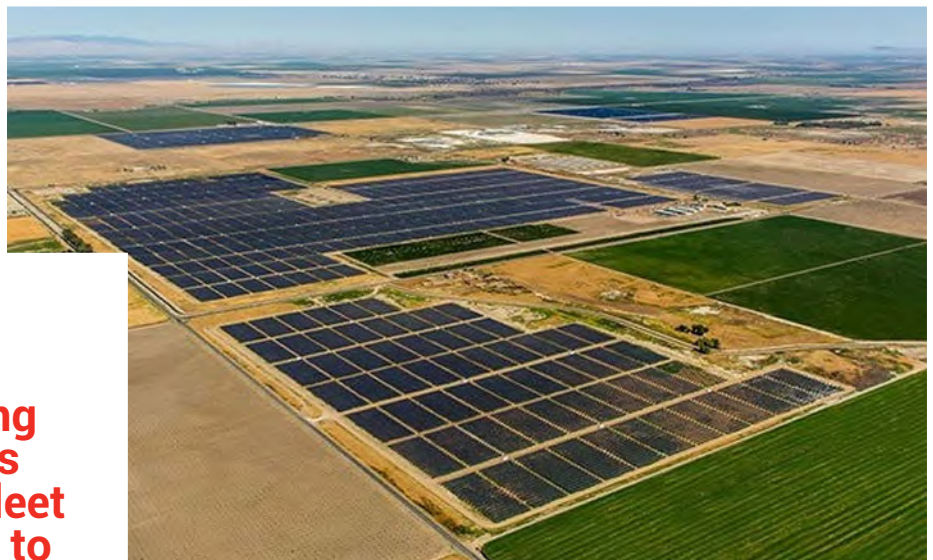
Their 102-megawatt Henrietta Solar Project in Kings County, California, USA (Figure 3) achieved commercial operation in October 2016. Southern Power had the foresight to install a bushing monitoring system from GE to monitor a key 50 MVA transformer.

Henrietta Solar Farm (Photo: Southern Company)

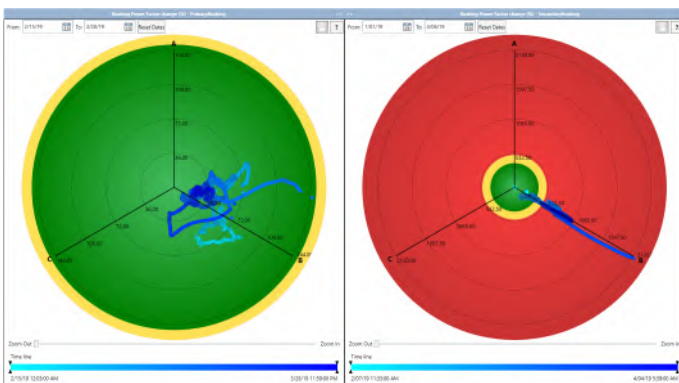
Figure 4. Polar Plots showing Relative % Change of Power Factor

Figure 4 compares the primary and secondary polar plots for the relative percent Power Factor change. The data on the Primary side does not show any abnormal behaviour. Although the data points are not tightly packed together, they are in the same region and within normal range.

Compare this to the secondary side where the data clearly shows a

very large and significant increase in the %PF generated by the phase B bushing. This increase in %PF started in February 2019.

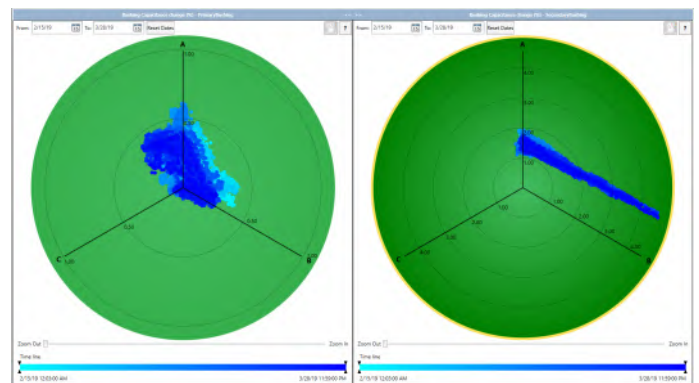
Figure 5. Polar Plots showing % Change of Capacitance C_1

Figure 5 below shows the polar plots for the primary and secondary bushing with respect to the %

change in Capacitance C_1 . The data points on the left polar plot from the primary side are neatly packed and stable which is expected in normal operation.

However, on the right polar plot for

the secondary side, data points show a change of ~1.5% on phase A, but the concerning element is the progression for phase B which reaches 4.2% on March 28th, 2019.
