Bushing Failure Prevention Through Online Monitoring

by **Marco Tozzi**

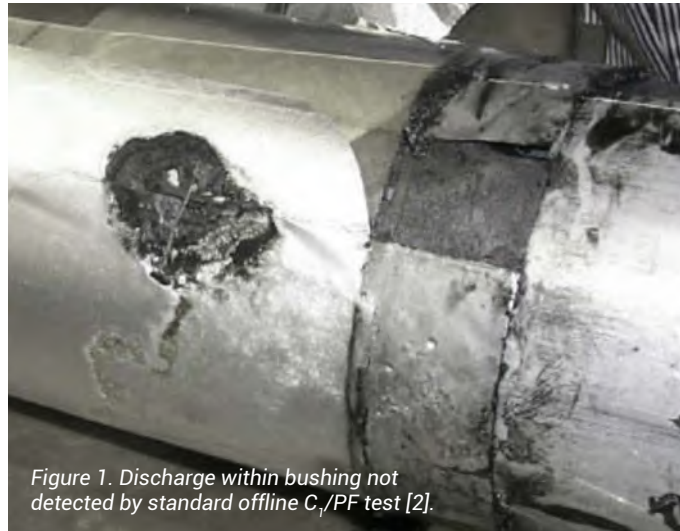
Figure 1. Discharge within bushing not detected by standard offline C_1 /PF test [2].

Some typical questions that are raised are, "Would you expect the offline measurement to be identical to the results of the online monitor?" The answer is: Potentially yes, but it depends on what the defect is, which offline measurement and in which testing condition, since there is not a single test or a single failure mode. Figure 1 shows a bushing which is in a critical condition due to the

detachment of the conductive strip that connects the first foil layer [2]. The bushing was showing perfect Capacitance and Power Factor values in the offline test and it would have been returned to service based solely on these results. However, DGA showed >3000 ppm of C_2H_2 clearly indicating that the bushing needed immediate replacement.

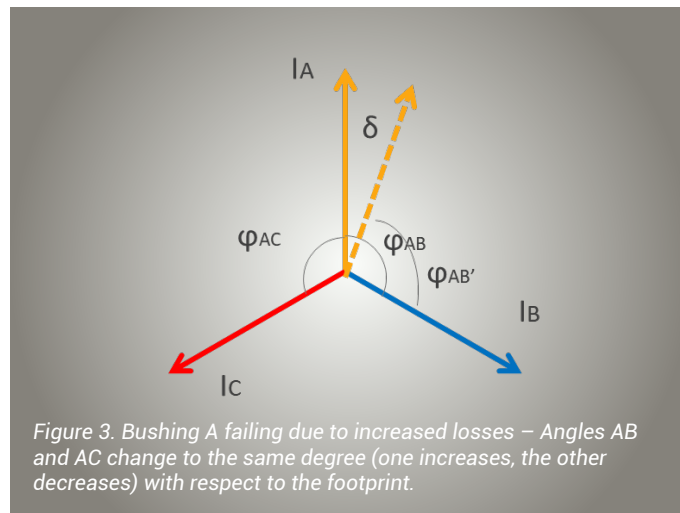
Figure 3. Bushing A failing due to increased losses – Angles AB and AC change to the same degree (one increases, the other decreases) with respect to the footprint.

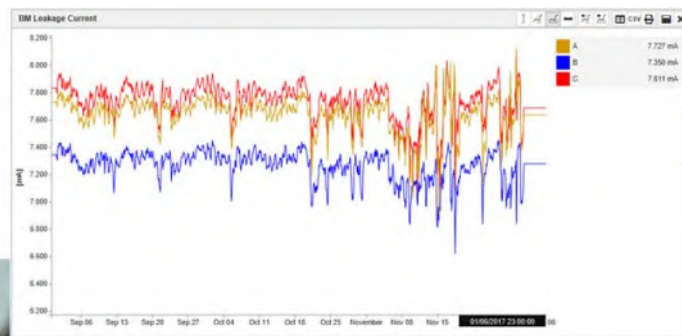
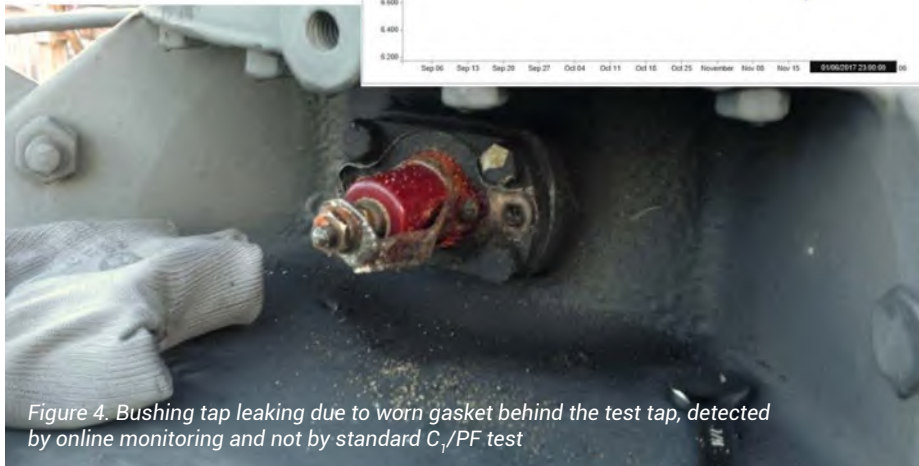
Figure 4. Bushing tap leaking due to worn gasket behind the test tap, detected by online monitoring and not by standard C_1 /PF test

To illustrate, Figure 4 shows a test tap leaking oil: This was found in six bushings and in three of them it was captured through online monitoring. The symptom was a continuously dropping leakage current. The system gave an alarm of low current and this triggered an inspection where the problem was identified. Again, the standard test here would not have highlighted any issue since both PF and capacitance measured offline were matching the nameplate values.

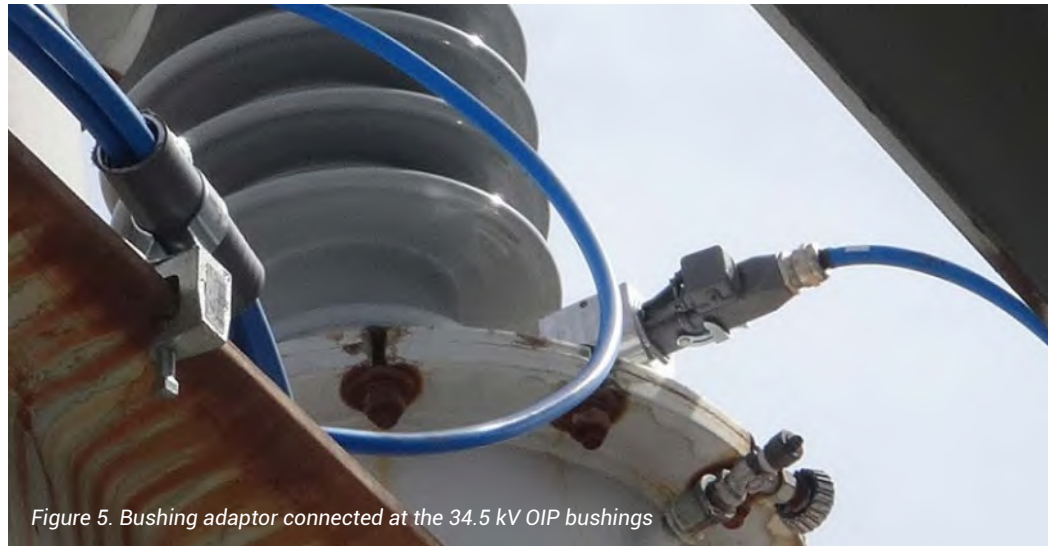
Figure 5. Bushing adaptor connected at the 34.5 kV OIP bushings

The installed device was continuously monitoring the bushing currents and partial discharges from both the main tank and bushings using properly designed tap adaptors installed at the test taps. The acquisition was continuous (*not scheduled*), simultaneous in all phases and results were summarized every hour. The bushings, as shown in Figure 5, were from McGraw Edison 1988, OIP, 34.5 kV, around 590 pF of Capacitance.

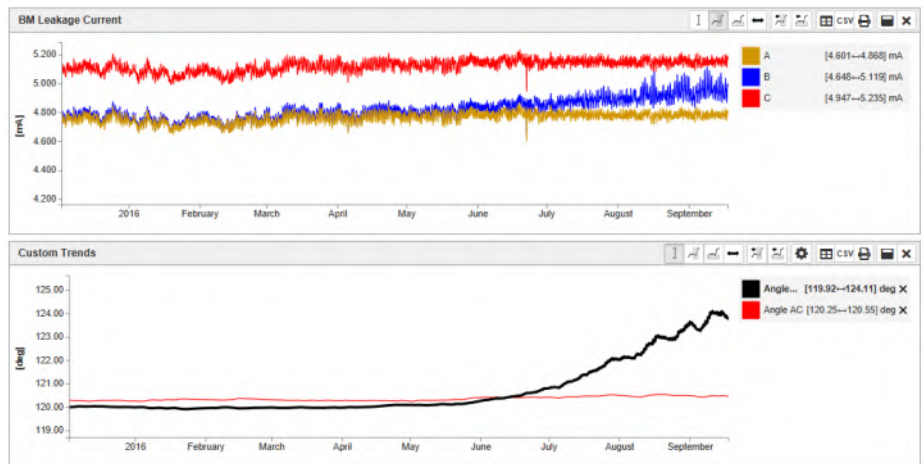
Figure 6. Test tap current magnitude (top) and angles recorded and summarized every hour (bottom). AB angle increased by about 4 degrees in 6 months.

Figure 6 shows the unprocessed data of the leakage current amplitude (top chart) and angles between bushings A and B (bottom chart, black line) and between bushings A and C (bottom chart, red line). It is easy to note that for several months the readings were very stable. After May, the angle between the bushings A and B started to increase while the angle between bushings A and C remained constant, thus suggesting that the change was related to some issue in bushing B. Looking at the readings of the current we notice that the leakage current of the bushing B also started to increase slightly after June, confirming something happening in bushing B.

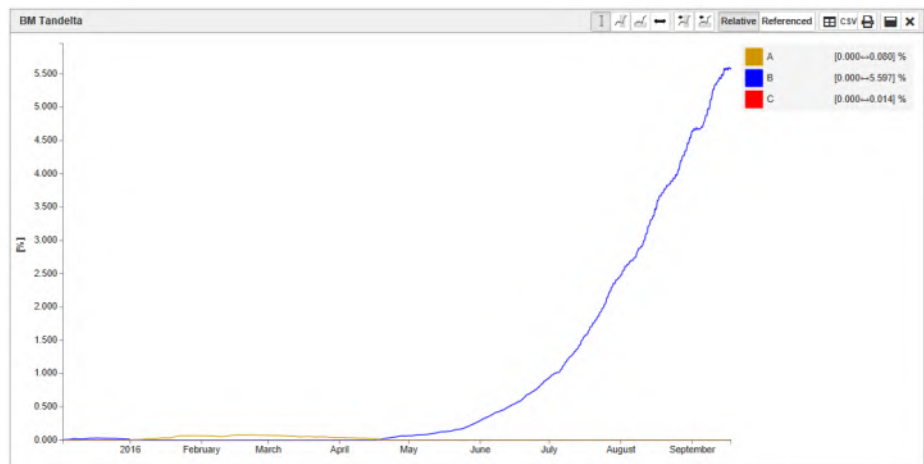
Figure 7. Relative PF increase displayed on the monitor.

Figure 7 shows the processed data using the algorithms embedded in the online monitoring system aimed at converting the current and

angle readings in relative changes of Capacitance and Power Factor. It was estimated that the change occurred only in bushing B, showing a relative increment of around 5.5% from the footprint, which means that if the nameplate value is 0.53%, the actual tan delta is estimated to be higher than 6%.

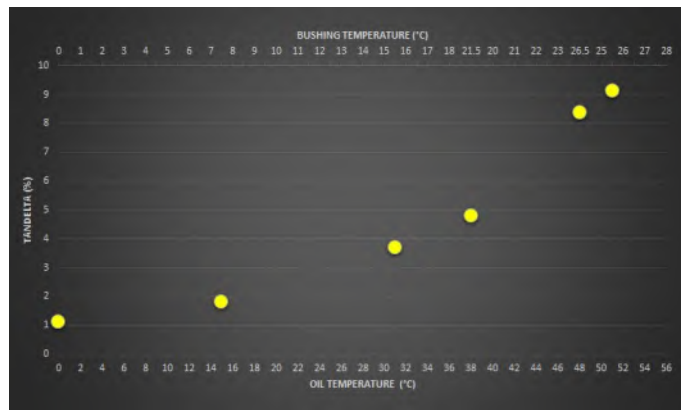
Figure 9. Offline PF test results at different ambient and oil temperatures showing that at normal operating oil temperatures (30-40°C) the PF readings match the online results.

Then the bushing was immersed in oil and the oil was heated up to 60°C for two hours. After 1.5 hours the bushing was tested again showing PF equal to about 9%, i.e. almost 20 times the nameplate value. After reaching the maximum temperature the bushing was left to cool down and PF was measured again at different temperatures. The final profile of the PF with temperature is shown in Figure 9, where both oil and bushing temperatures are reported. The exponential rise with temperature confirmed the critical stage of the insulation and, most importantly, the values measured at 30-40°C range were perfectly aligned with the variation measured by the online monitoring system in real conditions. Indeed, after May the ambient temperature started to rise, well exceeding 30°C, and thus causing the bushing PF to increase up to 6 -7%. The test demonstrated that the difference between the online and offline results were not caused by deficiencies in the monitoring system.

Quite the opposite, the PF reading at the real operating temperatures were correctly estimated and reported, while the offline test was done in a different condition and with lower oil temperature.

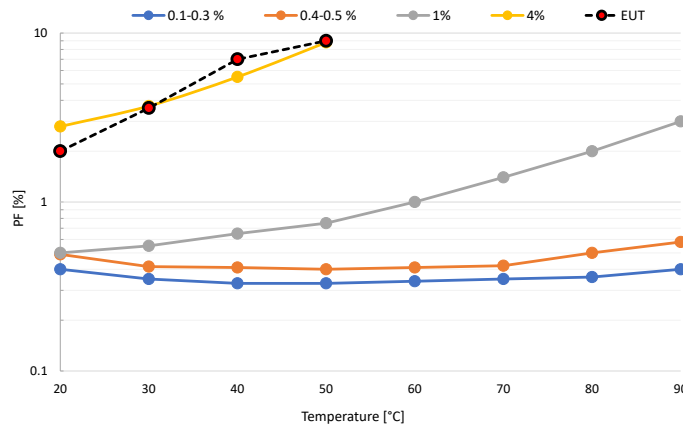
Figure 10. Bushing PF versus temperature. Redrawing of [8] comparing the results of the Equipment Under Test (EUT)

increases with temperature, this might indicate high conductive losses due to the presence of moisture [5]. As an example, it has been published that the power factor can increase from 0.3% at 20°C to 1.0% at 70°C with 2% water content [6]. By looking at the curves published in [7] and [8] and comparing it to the lab measurement of the bushing under investigation, it is possible to speculate that the bushing had an excess of moisture above 4% (Figure 10).

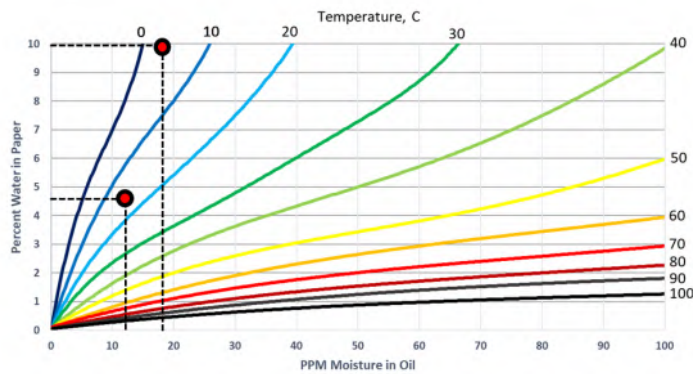
Figure 11. Moisture equilibrium isotherms (redrawing from Oommen curves [9]) showing that estimated water for the tested bushing exceeds 4%

A similar conclusion can be drawn from the oil result. An oil sample from the bushing was analysed at different temperatures, showing 12 ppm at 15°C and 19 ppm at 2°C. Putting the recorded value in the moisture equilibrium plot from Oommen [9] it is clear that again the moisture is well

above 4% (Figure 11). In particular, the sample at 2°C would fall outside the chart suggesting more than 10% of moisture.
