Transformer Bushings - What Can Go Wrong?

by **Thomas Linn**
+++++

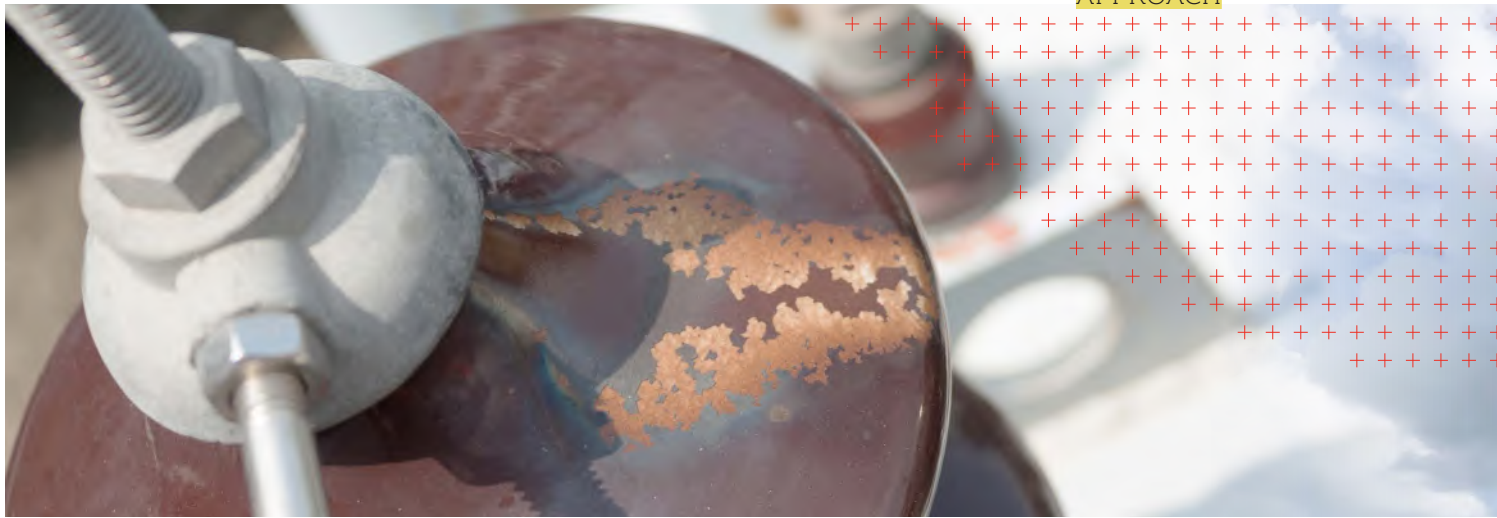
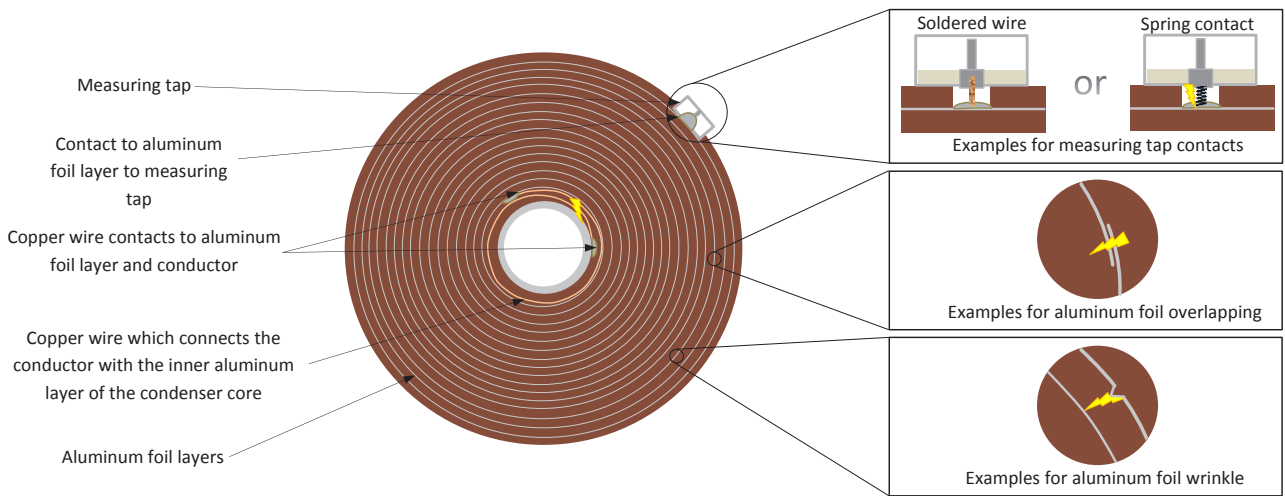
Figure 1. Contact designs and foil overlapping in a bushing condenser core

Figure 1 shows some critical points for transients. In some designs the connection of the conductor or conducting tube is contacted to the inner foil with a copper wire, which is wound together with the paper. This provides a relatively high impedance for VFTs and creates a high voltage

drop which can create sparking in the area of this wire. Over frequent occurrences the insulation material and even the connecting wire can slowly be destroyed. This will lead to a permanent or periodic sparking due to normal operation. It can further erode the insulating material and can lead to partial breakdowns, followed by a potential complete breakdown.

The measuring tap design is also relevant for transient stress and sparking. Figure 1 presents two different designs of measuring taps. The first one has a copper wire soldered to the contact system of the last aluminum foil and the inner pin of the measuring tap. The second design is using a spring as contact, which makes the assembly easier, but it is more prone to transient stress since the spring provides a comparably high impedance. Each transient event can generate a sparking in the bushing tap and can lead over time to bushing failure.

A third sensitive point for transients is the overlapping of the foils. The insulation layer between the two foil ends is only one thin layer, either impregnated with oil or resin. During a transient event, these two foil ends can have different potentials where the potential difference is high enough to create a sparking between the overlapping foil ends. Over a longer time period, this can lead to material erosions and finally the failing of the bushing.

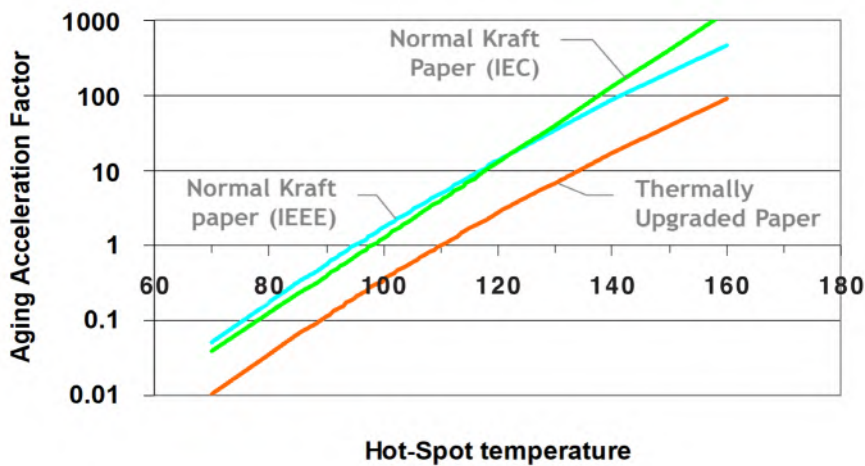
Figure 2. Aging acceleration due to temperature for different papers [2]

For oil impregnated paper bushings (OIP), the decomposition of the paper insulation and the insulation oil are important considerations. Figure 2 presents the relationship between accelerated aging expressed by the aging factor for different temperatures. The paper that is usually used in bushings is normal kraft paper (IEEE or IEC). At about 95°C the aging acceleration factor will be about 1. The increase of the operating temperature by 5K will increase this factor to 2, which means doubling the aging speed.

The diagram in Figure 2 has been established for insulation paper in transformers, but is valid for the insulation paper in OIP bushings as well.

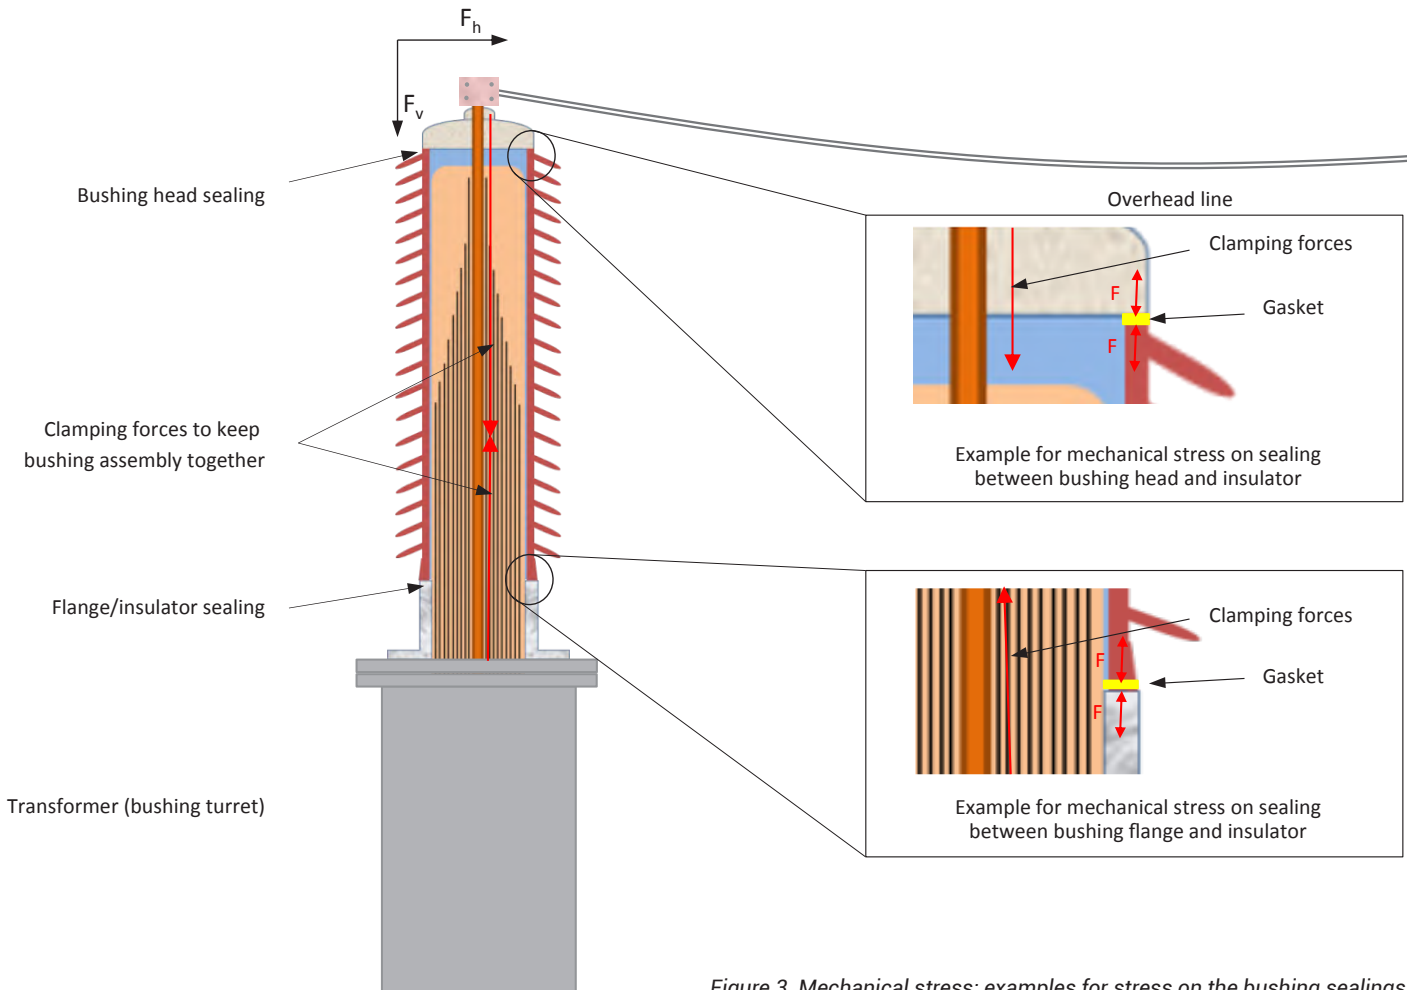
Figure 3. Mechanical stress: examples for stress on the bushing sealings

As shown in Figure 3, mechanical forces are being introduced by a connected overhead line for the air part of the bushing as vertical and horizontal forces. Static forces are determined by the weight of the overhead line and the designed tension to guaranty the minimum safety clearance of the overhead line to the terrain at maximum sag. Additional loads, typically snow, can contribute to the static loads along with seasonal and temperature related, slowly changing variations.

Bushings are designed to withstand static and transient mechanical forces. Nevertheless, excessive mechanical forces can mechanically destroy a bushing. The quasi-static forces and the transient force do have the potential to weaken the sealing system of bushings. The details in Figure 3 show the compressing of the gaskets on the pulling side. It could pull open between the sealing and flange/porcelain/head (depending on the design) as a possible defect. This would lead to moisture ingress. The moisture would in this case presumably stay between the bushing core and the inner porcelain or inner composite insulator surface. The moisture will, over time, migrate into

the condenser core as well, but before that, it can also result in a breakdown along the inner insulator surfaces.
