What is a Transformer Save?

by **John Eastman**
+++++

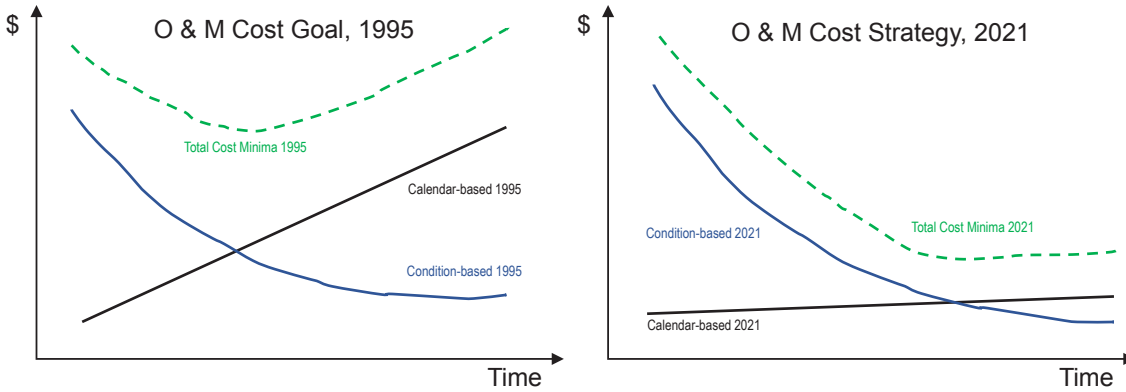
Figure 1. Additive expenses of calendar-based and condition-based maintenance, past & present

the monitoring system. The reality of the reliable automatic system is that calendar-based maintenance is nearly eliminated and monitoring intersects at a much lower cost point, as shown in Figure 1.

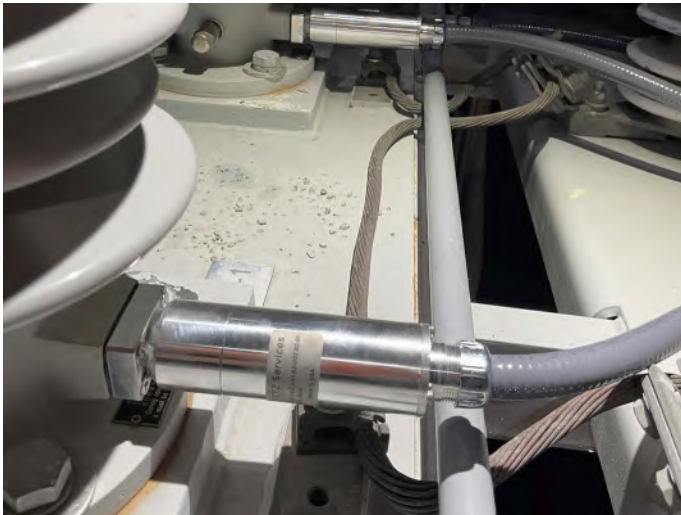
Figure 2. Bushing sensors installed on low-side bushings

transformer at a large solar installation in Imperial County, California in May of 2021. For this system, six signals given by the transformer C1 test taps, three voltage signals given by the low-side PTs (Figure 2), and three voltage signals given by the high-side CCVTs were connected to

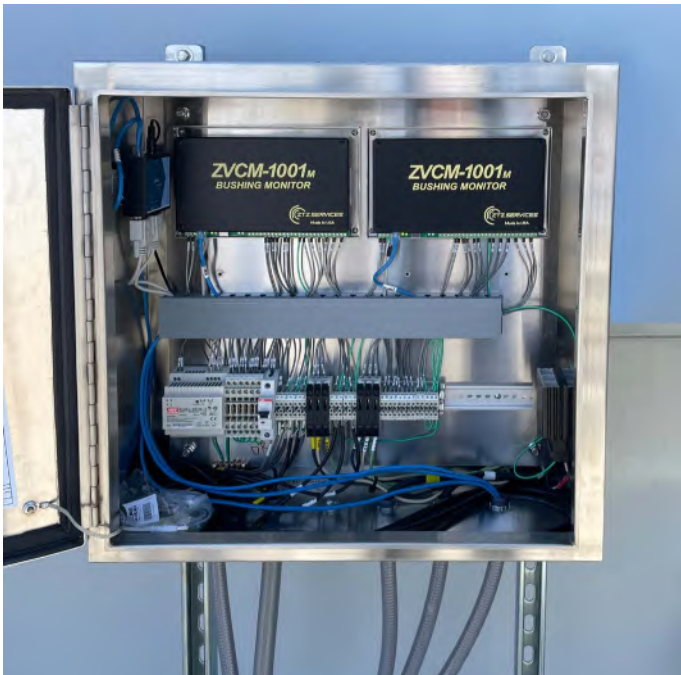
Figure 3. Two six-channel bushing monitors are installed beside the transformer

the 12-channel monitoring system (Figure 3).

The use of all twelve phasor measurements makes for an extremely robust system with very high signal-to-noise ratio. By using measured system phasor quantities, the bushing attributes can be very accurately known.

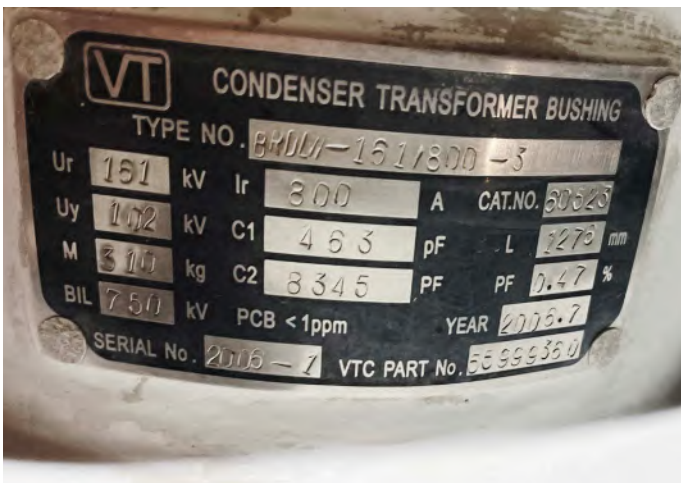
Figure 4. High-side bushing nameplate showing factory test data

Within a few days, it was quite apparent there was a problem with the H1 high side bushing, with power factor nearing three times nameplate (Figure 4). Phases H2 and H3 showed stable power factor, essentially at nameplate values (Figure 5). Because of the heavy load cycle, this transformer was classified as being applied to "rough service". The high power factor reading put it beyond the limit for any "watch list" but was classified as "unstable", in danger of failure.

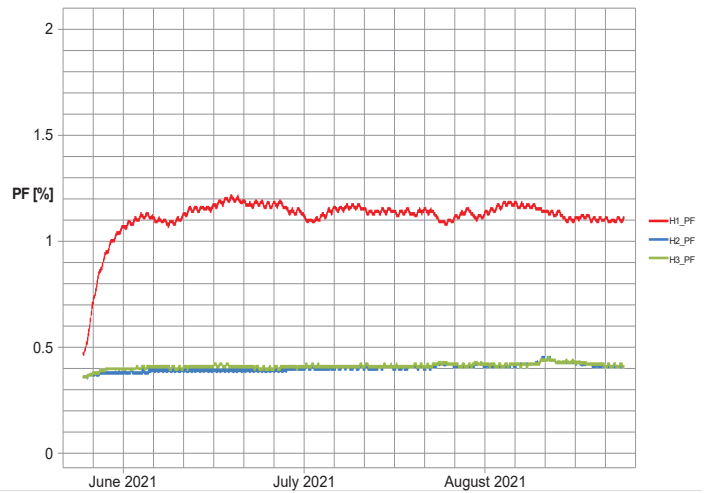
Figure 5. High-side percent power factor for three months since monitor installation

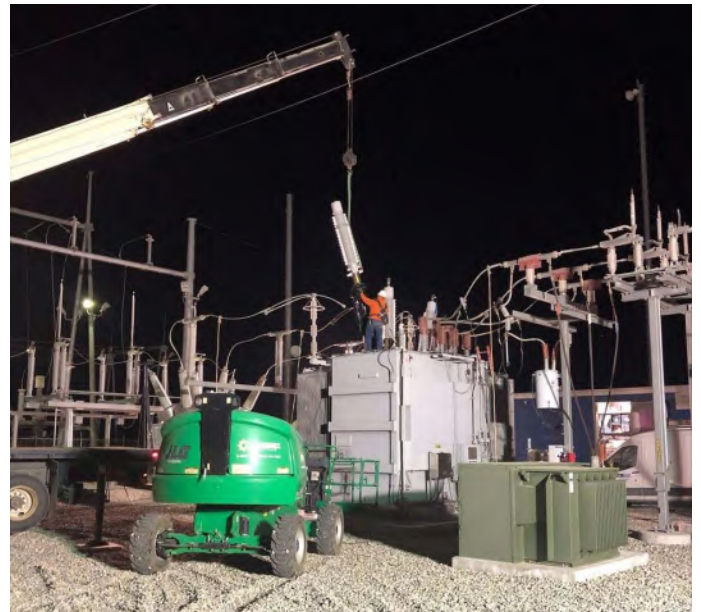
Figure 6. Night time H1 bushing replacement

In August, the bushing was tested with offline techniques. The test confirmed the high power factor and the bushing was replaced without incident three weeks later (Figure 6). Plots of bushing capacitance and high side imbalance current were stable since the monitor installation, showing the likelihood that the H1 bushing had high power factor when the transformer was commissioned, but was not detected with offline test techniques.

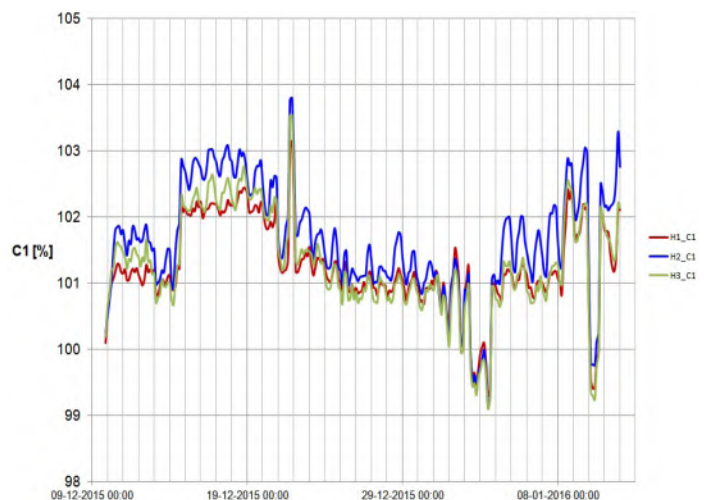
Figure 7. C1 percentage above nominal of high-side bushings, two month plot

At a power plant in Eastern Europe, bushing monitoring was added to the high-side bushings of a 17-year-old 270 MVA GSU in December of 2015. Six phasor inputs were used; three high side C1 test tap connections and three CCVT inputs. Two months after installation, the data showed the C1 from H2 (blue trace) above the others by 0.5% (Figure 7). The power factor data (Figure 8), shows power factor of H2 peaking at 1.5% (red trace).

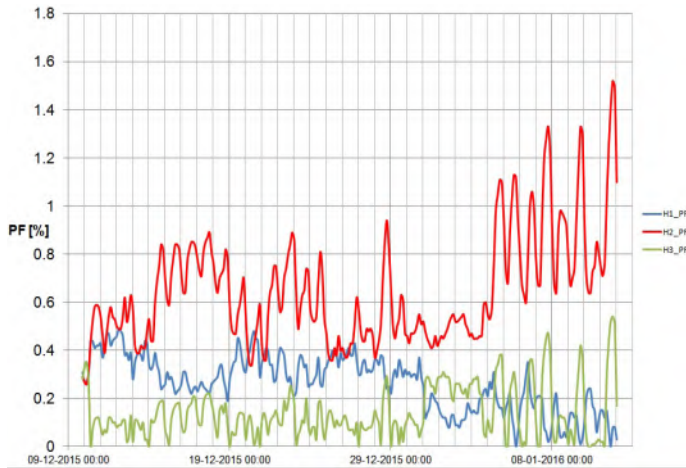
Figure 8. Percent power factor data of high side bushings, two month plot

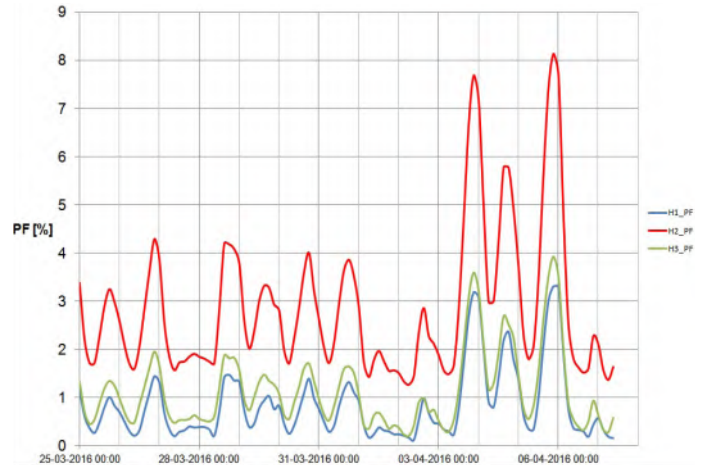
Figure 11. Percent power factor data of high side bushings, four month plot

Four months from installation, data shows worsening conditions. C1 at 111% (Figure 10), PF at 8% (Figure 11), and leakage current imbalance of 8.0% (Figure 12).

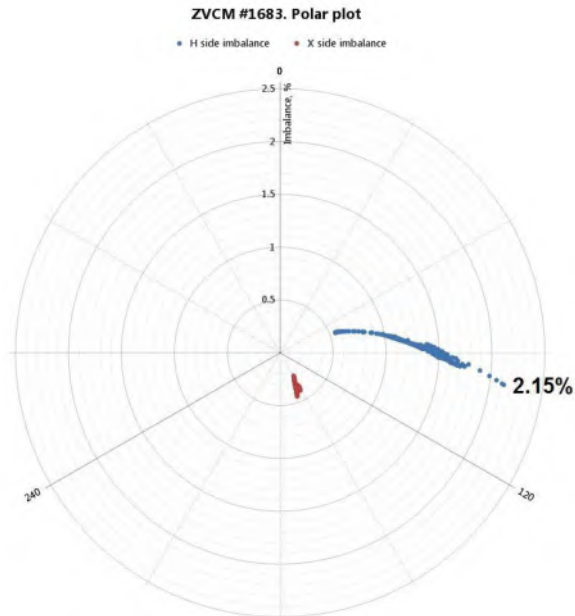
Figure 9. Polar plot of leakage current imbalance, two month plot

Further increasing confidence, the polar plot of the high side leakage imbalance current (Figure 9) shows steady increase, showing strong polarization.

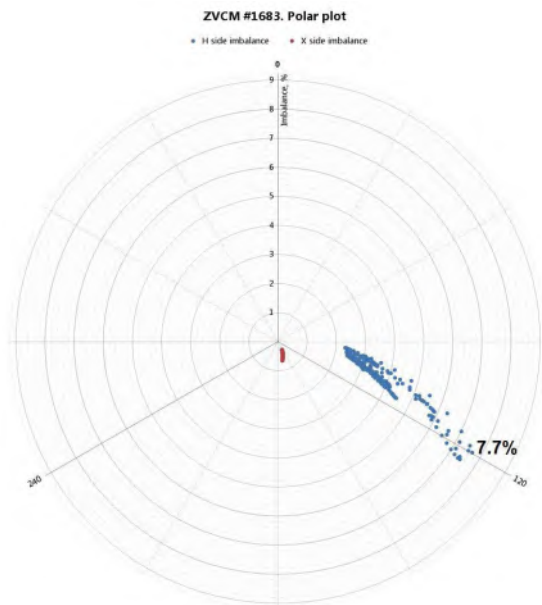
Figure 12. Polar plot of leakage current imbalance, four month plot

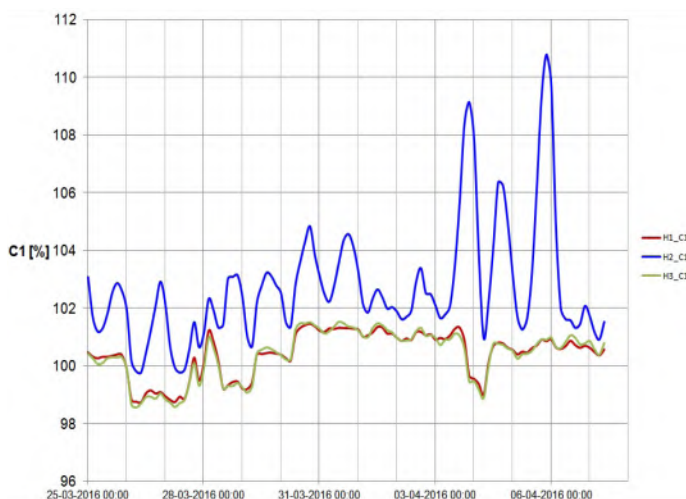
Figure 10. C1 percentage above nominal of high side bushings, four month plot

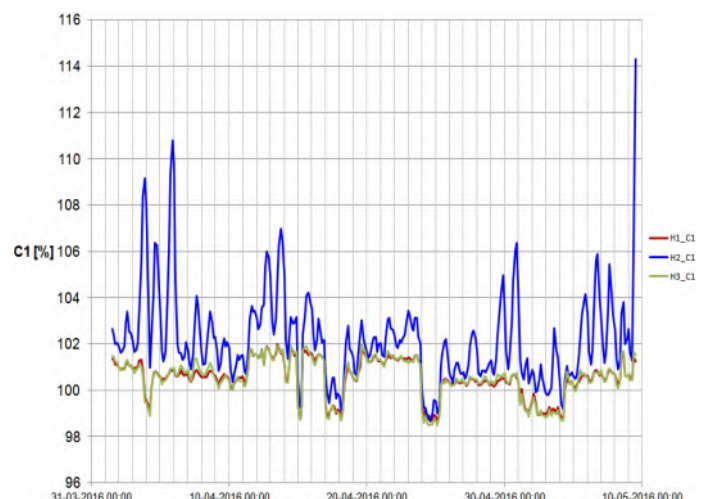
Figure 13. Final death rattle of the H2 bushing, showing last measurement of C1

In May of 2016, it was advised that the transformer be taken immediately out of service for testing. Because an outage was planned within five weeks, the owner decided to wait until then. Two days before the outage, the bushing exploded (Figure 14). The final C1 measurement of H2 was 114% (Figure 13) and 8% power factor. In the last moment before failure, the big increase of C1 can be observed, caused by break of insulation layers between metal foils in bushing condenser core (Figure 15).

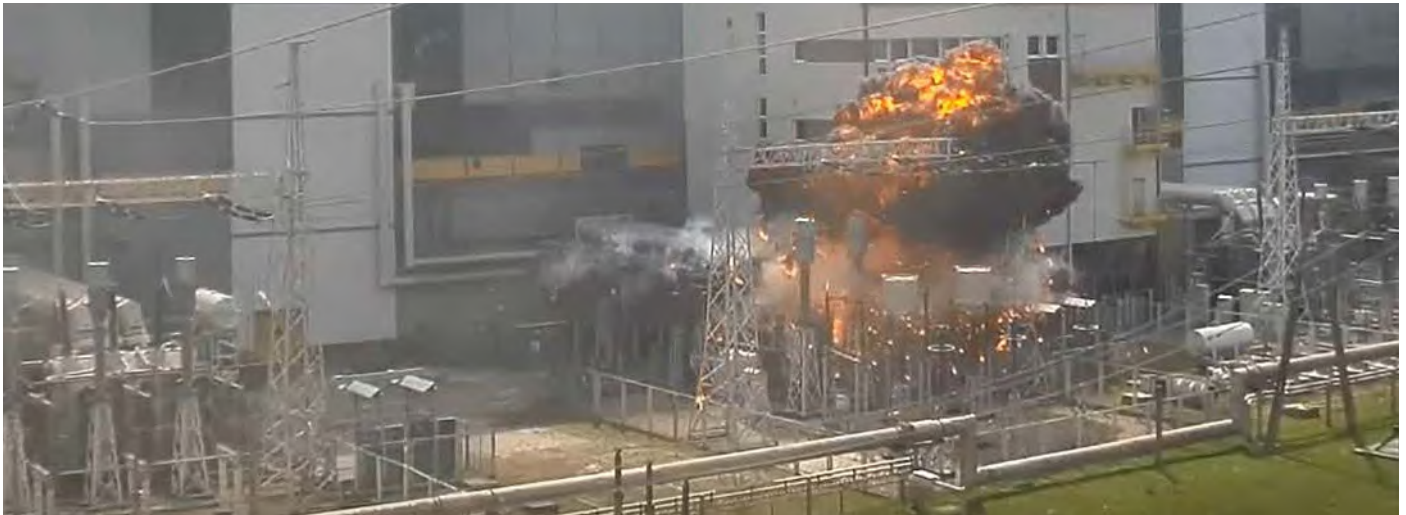
Figure 14. Station security camera view of exploding H2 bushing

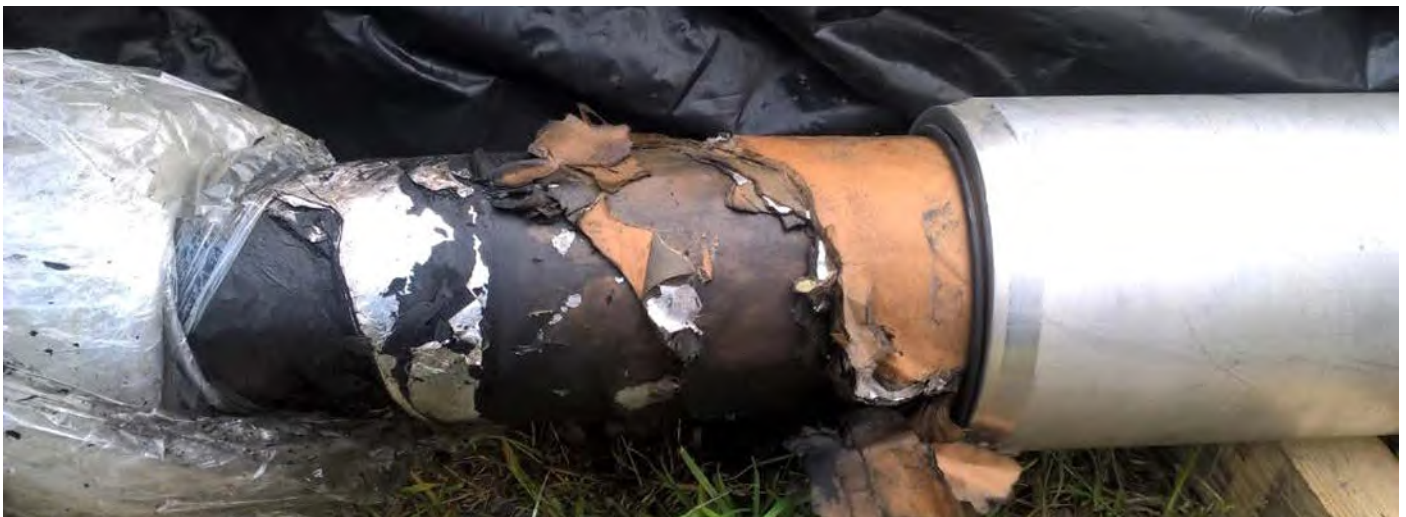
Figure 15. H2 bushing debris found in yard showing failed capacitive layers
