Electric Substation Large Power Equipment: Cost Effective Methods for Repairing Oil and Gas Leaks

by **Steven H. Wickman**

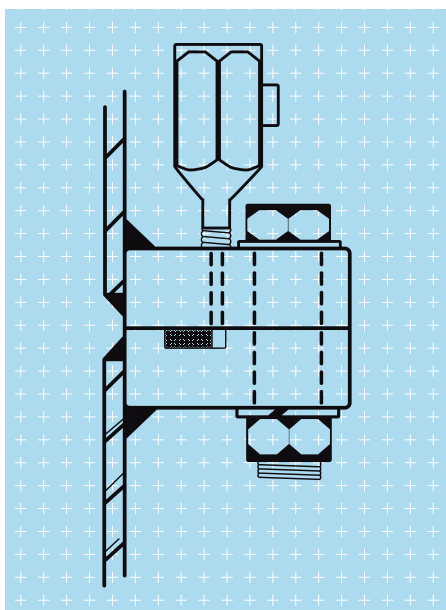
Figure 2. Drill and Inject technique. Left: A graphical sketch depicting how the injection valve is drilled into the gasket groove to inject the liquid sealant material and effectively replace the failed gasket material. Right: Injection valve with sealant injection hose.

There are two techniques prevalent amongst the leak-sealing specialists. The first of these is a Drill and Inject technique whereby the leak seal technicians are able to drill access holes to the gasket groove and inject, under pressure, a sealant compound, essentially creating a new gasket without disassembly of the transformer to access the gasket groove (Figure 2).

Then pipe plugs are inserted to contain the sealant under pressure while it cures. The sealant is injected in a fluid, liquid state that has a consistency similar to honey or pancake syrup, to use an easily understood analogy.

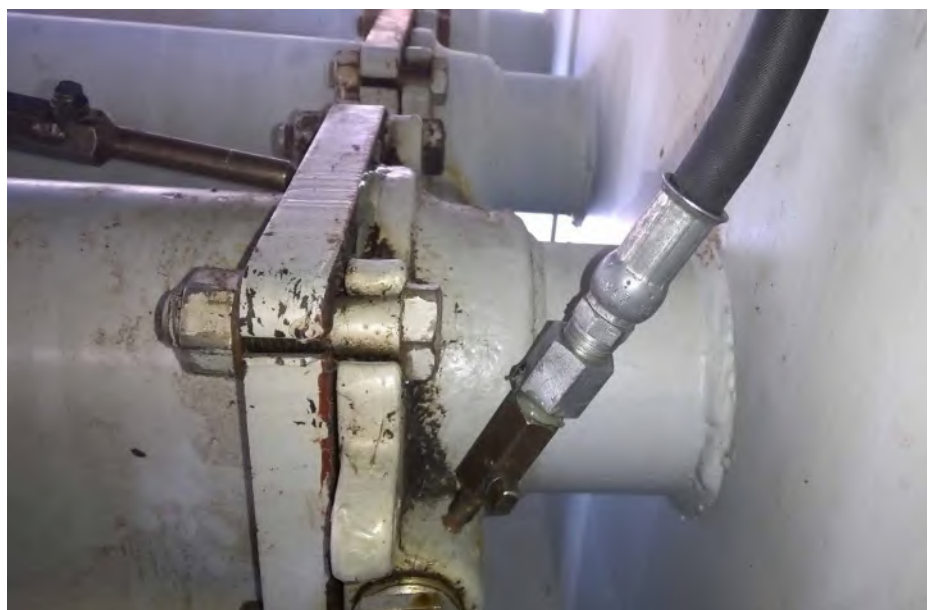
Figure 3. Drill and Inject technique: Online leak seal

The sealant cures into a flexible material that has durometric properties essentially identical to those of OEM nitrile rubber gaskets. The life cycle of the leak seal installed gasket material is essentially the same as OEM gaskets. Thus, with the leak seal repair technique you get the same result as regasketing without all the extra time, labor, and expense of a drain and regasket repair. Additionally, many Drill and Inject repairs, particularly if the leaks being addressed are on piping flanges at the lower end of radiators, away from

the energized components, can be performed with the transformer still in service carrying load (Figure 3).

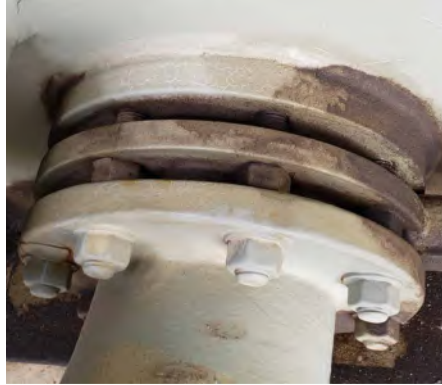
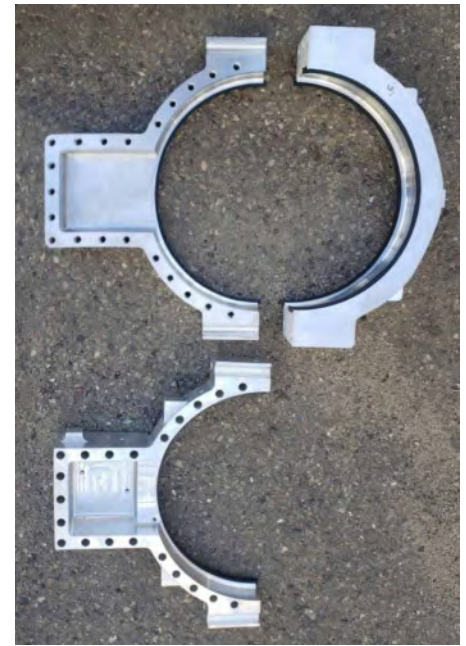
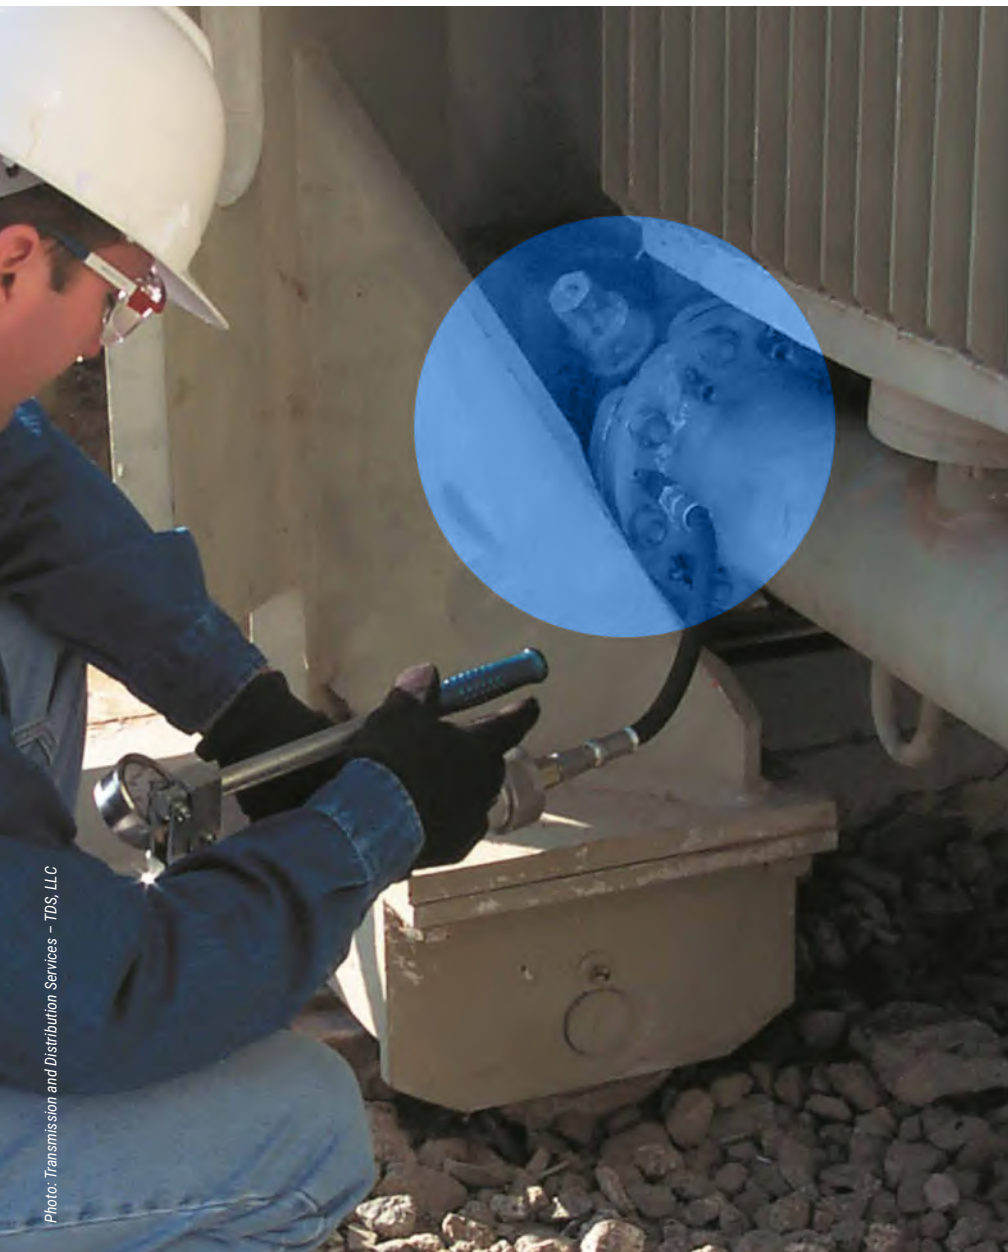
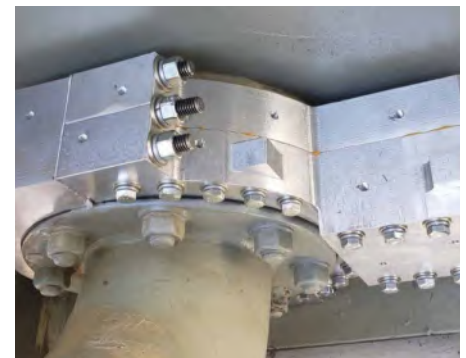
Figure 4. Top left: Open face flange and butterfly valve. This configuration will not support the Drill and Inject technique. Top: A three-part clamp butterfly valve. Bottom: A three-part clamp butterfly valve installed.

Some flanges on oil-filled apparatus cannot be repaired by the Drill and Inject technique. Open-faced flanges, where there is not a recessed gasket groove, require an alternative repair technique, which is to apply a custom fabricated aluminum clamp externally around the leaking flange. This clamp, measured and fabricated to the precise dimensions of the flange, is put in place and has an internal groove that is filled with the

same leak seal sealant to create, in essence, an external gasket around the leaking component. This leak repair technique works effectively on virtually any flange that cannot be drilled and injected (Figure 4).

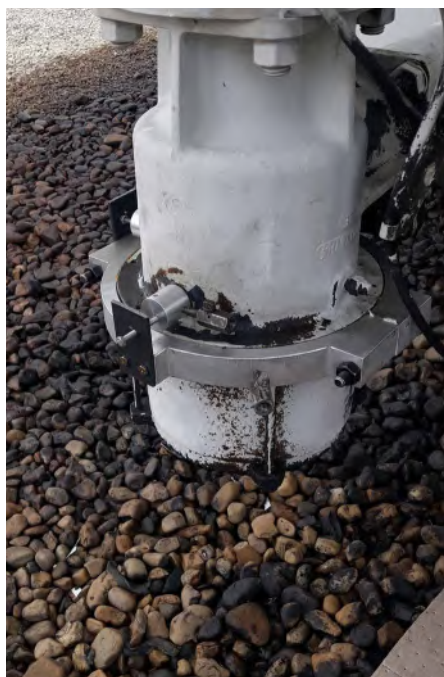
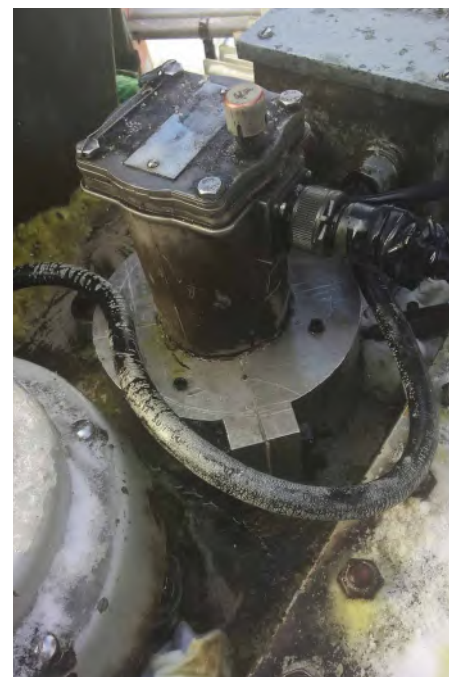
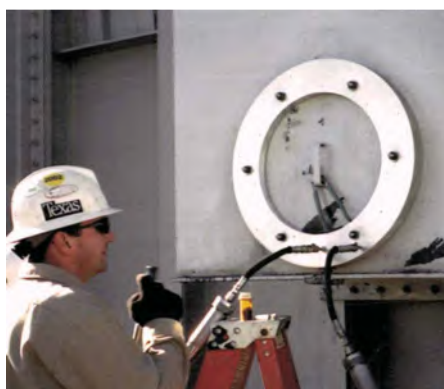
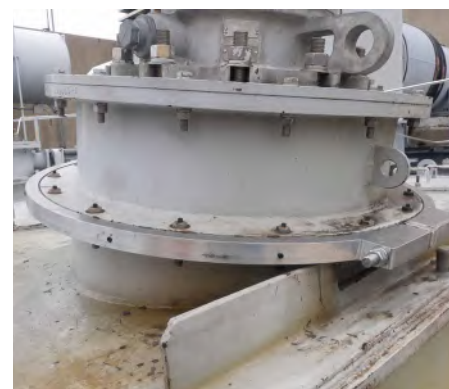
Figure 5. Top left: Clamp installed on transformer oil pump. Top right: Clamp installed around a top-mounted sudden pressure relay leaking oil at its mounting flange. Bottom left: Clamp being installed on the flange of a transformer access hatch. Bottom right: Transformer bushing turret clamp.

In addition to open-faced flanges, this technique has been used on flanges on pumps, fault pressure relays, access hatches, bushing flanges and bushing turrets (Figure 5).

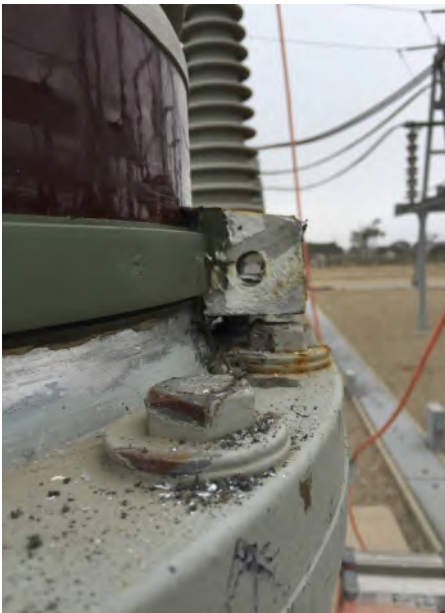
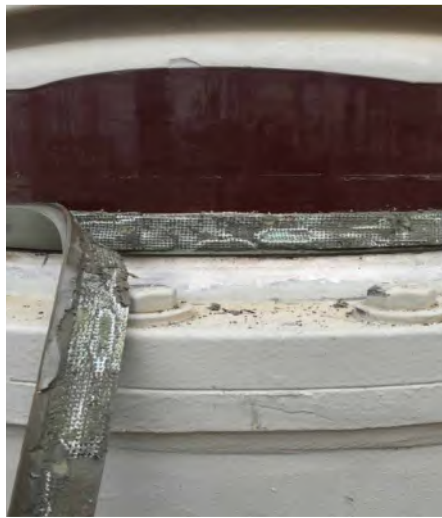
Figure 6. Left: Portion of clamp removed showing cured sealant. Top: Same repair, sealant cut away showing its flexibility.

nitrile rubber gasket material. The cured compound material does not adhere to the internal surfaces of a gasket groove, nor to the internal cavity of an external clamp. Thus, if the leak seal repaired flange requires disassembly for other repairs of the apparatus, the cured leak seal compound can be easily peeled away with a simple tool, even a pocket knife (Figure 6).

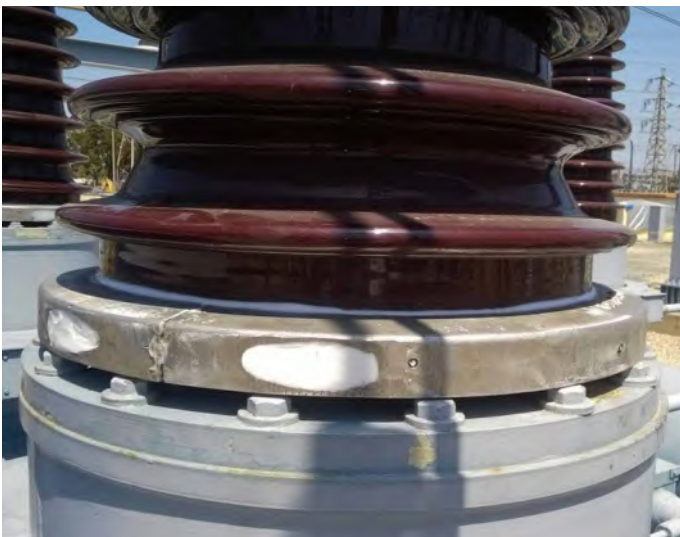
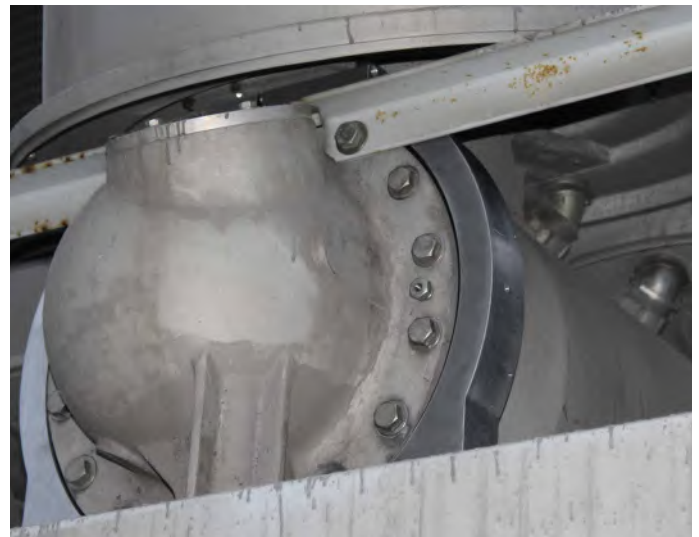
Figure 7. Left: Clamp on an EHV GCB bushing base. Right: Clamp enclosing on the end bell flange of an EHV GCB interrupter tank.

Gas Circuit Breakers (GCBs) have multiple flanges on bushings and other components that are ideal candidates for leak seal repairs via the external clamp repair technique (Figure 7).
