Best Practices for HV Bushing Condition Assessment

by **Daniel Carreño**
Abel González Gómez
and **Volney Naranjo**

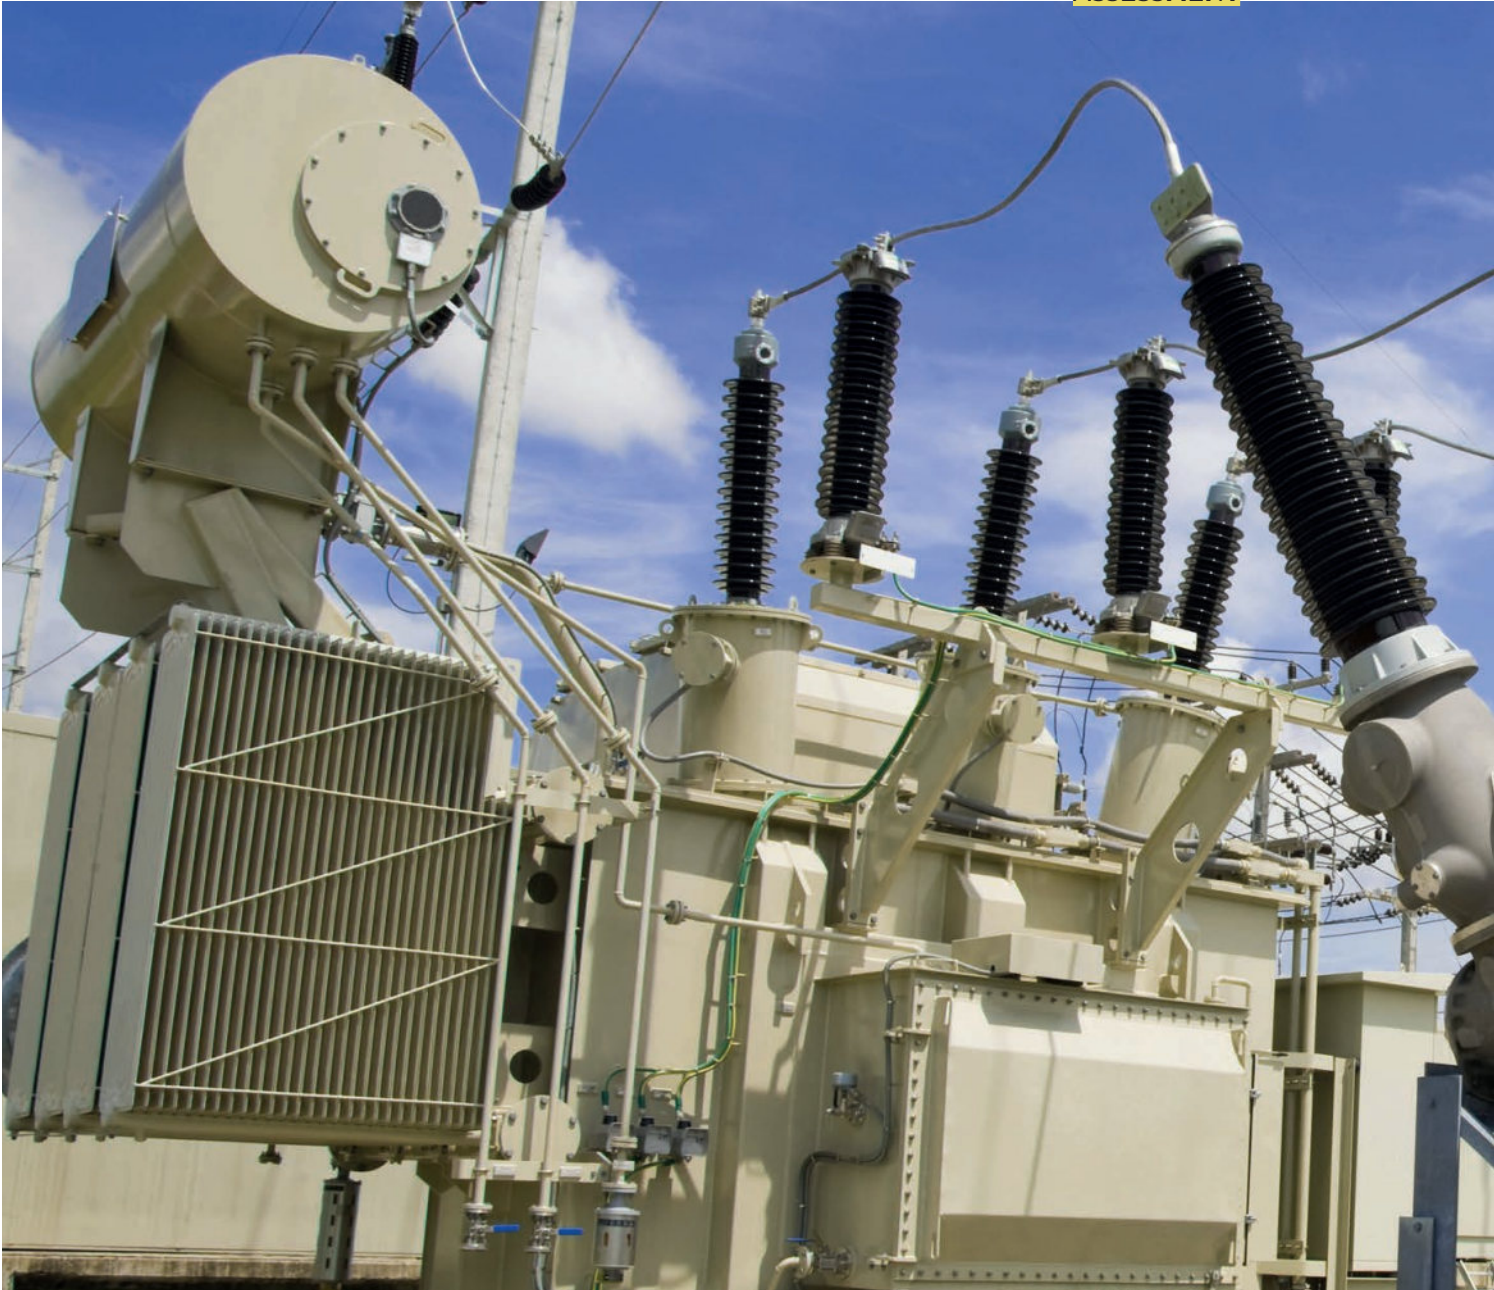
Figure 5. Example of bushing PF temperature dependence

Although PF measurements are obtained from accurate instruments, results need to be corrected to 20°C for trending analysis and comparison against nameplate data. Temperature correction is highly dependent on insulating material and its structure, ageing condition, presence of moisture or contamination, so that a fixed correction factor from a reference table may introduce some error in the corrected value by over or undercompensating. An alternate correction method is the Individual Temperature Compensation (ITC), which calculates an accurate correction factor based on a variable frequency PF measurement and

Despite the method, proper determination of the bushing temperature is required to avoid introducing a higher error in the corrected value. Since there is no direct measurement of the bushing temperature, it must be estimated, and the recommended approach is calculating the average from the transformer top oil temperature and the ambient temperature.

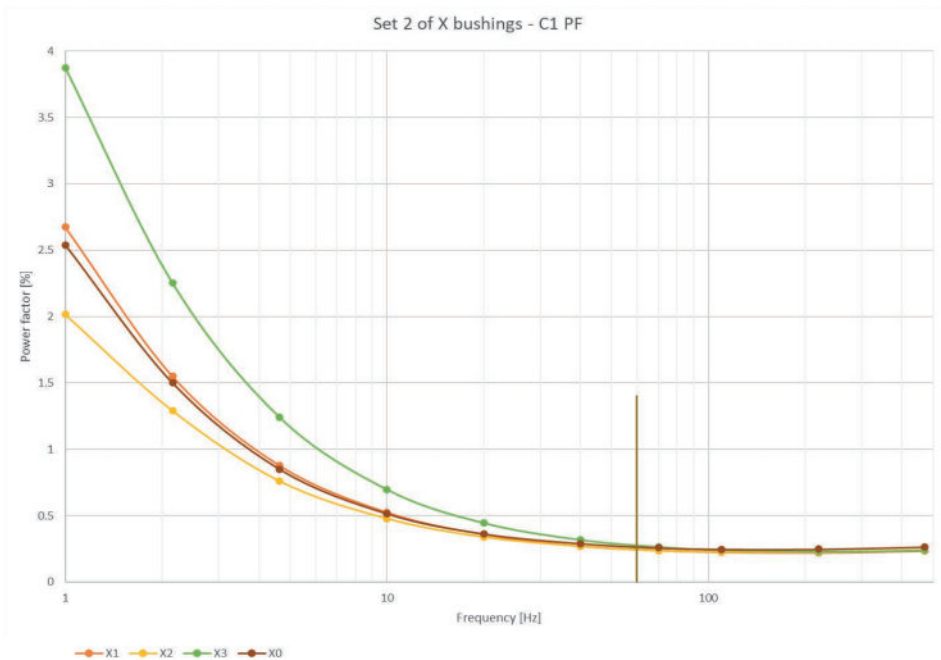
Figure 8. NBDFR on four OIP bushings

The example in Figure 8, illustrates a case of four LV bushings exposed to the same loading/thermal profile and environment. The 60 Hz results are below 0.5% and almost identical, the evaluation of this result will not trigger any investigation or action. The NBDFR result shows that X3 has higher losses, yet unnoticeable at 60 Hz; enabling an individual to decide on proper remedial actions.
