# When Bushings Go Bad: Check Your Data

by **Tony McGrail**  
and **Kenneth R. Elkinson**

*In bushing monitoring it is very important to be aware of all available data – the raw phase angles and rms leakage currents for each individual bushing are often as useful as the derived power factors and capacitances in terms of deterioration detection, investigation and diagnosis.*

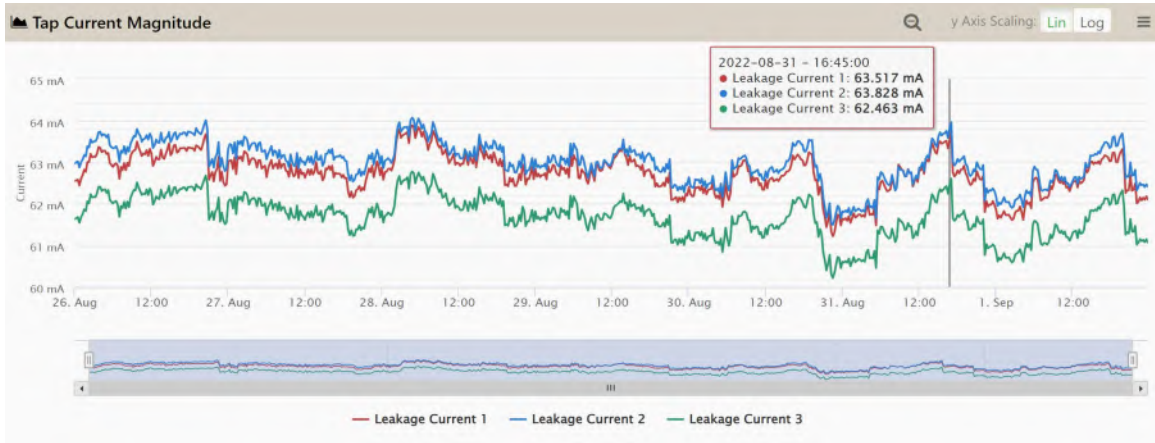
Figure 1. Showing the variation in leakage current magnitude for three GSU bushings over 7 days in 2022

These two findings are also useful in online measurements where raw current waveforms are recorded, from which we can calculate relative phase and rms magnitudes for the leakage current of each bushing; from these values we can calculate the individual bushing power factors and capacitances (TT). Leakage current varies with both bushing condition and system voltage providing a lot

of 'noise' in the measurements, as shown in Figure 1.

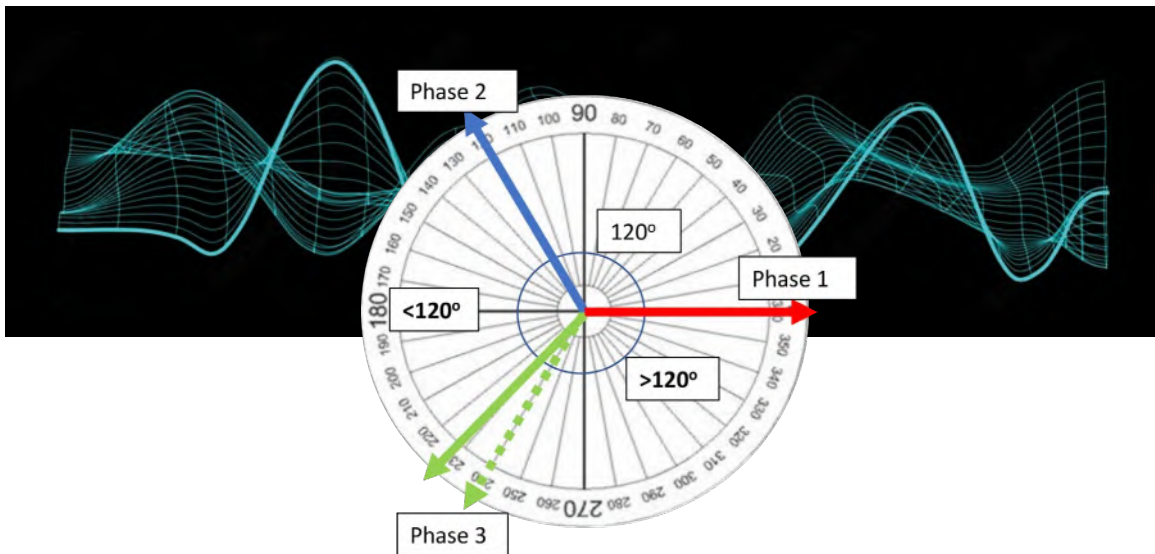
Figure 2. Exaggerated phase angle change for Phase 3 bushing showing Phase 1-to-2 staying unchanged

In Figure 2, we show the three phasors associated with the three leakage currents from a set of bushings which, in an ideal balanced system would all be  $120^\circ$ . We have added a very large change in the Phase 3 bushing – a change 100 times greater than expected from bushing deterioration – so we can easily see the effect on the relative phase angles:

- Phase 3-to-1 increases
- Phase 3-to-2 decreases by the same amount that 3-to-1 increased
- Phase 1-to-2 stays the same

Consequently, if we were to plot the data over time, Phase 1-to-2 should stay constant if just bushing 3 is deteriorating. Also note that the sum of the three phase angles is always  $360^\circ$ .

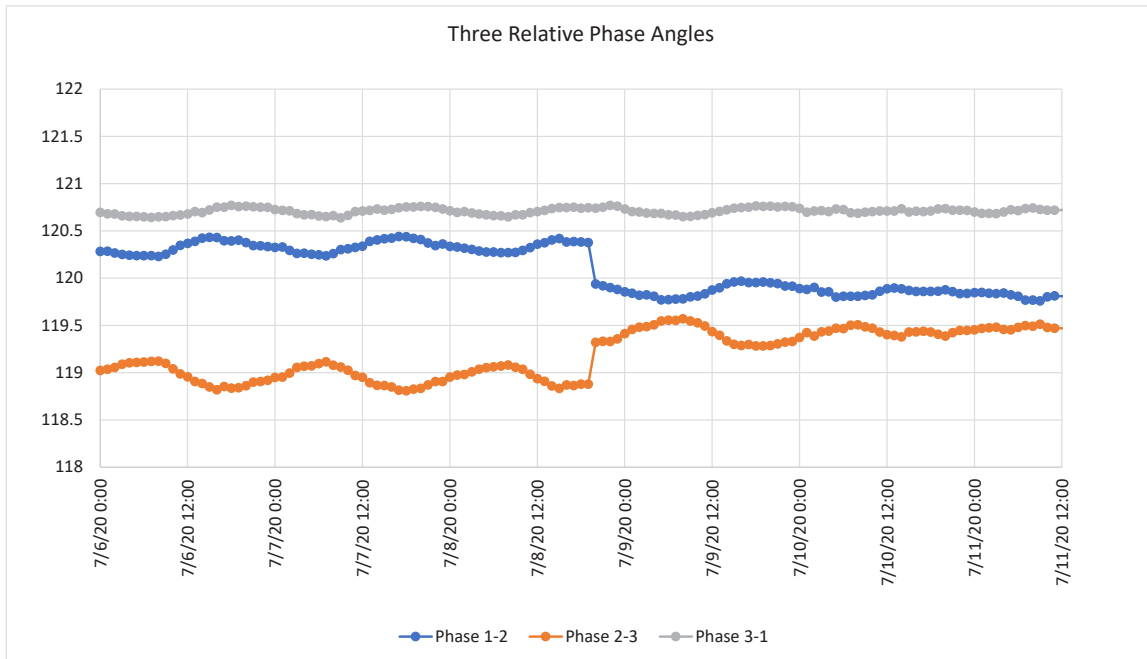
Figure 3. Step change in phase angle for Phase 2 bushing

In Figure 3 we can see example results where both traces involving the phase 2 bushing show a sudden change in angle. Note that the remaining trace is relatively constant, indicating that it is just one bushing deteriorating. As expected in Figure 3, the sum of phase angles at any point is 360°, and the traces involving the deteriorating bushings

show reflections of the variation, as expected: the increase in one is the same as the decrease in the other.

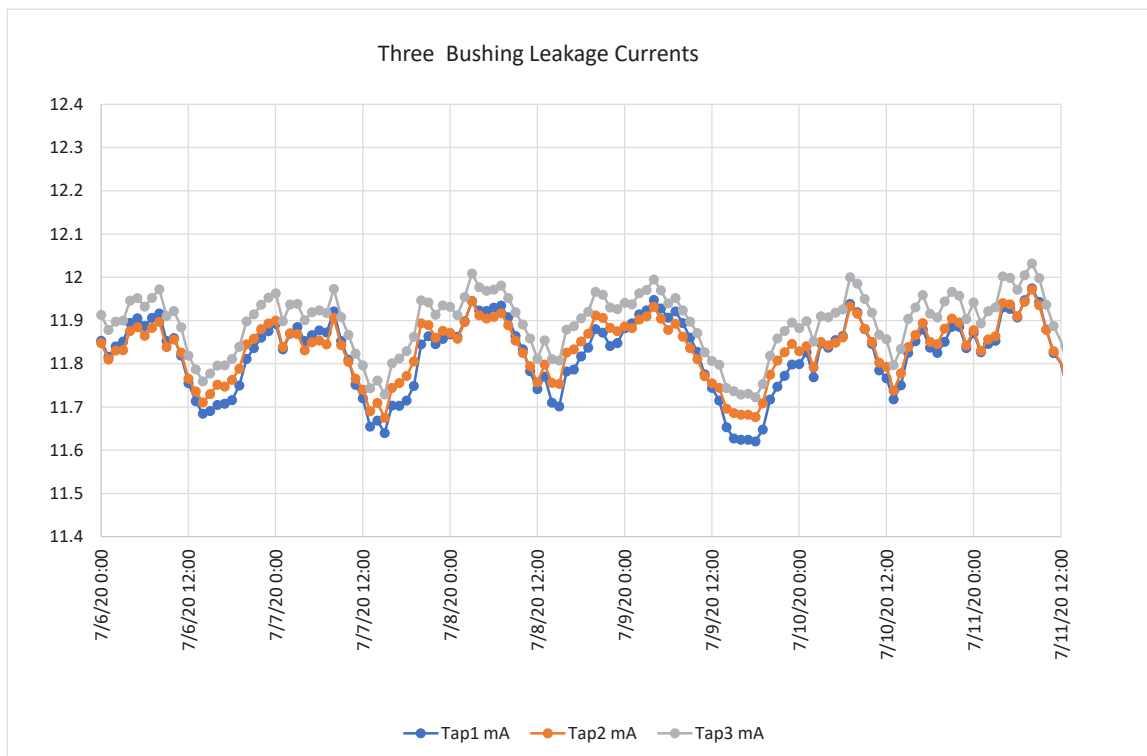
Figure 4. Leakage current magnitude for the three bushings

At the same time as recording the phase angles, we can also look at leakage current magnitude for the three bushings, shown in Figure 4. The natural variation in current magnitude, following a daily cycle

shows no particular disturbance at the date/time of the anomaly in Figure 3.

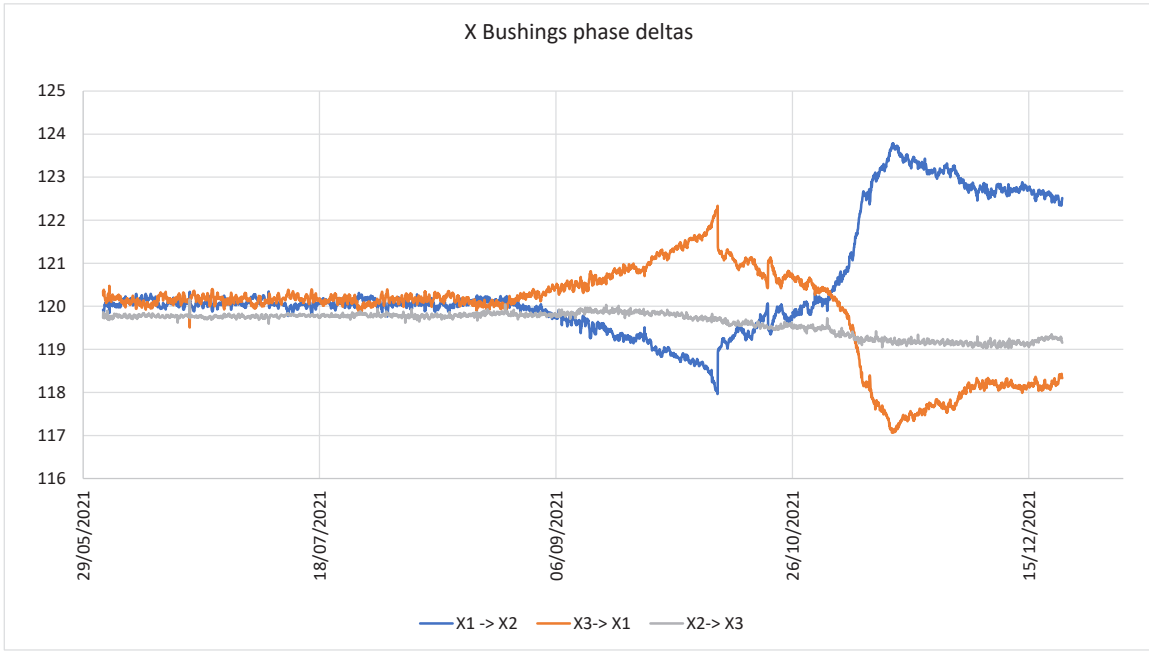
Figure 5. Relative phase for 3 bushings

In Figure 5 we can see the relative phase angles for three low voltage bushings recorded over several months. The changes recorded in Figure 3 were small, as expected, but in Figure 4 we are seeing changes of several degrees.

In Figure 5, none of the traces show a constant value, indicating that more than one bushing is deteriorating. The two traces with large changes in phase angle both include the X1 bushing, which is thus the suspect bushing. In addition, the fact that for the X1 bushing the phase angle heads in one direction then reverses implies that the power factor has increased then decreased again. This is an uncommon effect where a bushing shows the effect of internal tracking within the bushing due to

contamination or moisture ingress and can eventually lead to a negative power factor being recorded. The effect of tracking can also be seen in the leakage current magnitude over the same time period, as shown in Figure 6.

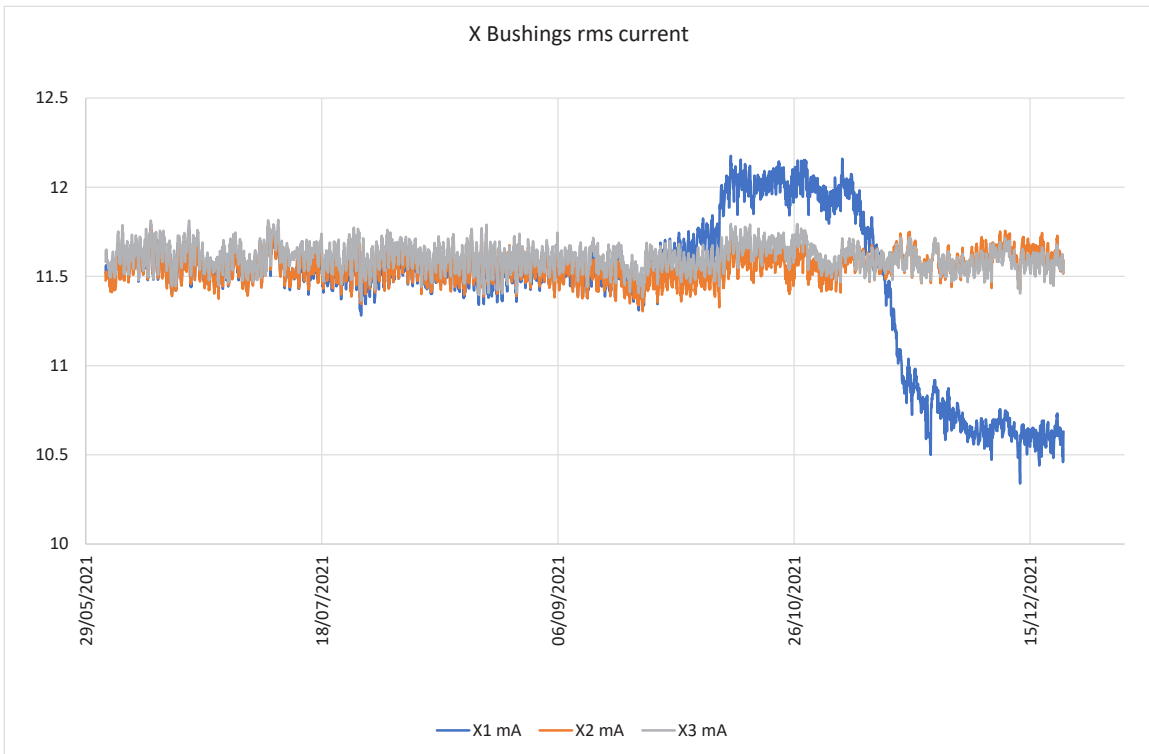
Figure 6. Leakage current magnitude for three bushings

A rising current is typical of deteriorating bushing, but here the current rises, and then subsequently falls – again, an uncommon event, and one which relates to internal tracking within the bushing.
