Using Visual Inspections of Components to Increase Transformer Reliability

by **Bob Rasor**
and **Jon Bucciarelli**

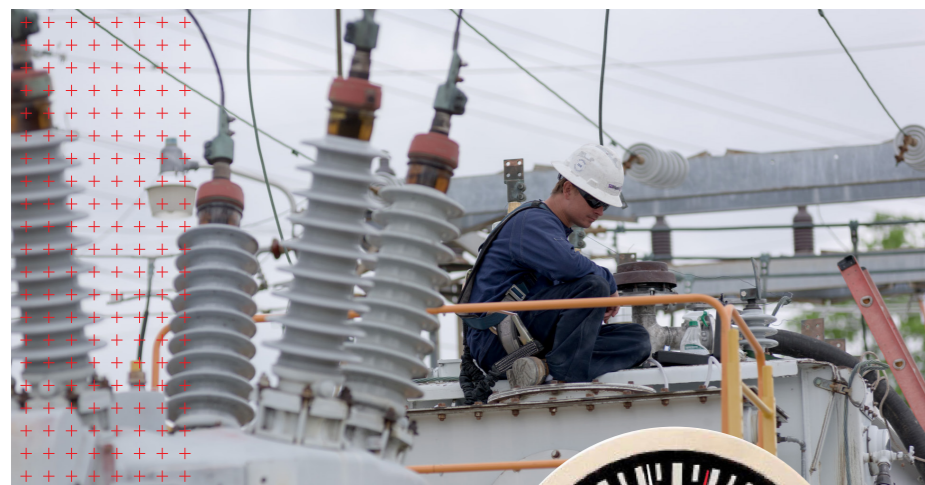
Figure 4

the bottom peg (red arrow) is either very low or the float on the lever has somehow failed. It is important to verify the level in this case. One method is using a long piece of clear tubing on the bottom valve with a vented tank. Raising it to the top of the transformer will show the exact liquid level.

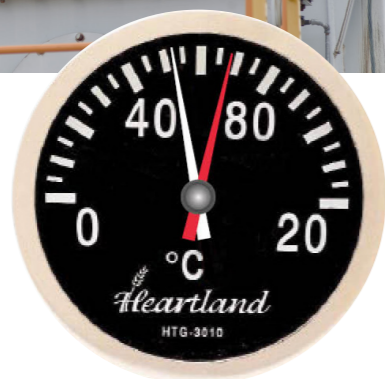
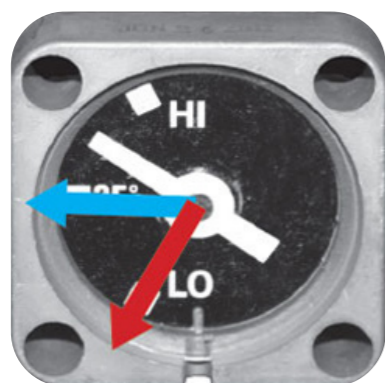
Figure 5

At 25°C, most level gauges have a horizontal pointer position. As the temperature rises, so will the "NORMAL" level position of the pointer. For instance, a transformer running at a 43°C top liquid temperature with a pointer position around the 25°C mark indicates a low liquid level and should be corrected as soon as possible.

When considering liquid level, reading a level gauge is not quite as simple as seeing where the needle is pointing. It is necessary to include the relationship of the liquid level with respect to temperature.
