# Twin Technologies Test Transformer Reliability

by **Allan Rienstra**  
+++++

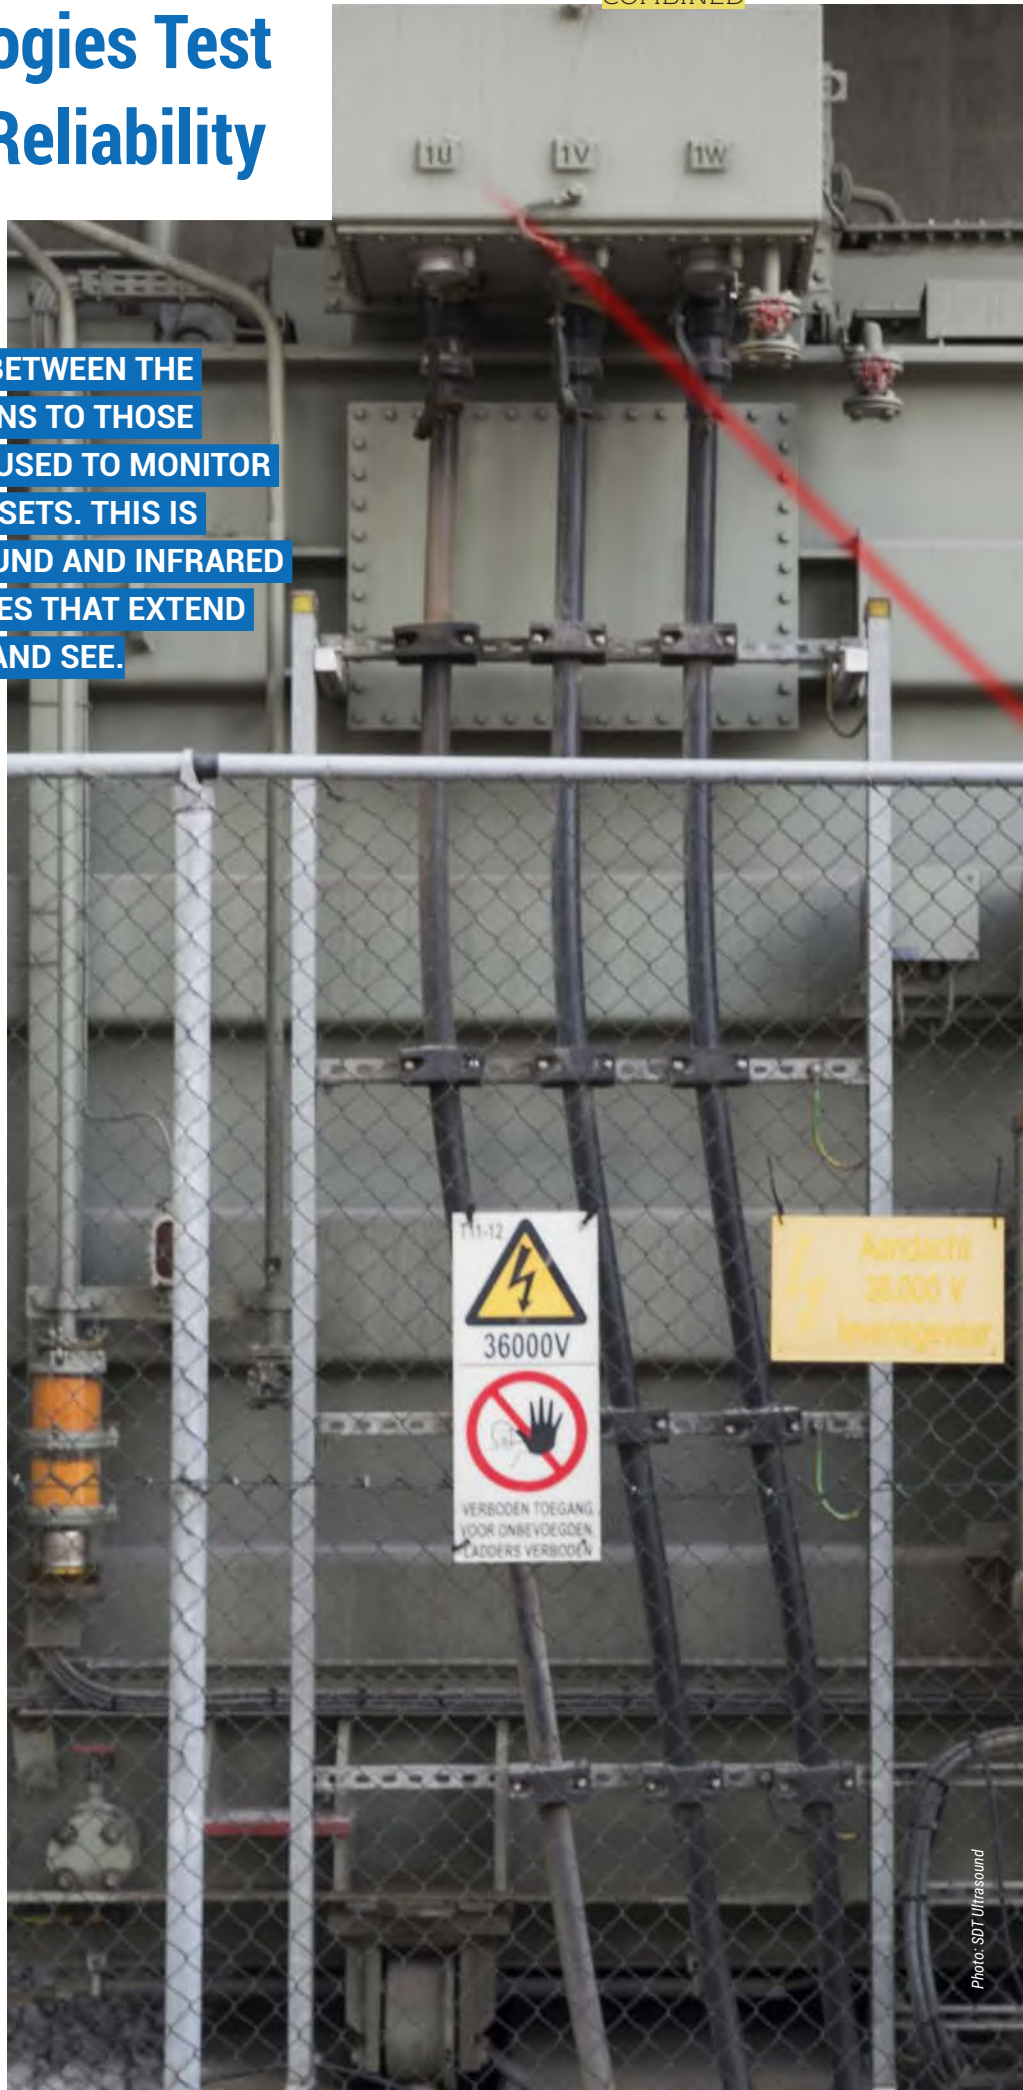
The laser of this parabolic dish from SDT is pointing at the left phase of this 36 kV transformer while the inspector remains safely on the other side of the fence.

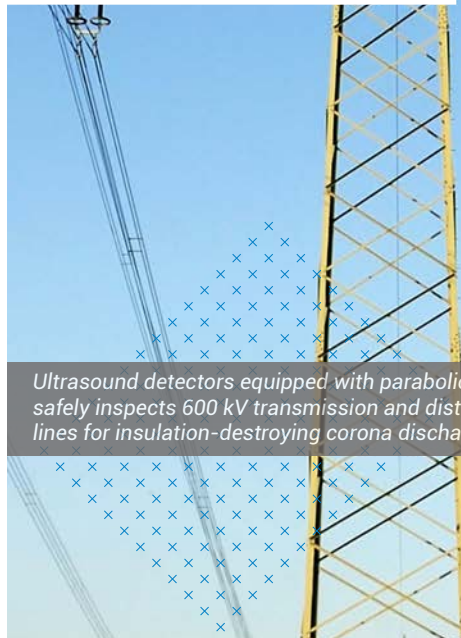
Ultrasound detectors equipped with parabolic sensors safely inspects 600 kV transmission and distribution lines for insulation-destroying corona discharge.
