# The Importance of Continuously Monitoring Partial Discharges Online in HV Bushings

by **Marco Tozzi**

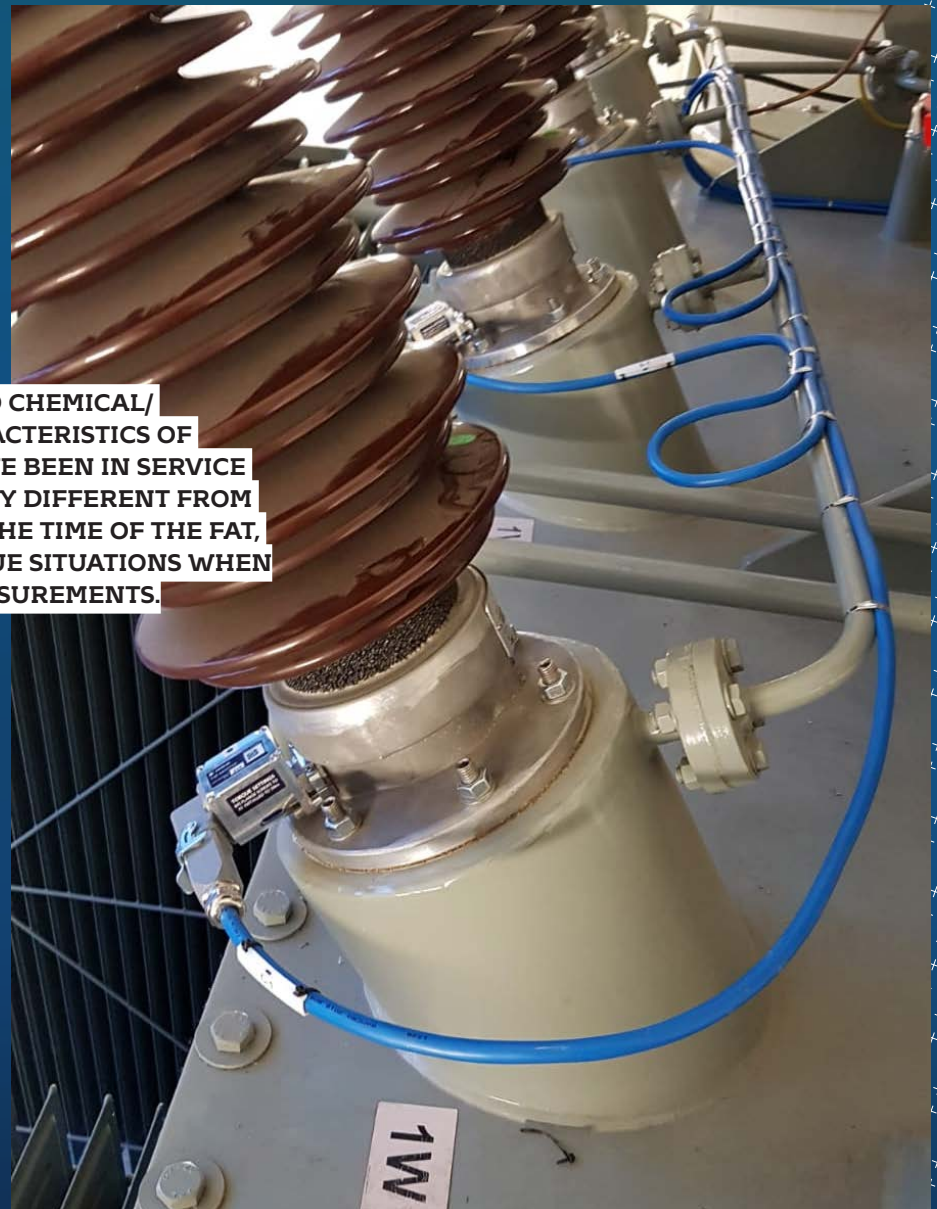
Figure 1. Bushing adaptor installed at the test tap for PD and Leakage Current online monitoring.

under real operating conditions. Historically, this is done by collecting the 50/60 Hz leakage current at the test (or voltage) tap (Figure 1) and then comparing the currents in each bushing to check for anomalies in one bushing current in terms of either amplitude or angle [7]. Modern devices can do something more, by extending the frequency range of the sensor and acquisition system within the MHz range in order to detect another important parameter: Partial Discharges (PD). However, this technology is not widespread and is rarely requested as a mandatory requirement from end-users. Why?

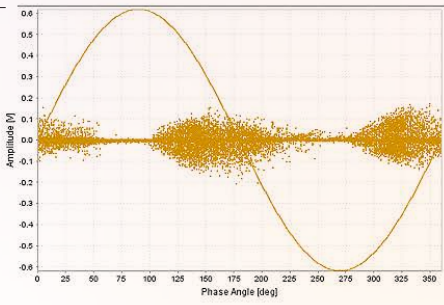
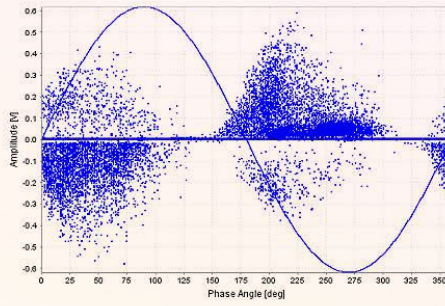
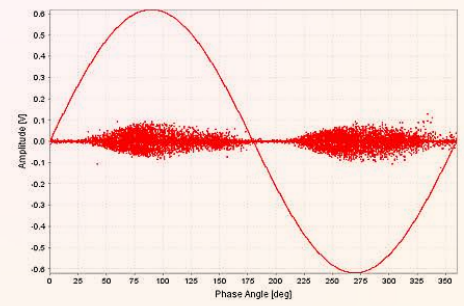
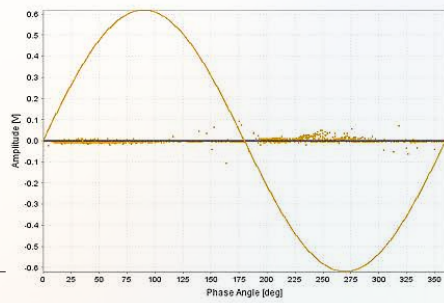
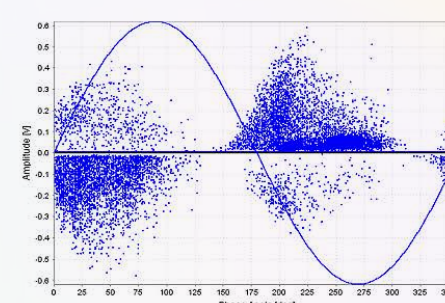
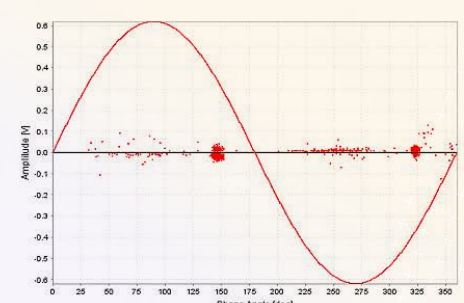
Figure 2. Differences between an acquisition with (bottom) and without (top) an automatic denoising and cross coupling rejection logic.

This is important because these interferences can overlap to the actual PD and affect the evaluation of amplitude and repetition rate, i.e. PD intensity and its trending over time. Figure 2 shows an example of a PD acquisition in three phases. Each phase has a PRPD pattern, but the defect is actually generated from Phase B only. Without the automatic denoising logic, the system would record and keep pulses in each phase (Figure 2, top), instead of focusing on where the actual PD source is (Figure 2, bottom) and this would affect the statistical amplitude and repetition rate evaluation. Furthermore, it would make the pattern analysis difficult, relaying on experts to help in understanding if that PD is an actual PD or a cross-coupling event.

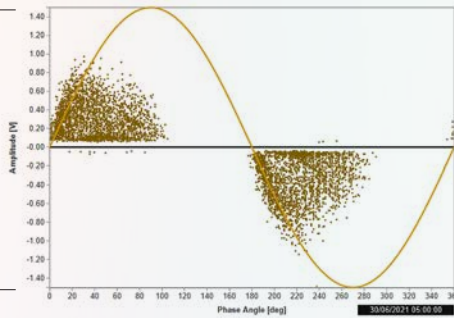
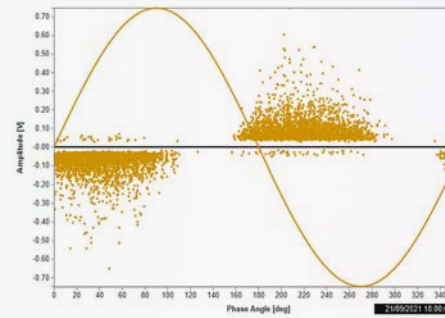
Figure 3. PRPD pattern of a PD acquired in the bushing (left) against a PD on the top of the winding (right). They have opposite polarity under the same sinewave.

conception of an intelligent algorithm capable to discriminate if the recorded PD activity is inside the bushing or not. One of the most known elements, as an example, relates to the ability of analyzing the PD pulse polarity with respect to the applied voltage. Indeed, the PD pulses coming from the main tank have opposite polarity from those coming from the bushing condenser core when detected by an impedance installed between the test tap pin and ground. This is quite complex but can be summarized by the difference between having the measuring impedance in either "direct" or "indirect" circuit within the Equipment Under Test (EUT).

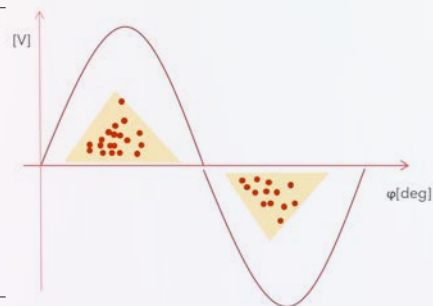
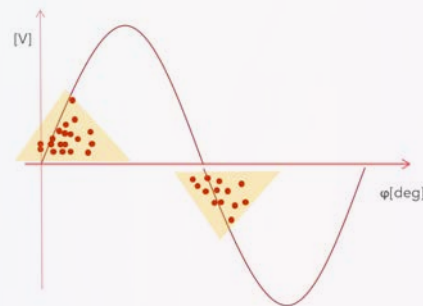
Figure 4. The same PRPD pattern could show a very early (left) or quite advanced (right) stage of degradation depending on its position with respect to the zero crossing of the applied voltage, which must be very accurate and acquired from the bushing tap together with the PD.

The position of the PD pulses with respect to the zero crossing of the applied voltage is very important to understand the source of PD and its degradation stage [12-13]. Few degrees of differences can make a huge difference in the diagnosis. For that reason, the synchronization voltage must be accurate and be recorded from the test tap together with the high frequency pulses, i.e. not from external power supply sources in the substation to which a manual phase shift has then to be applied.
